# A CASE HISTORY-IMPROVEMENTS TO AN EXISTING COOLING TOWER SUMP AND HORIZONTAL SPLIT CASE PUMPS

**Paul J. Wallen**

**Gregory S. Towsley**

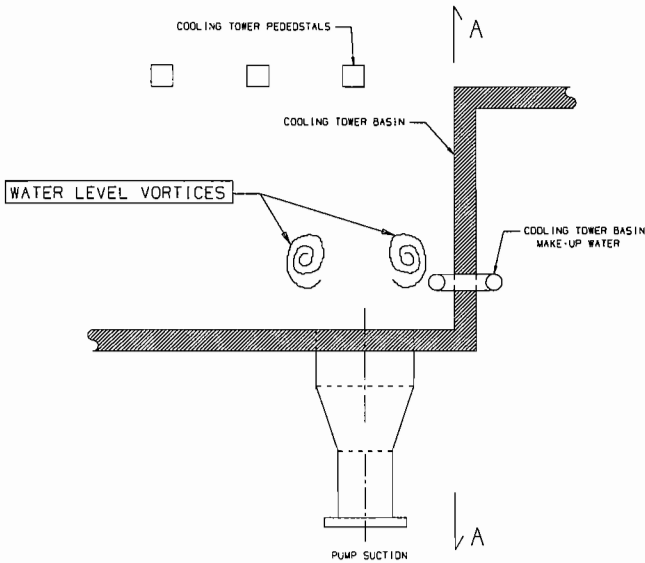
Figure 8. Location of Water Level Vortices.

Since the construction of the cooling tower basin, water level vortices have been present. Both pump units always had two vortices located near the suction piping inlet, as is depicted in

Figure 8. Based on Hydraulic Institute's (1994) Vortex Classification System, as shown in Figure 9, the vortices were a Class 4, due to the air/vapor bubbles observed in the core. Occasionally, Class 5 vortices were also observed. As this chart depicts, large amounts of air and any top-water floatables would be immediately pulled into the vortex, and eventually into the pump.

Utilizing Figure 10 and Figure 14, modifications were made to the sump to reduce or eliminate vortices. Four modifications were made to the cooling tower basin at the pump suction inlets as described below and shown in Figures 15 and 16.
