Bearing Failure on a Boiler Feed Water Pump

A Case Study by:

Kevin Karban

Kerry Gunn

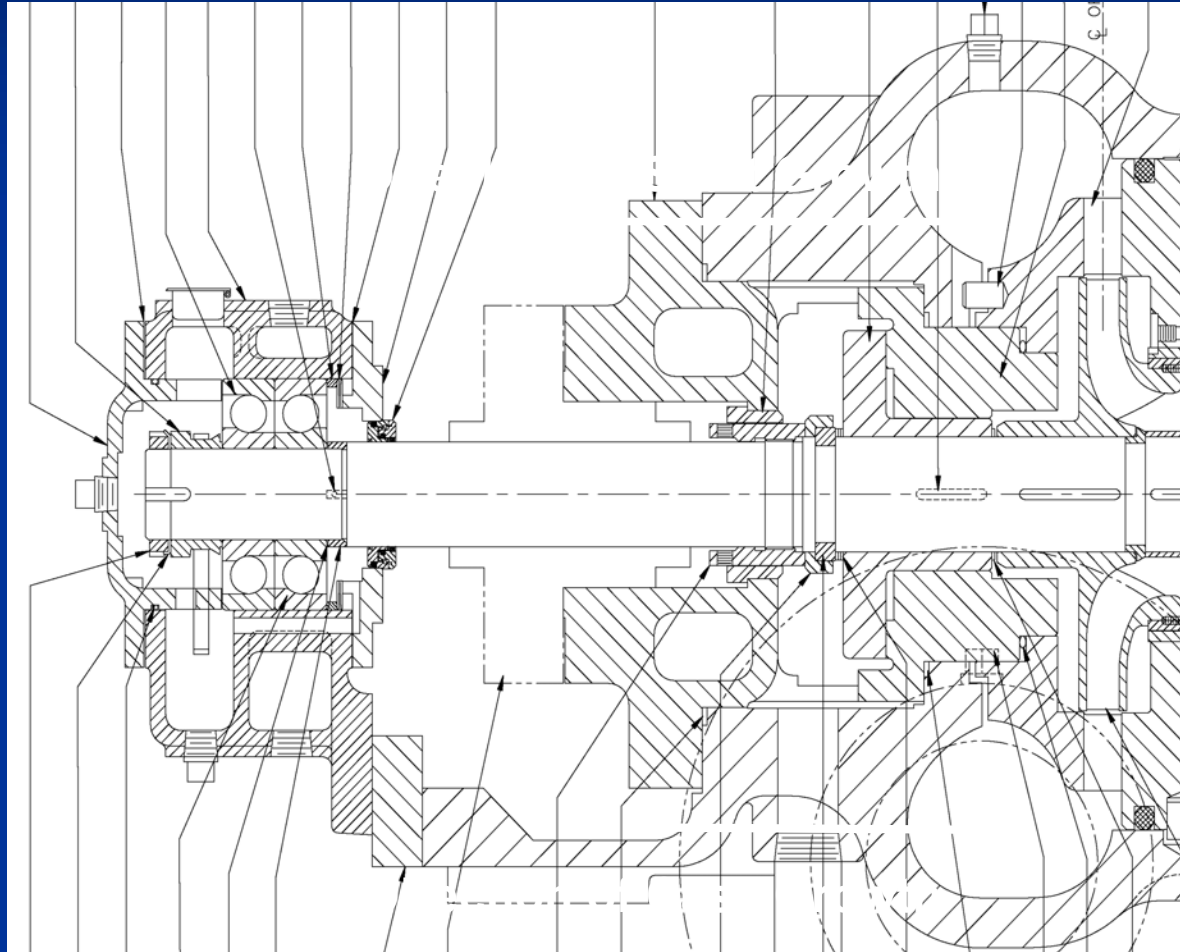
Shaft Design Issue

- It was discovered that the installed shaft material was 410SS.
- The pump was originally designed with a 316SS shaft to match the 316SS casing.
- Thermal growth difference of $5.5 \cdot 10^{-6}$ in/in F vs. $8.9 \cdot 10^{-6}$ in/in F
- ΔL for 410SS = $5.5 \cdot (250\text{F} - 80\text{F}) \cdot 12 \text{ in} = 0.01122 \text{ in}$
- ΔL for 316SS = $8.9 \cdot (250\text{F} - 80\text{F}) \cdot 12 \text{ in} = 0.01815$
- Difference of 0.007 in

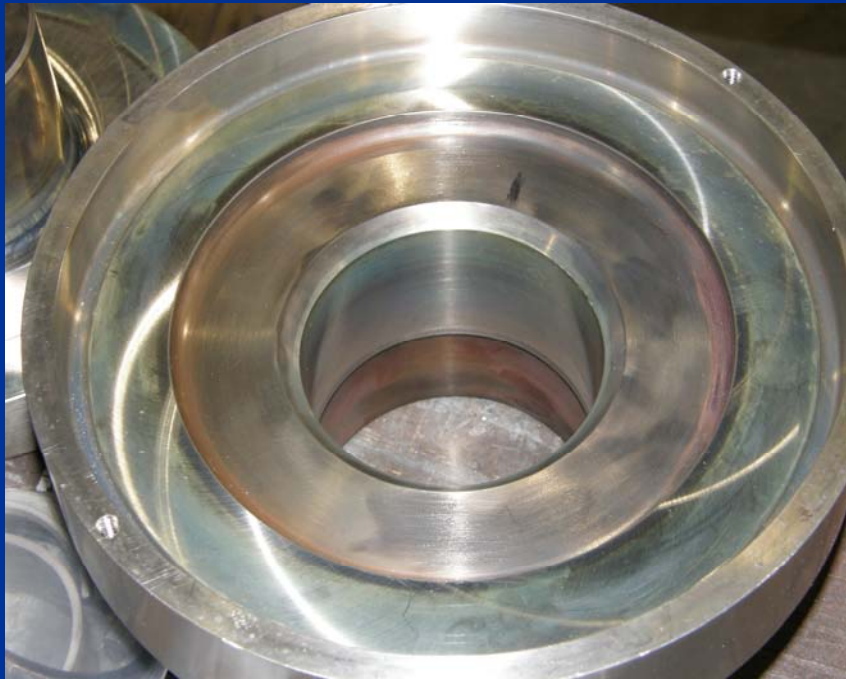
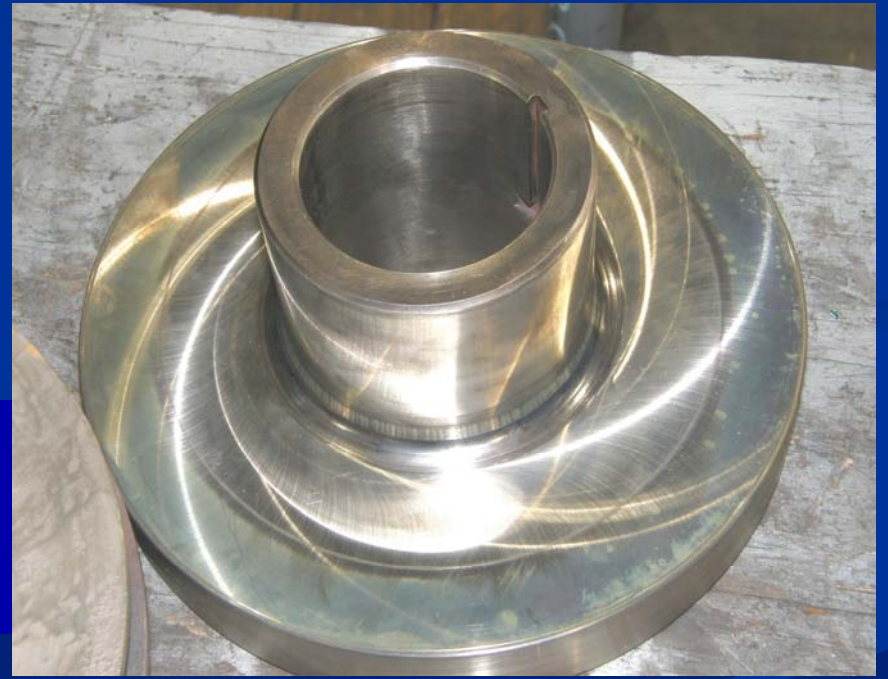
Balance Drum and Balance Piston Pictures

- Existing design balance drum setting relied on a fairly tedious and vague thrust
- A spring was added in the thrust bearing assembly which allowed the balance drum to close as needed to balance the load and not be constrained.

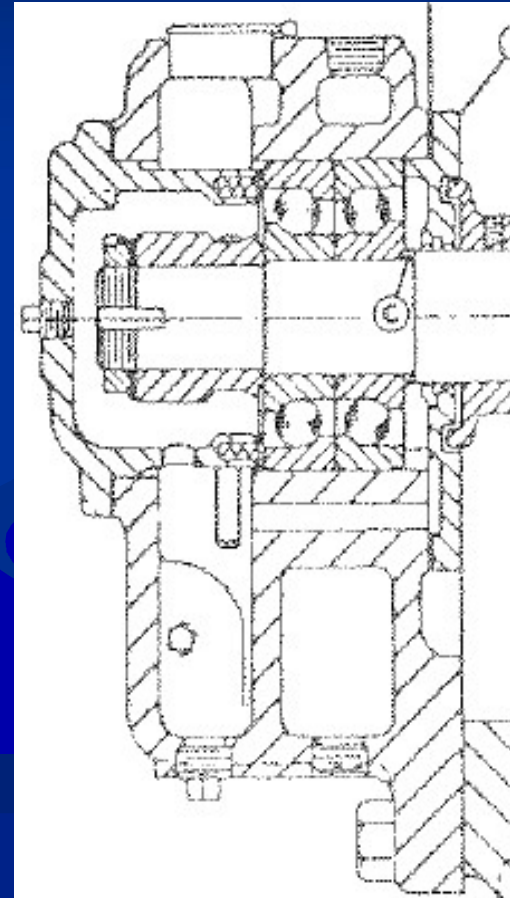
Existing Design

- Thrust bearing is contained on both ends in a traditional manner.
- A spacer is used between the bearings and inboard cover to set the balance piston gap at 0.002" to 0.005".

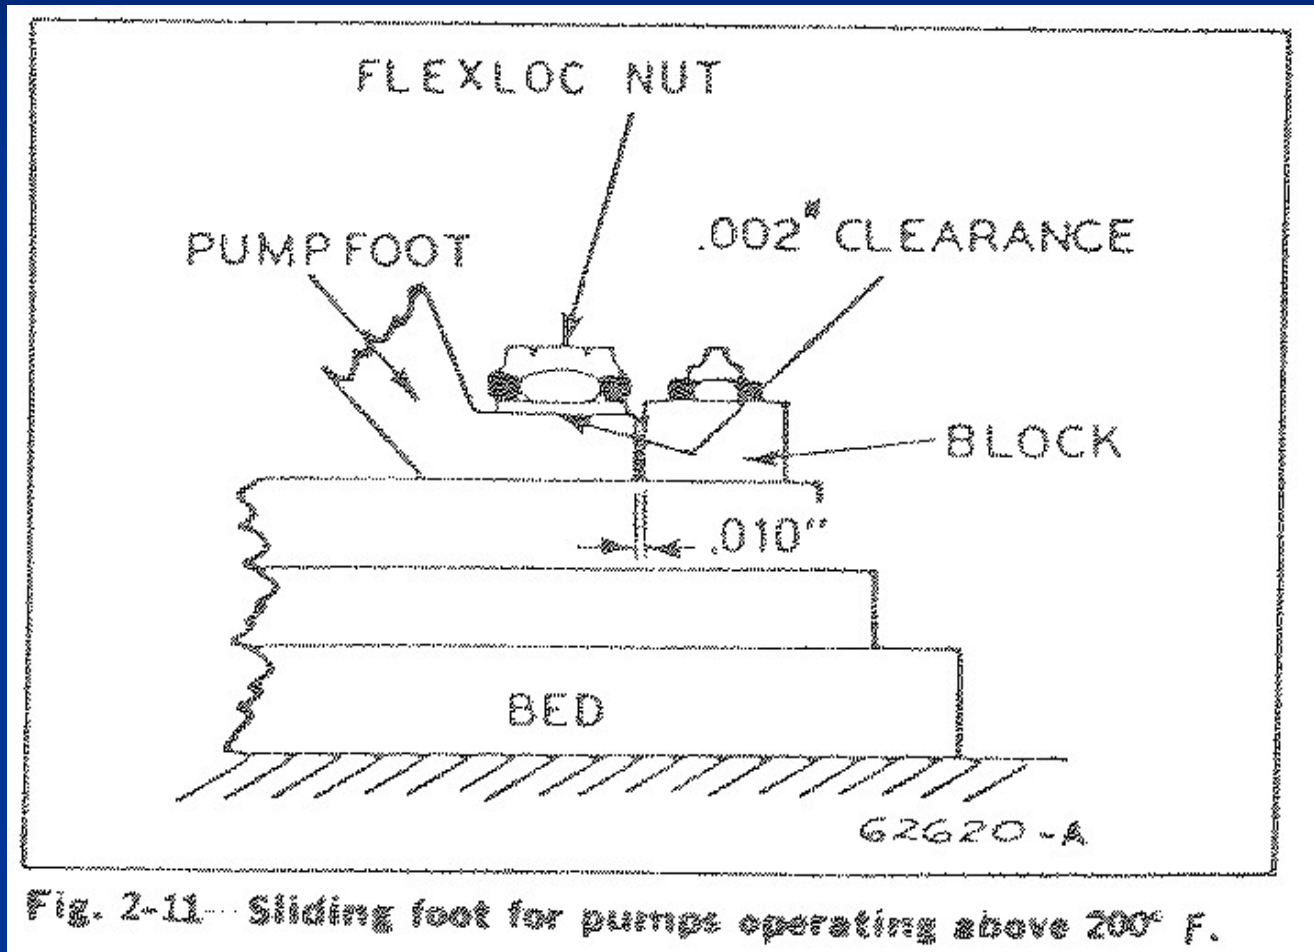
OEM Recommended Mounting

- One issue identified after the 2nd shop repair was possible thermal growth of the casing binding the pump.
- The pump was not installed per the OEM recommendations for 200F and higher applications.
- On each repair after the 2nd shop repair the base bolts were loosened after heating with an indicator placed on the bearing housing.
- Thermal growth was found as high as 0.025”.
