CHALLENGES FOR PUMPS HANDLING HOT REFINERY RESIDUUM

Petroleum Company of Trinidad and Tobago

2008 Jan 16

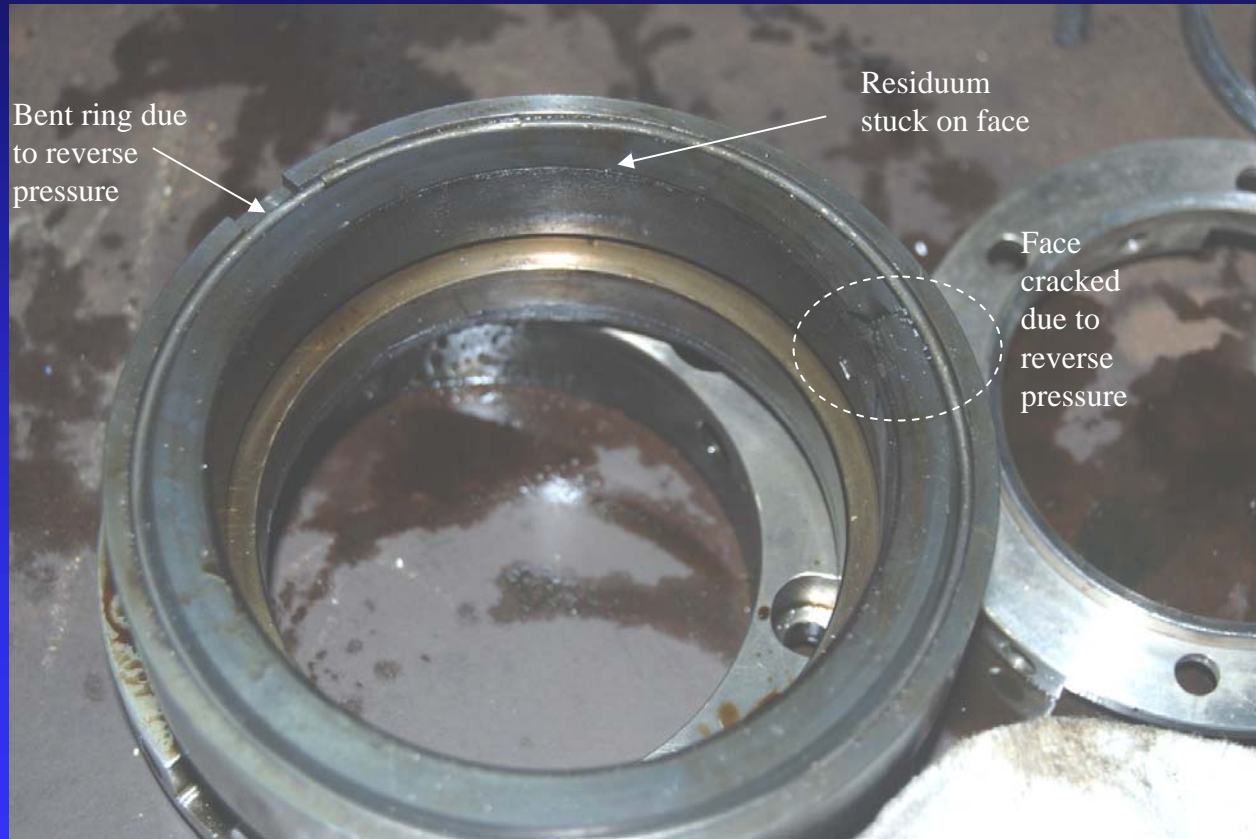
Picture 1: *East Pump Interstage End – Inner Seal
Face (Rotating)*

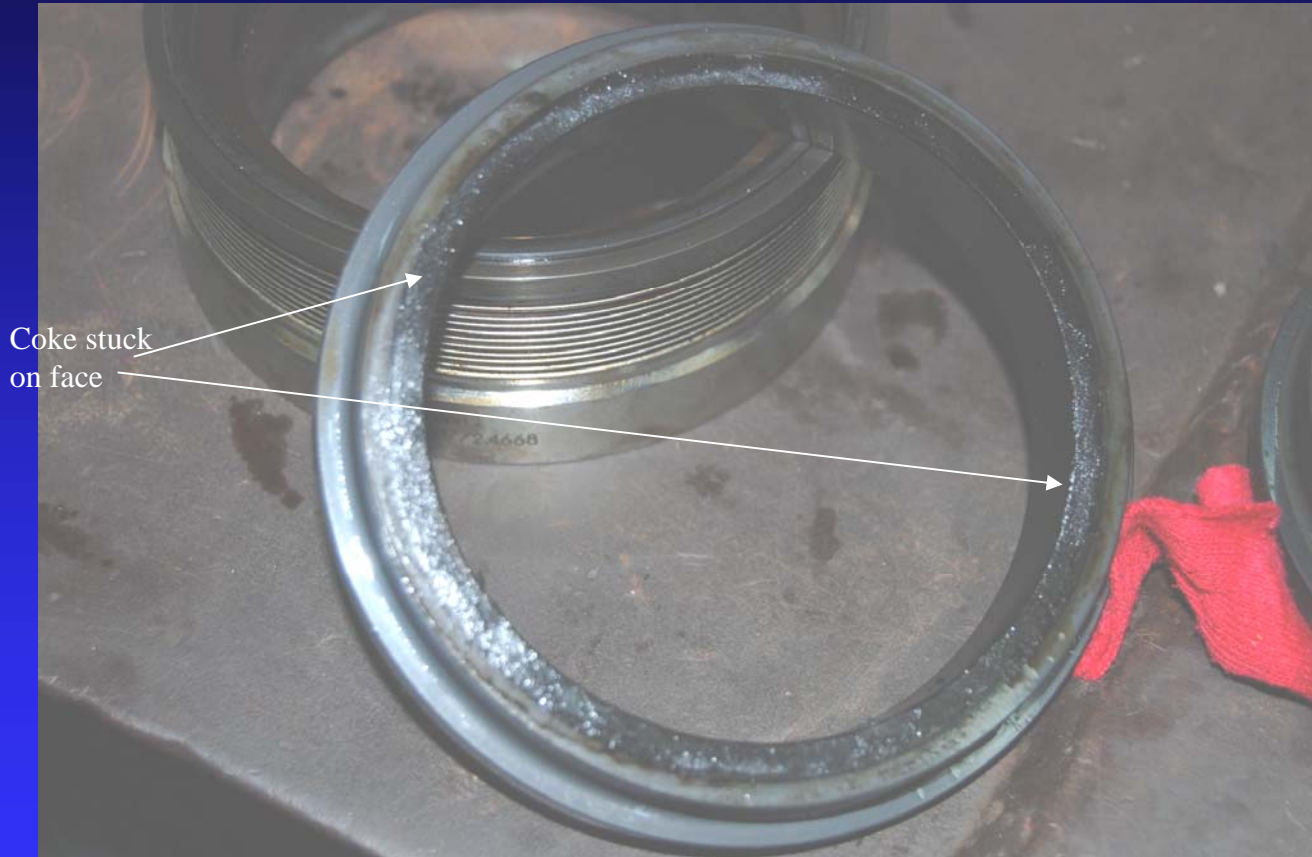
Picture 2: *West Feed Pump Interstage End – Inner Seal Face
(Stationary)*

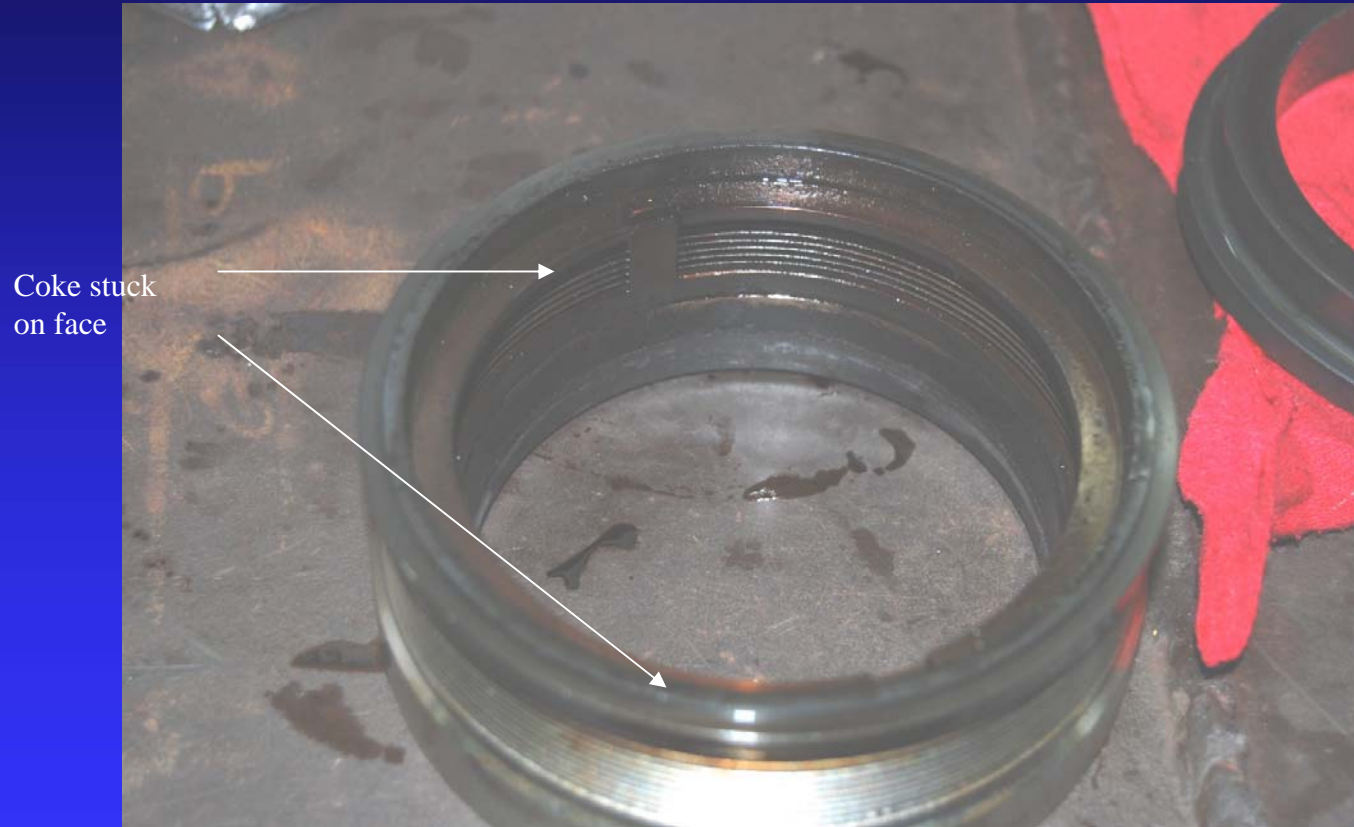
*Picture 3: West Feed Pump Interstage End –
Inner Seal Bellows (Rotating)*

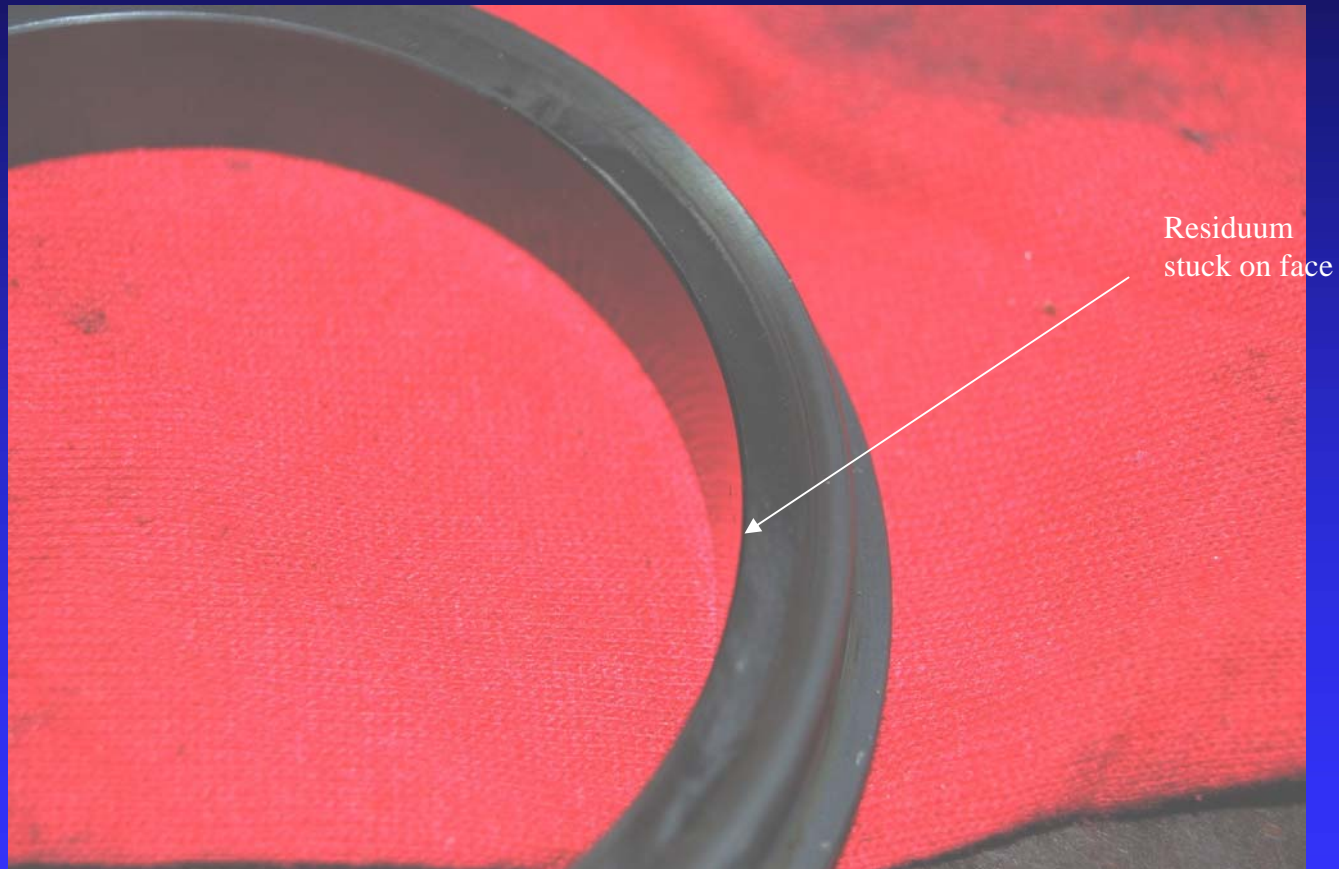
*Picture 4: West Feed Pump Suction End –
Inner Seal Face (Stationary)*
