# Diagnosing and Correcting a Damaging Below-Ground Column Natural Frequency in a Vertical Pump Using Field Testing and FEA

28<sup>th</sup> International Pump Users Symposium  
September 24 - 27, 2012

Case Study

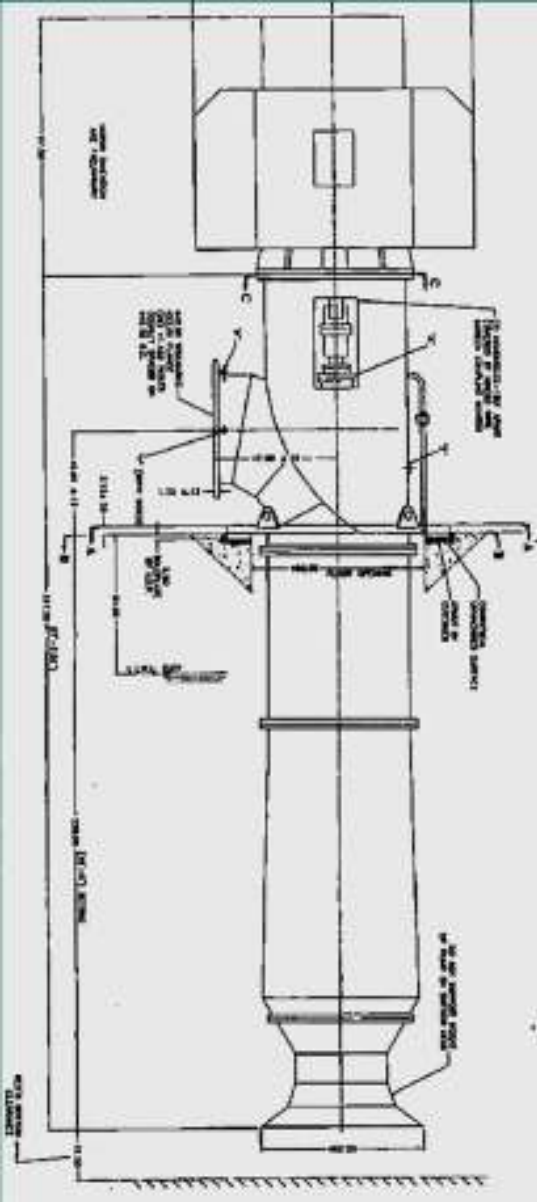
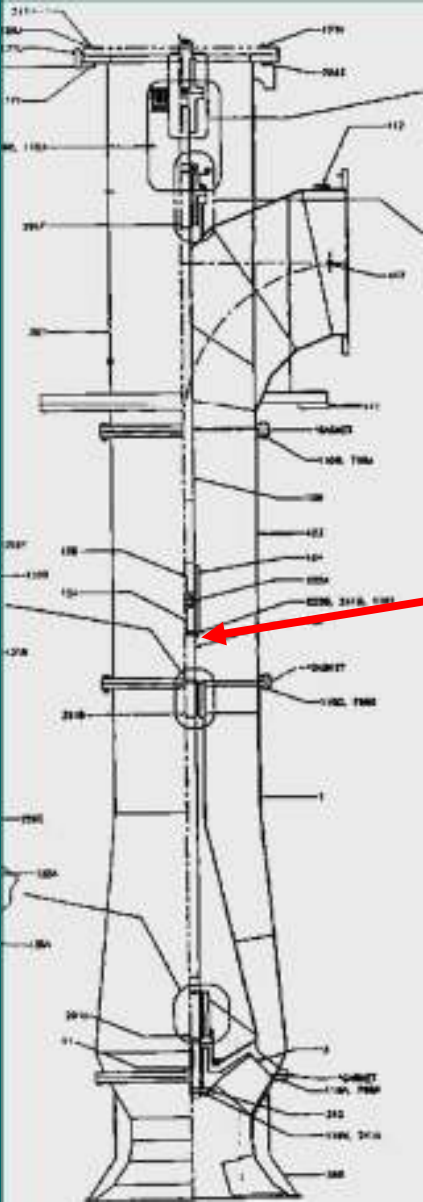
Shaft Failure

- In 2008, acceptable vibration (0.10 in/s pk) in two orthogonal directions was measured at the top of the motor. The amplitude increased gradually over the next 2.5 years. Within this period, the pump shaft failed in December 2009 (5.5 inch diameter at the upper end of the pump shaft coupling). Before the failure, the vibration was approximately 0.20 in/s pk. In addition, there were only a few of the upper column flange bolts remaining in place, and there was minor rubbing detected at the tip of the impeller vanes. During this period, when the pump was sent out for repair, the soleplate was replaced.
- After the pump was re-installed in March 2010, the vibration was around 0.20 in/s pk, then it started to increase quickly reaching the alarm level of 0.40 in/s pk in the mid-2010.

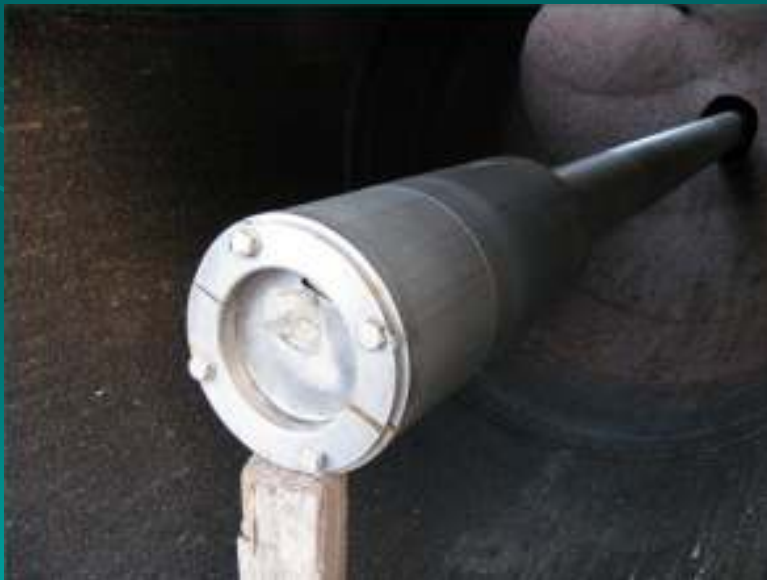
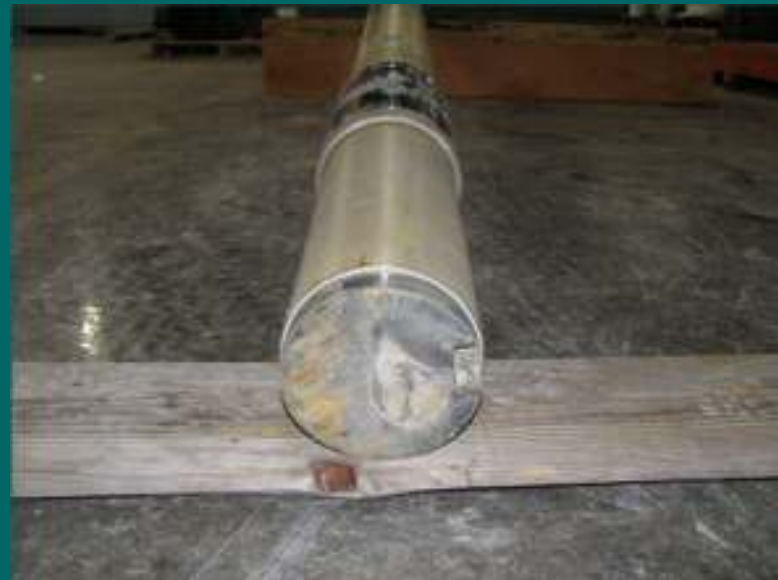
- In order to achieve an adequate level at the mounting flange of the motor (April 2011), variable thickness shims were required between the discharge head and the soleplate to reduce the vibration.
- Vibration was also susceptible to the discharge pressure. By throttling the valve, the response in vibration amplitude was favorable (lower).

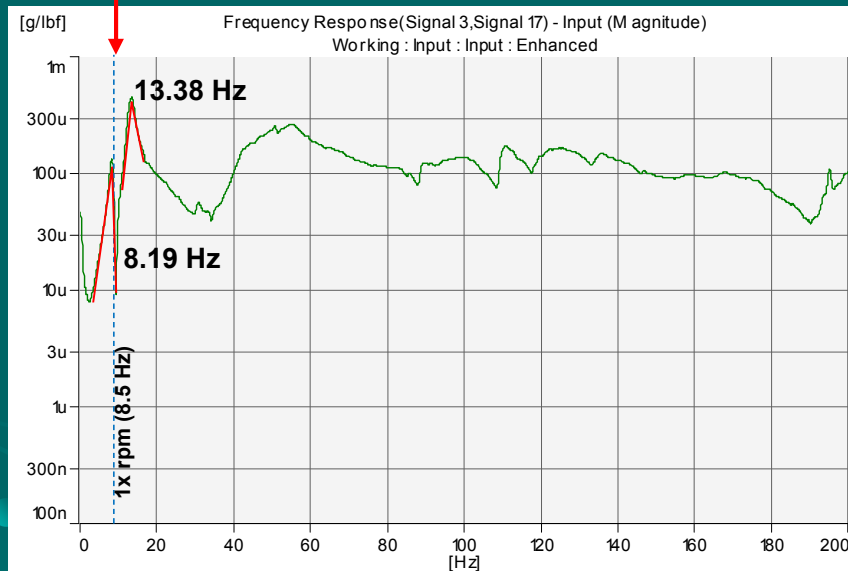
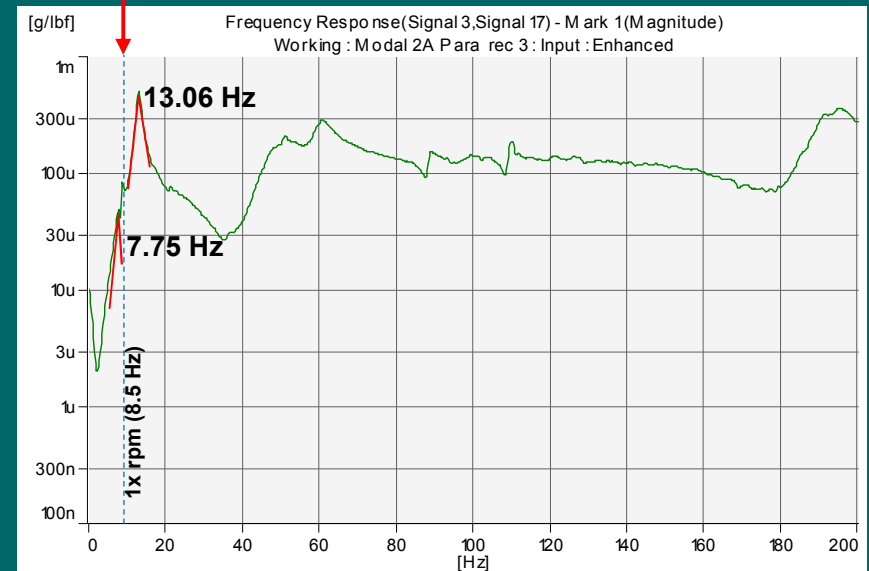
Pump A While Operating  
(Loose Pump)

Running speed (8.50 Hz)

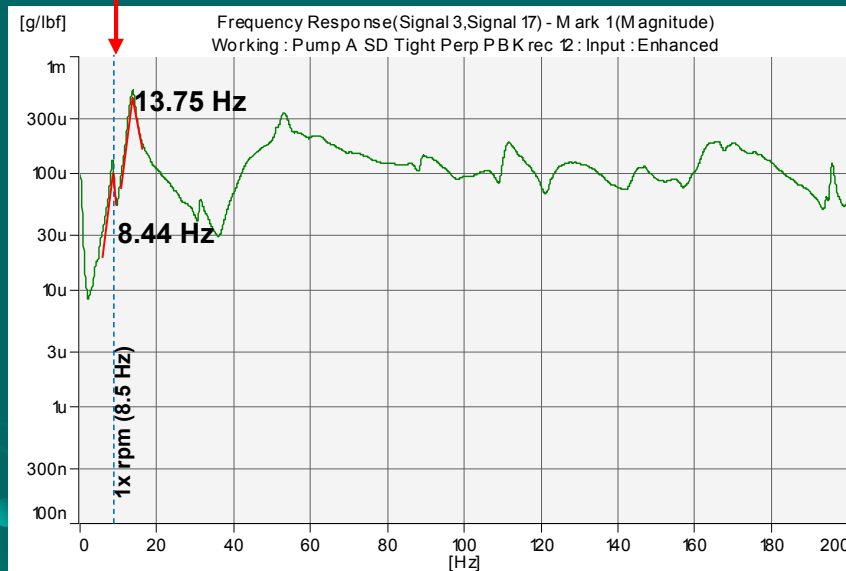
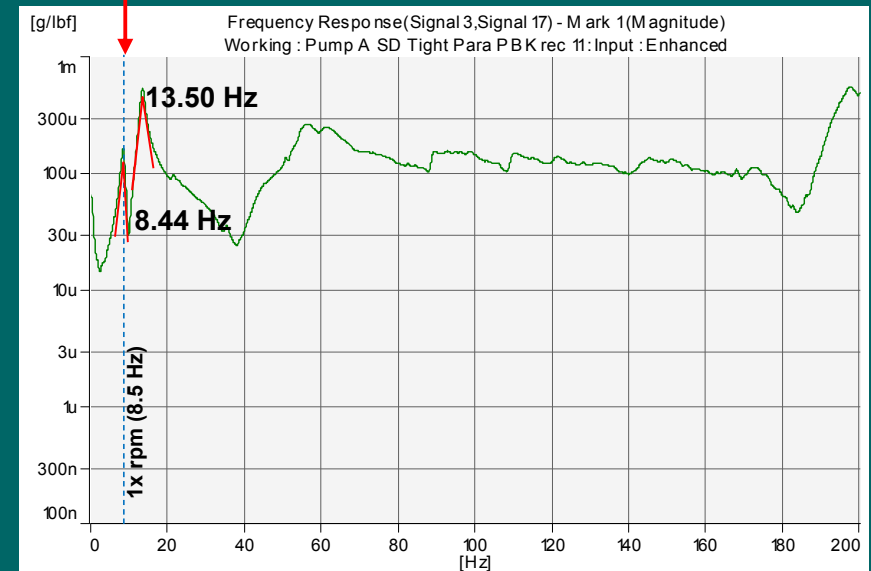
Pump A While Shut-down  
(Tight Pump)

Running speed (8.50 Hz)

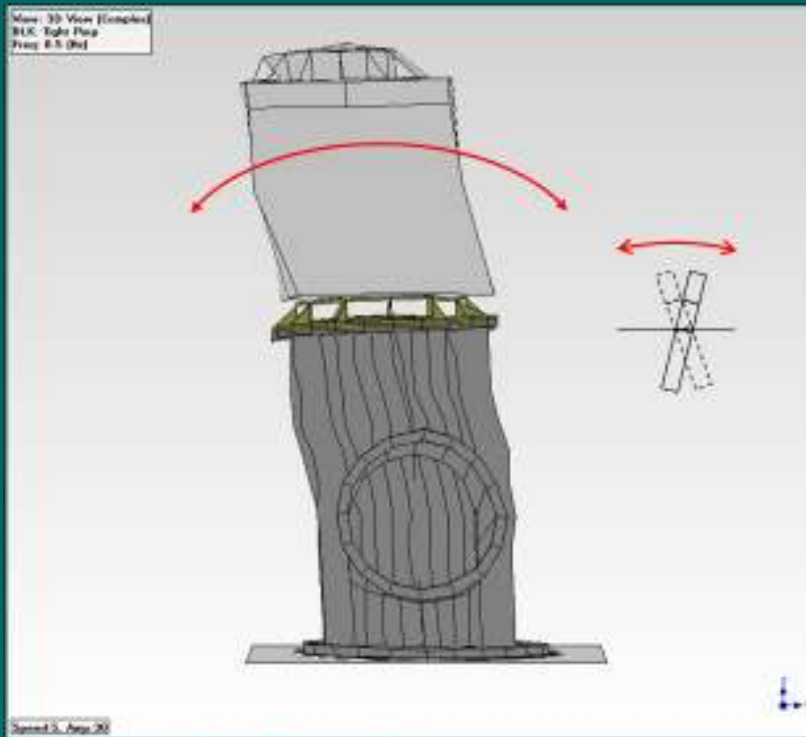
Trunion mode at 8.44 Hz in the perpendicular direction

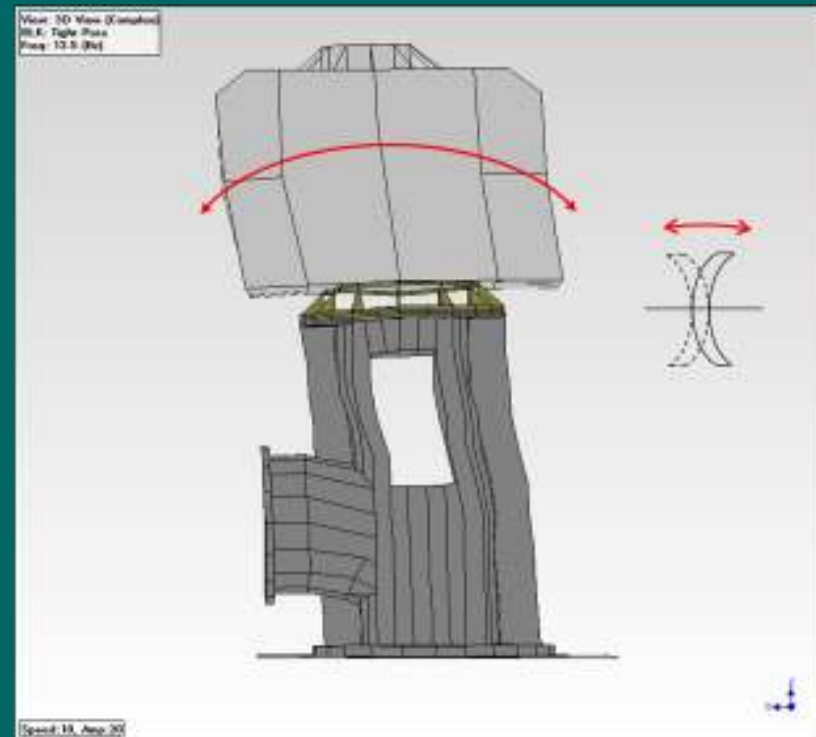
Global "C" shape mode at 13.50 Hz in the parallel direction

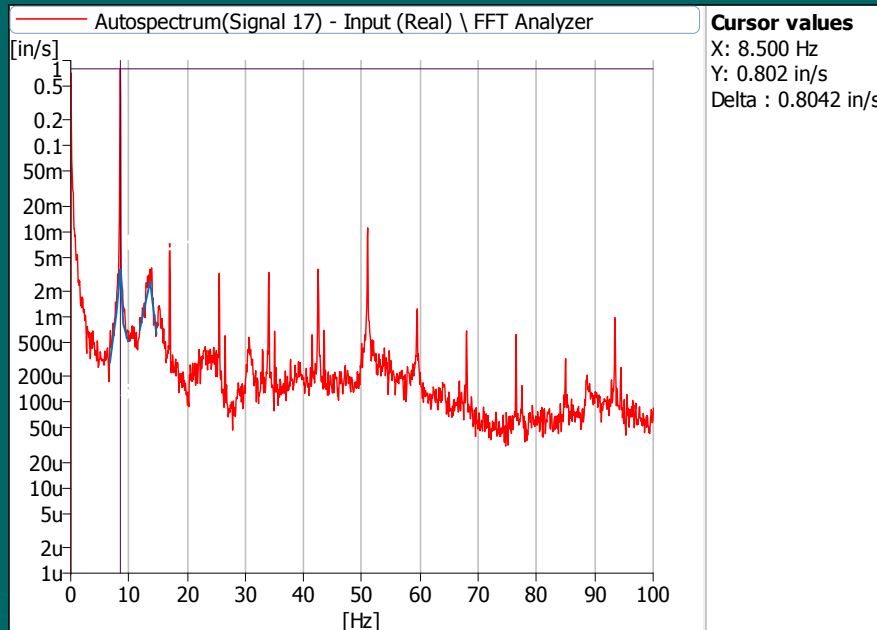
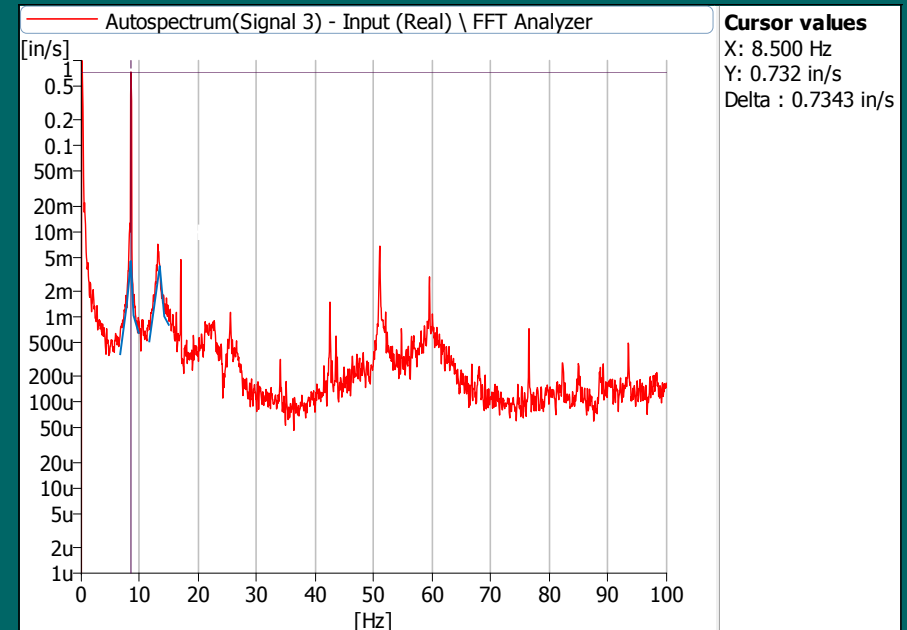
**Pump A While Pump was  
Tightened to the Soleplate**

**Motor Top Perpendicular**  
Overall: 1.13 in/s pk

**Motor Top Parallel**  
Overall: 1.04 in/s pk

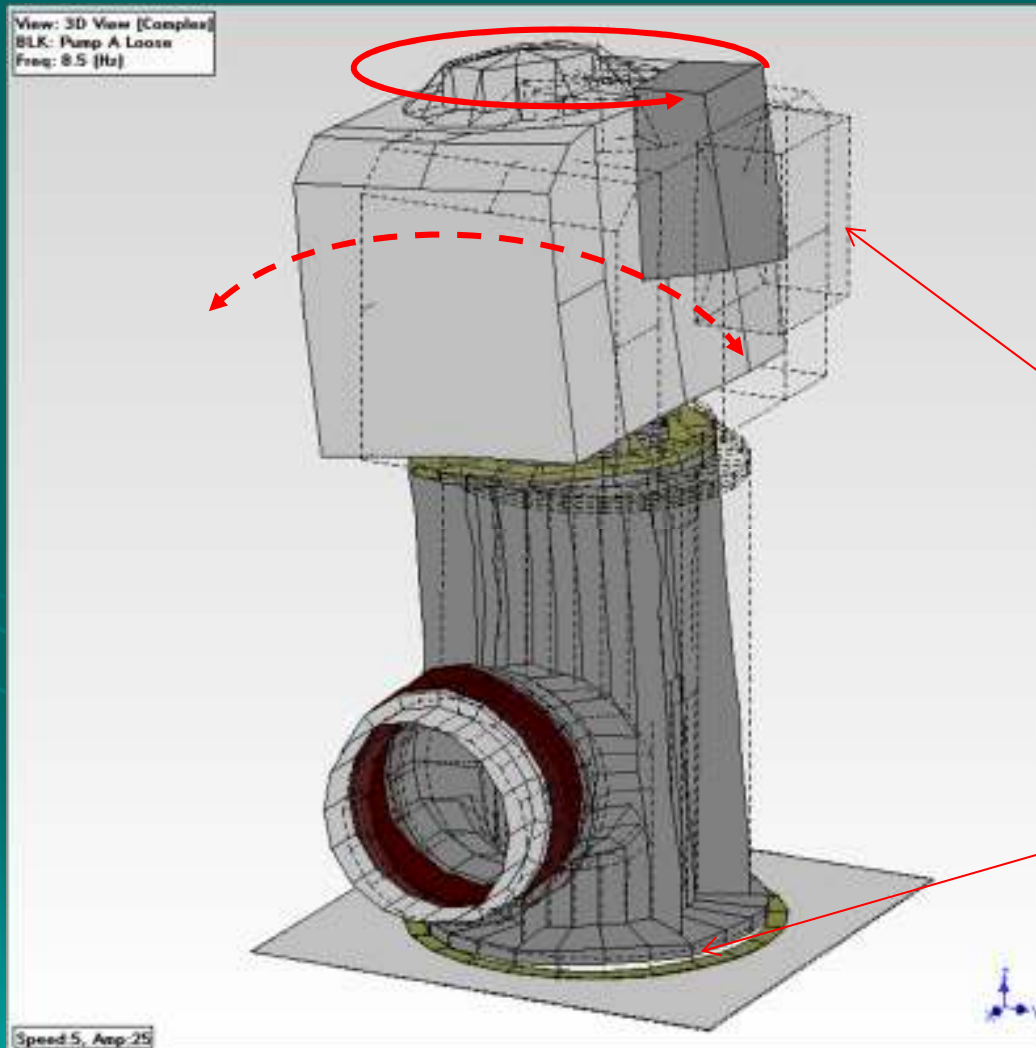
Discharge head mounting flange loosened to reduced the vibration amplitude at the top of the motor.

Orbiting motion at the top of the motor mostly in the perpendicular direction to the discharge nozzle.

Soft-foot all the way around the discharge head mounting flange due to shimming and looseness between parts.

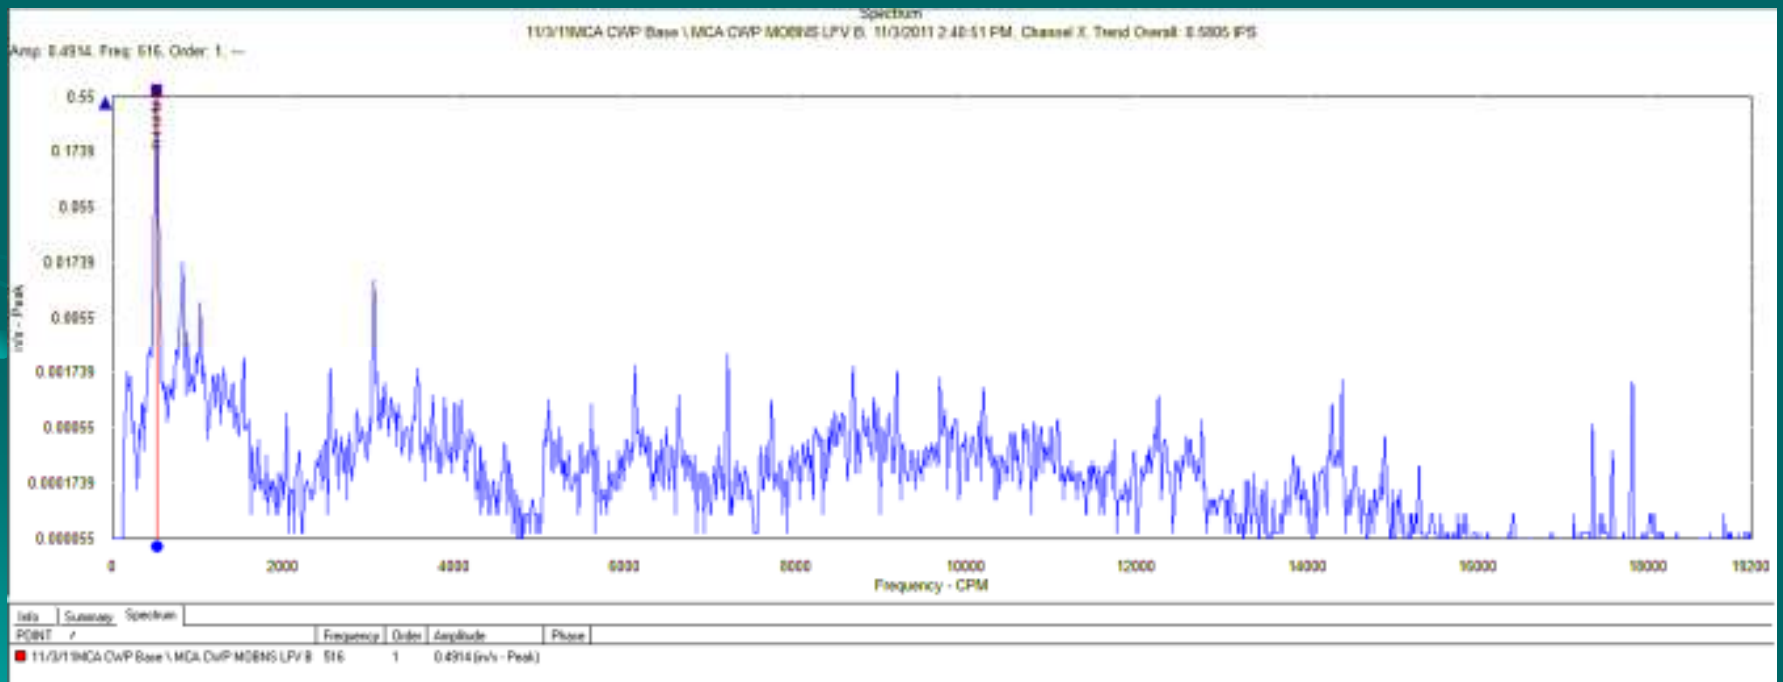
- 50% reduction in vibration amplitude at the top of the motor, but still high (0.50 in/s pk).
- The increase in the above-ground stiffness did not shift the offending mode of the system as expected.

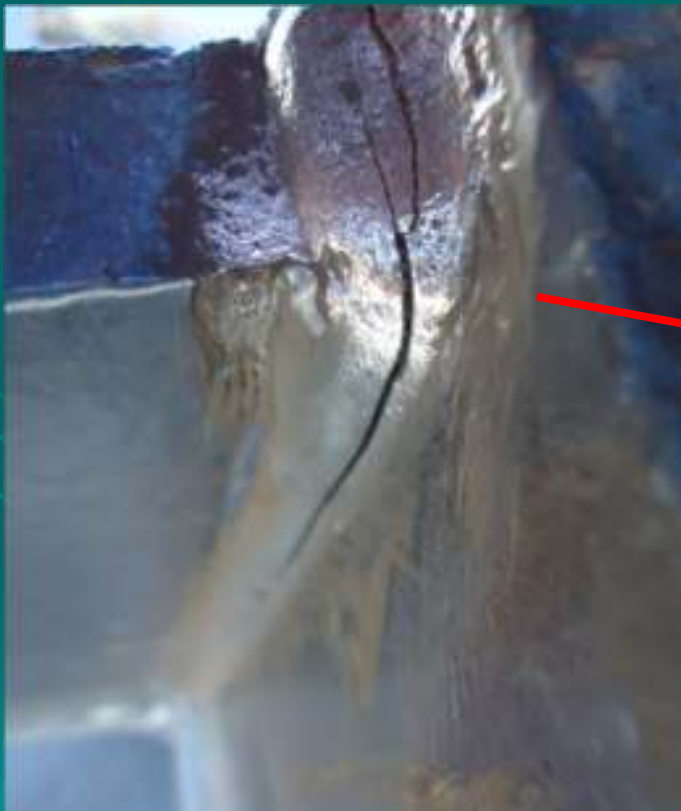
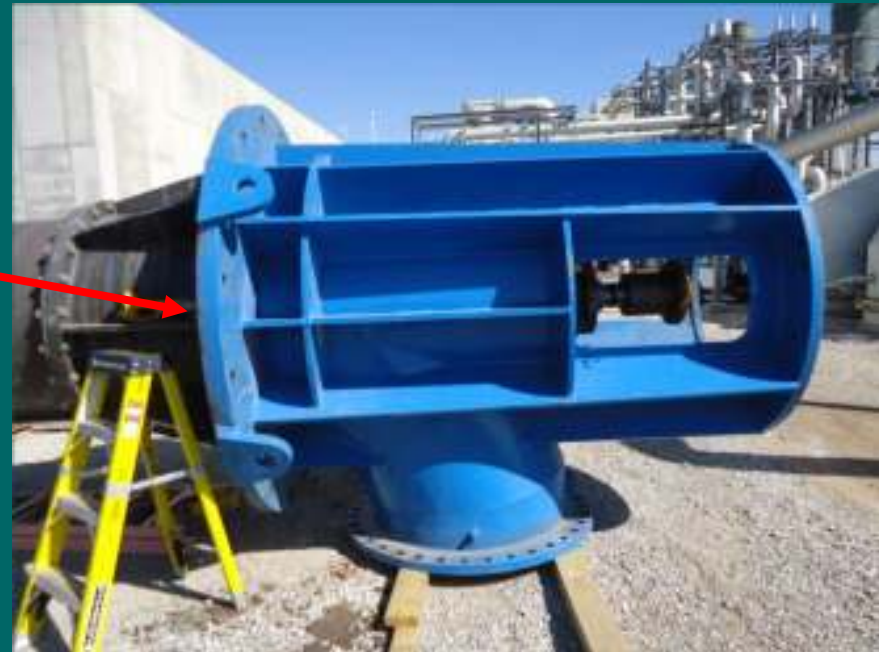
- Two months later, during the next outage the pump column was lifted from the sump, and a crack was identified in one of the lower gusset welds

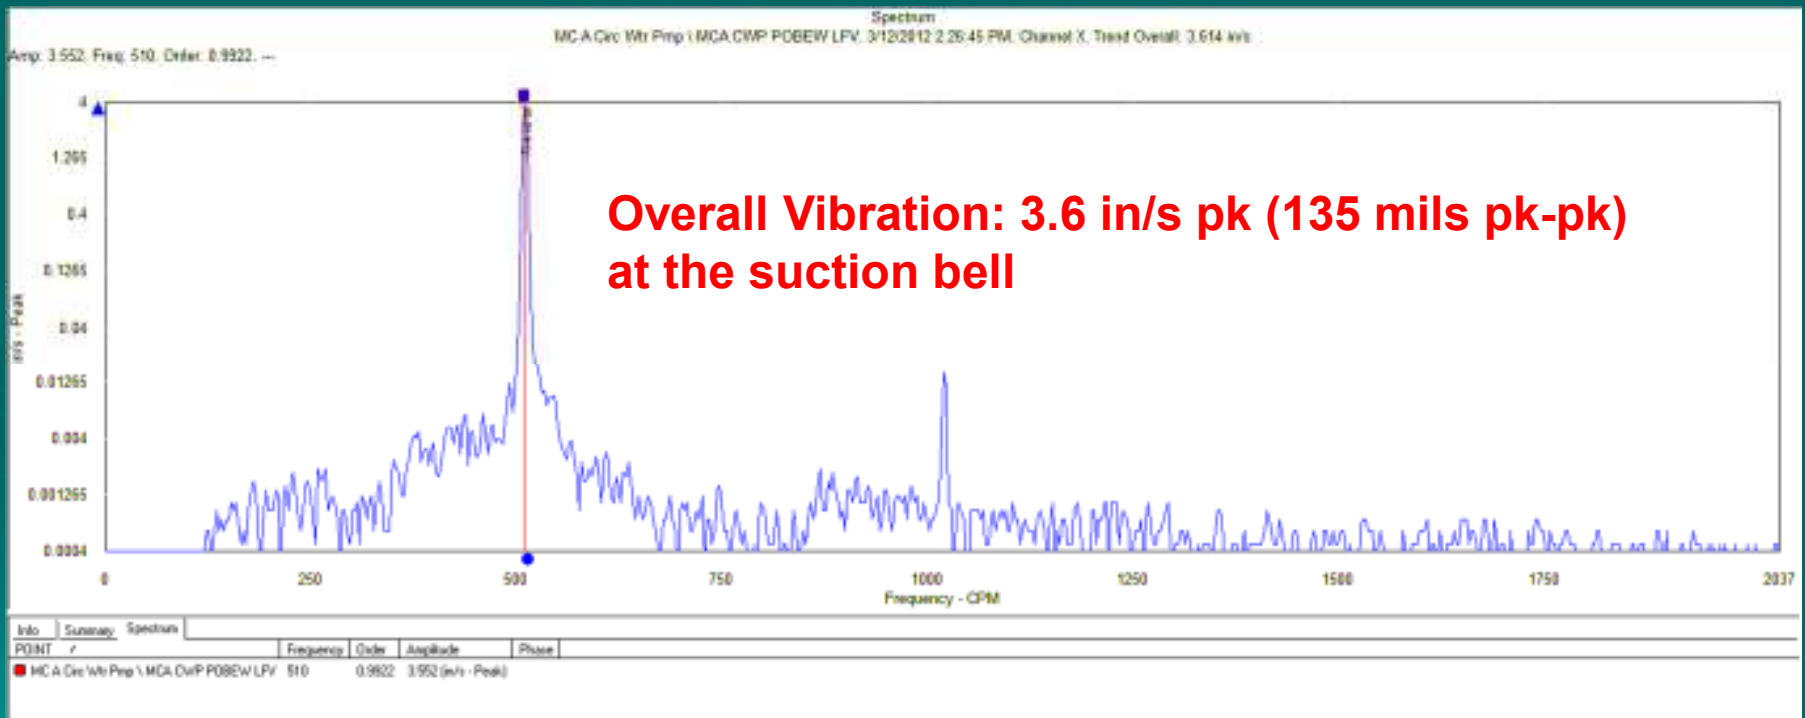
- Below-ground accelerometers were installed at the suction bell flange in two orthogonal directions.

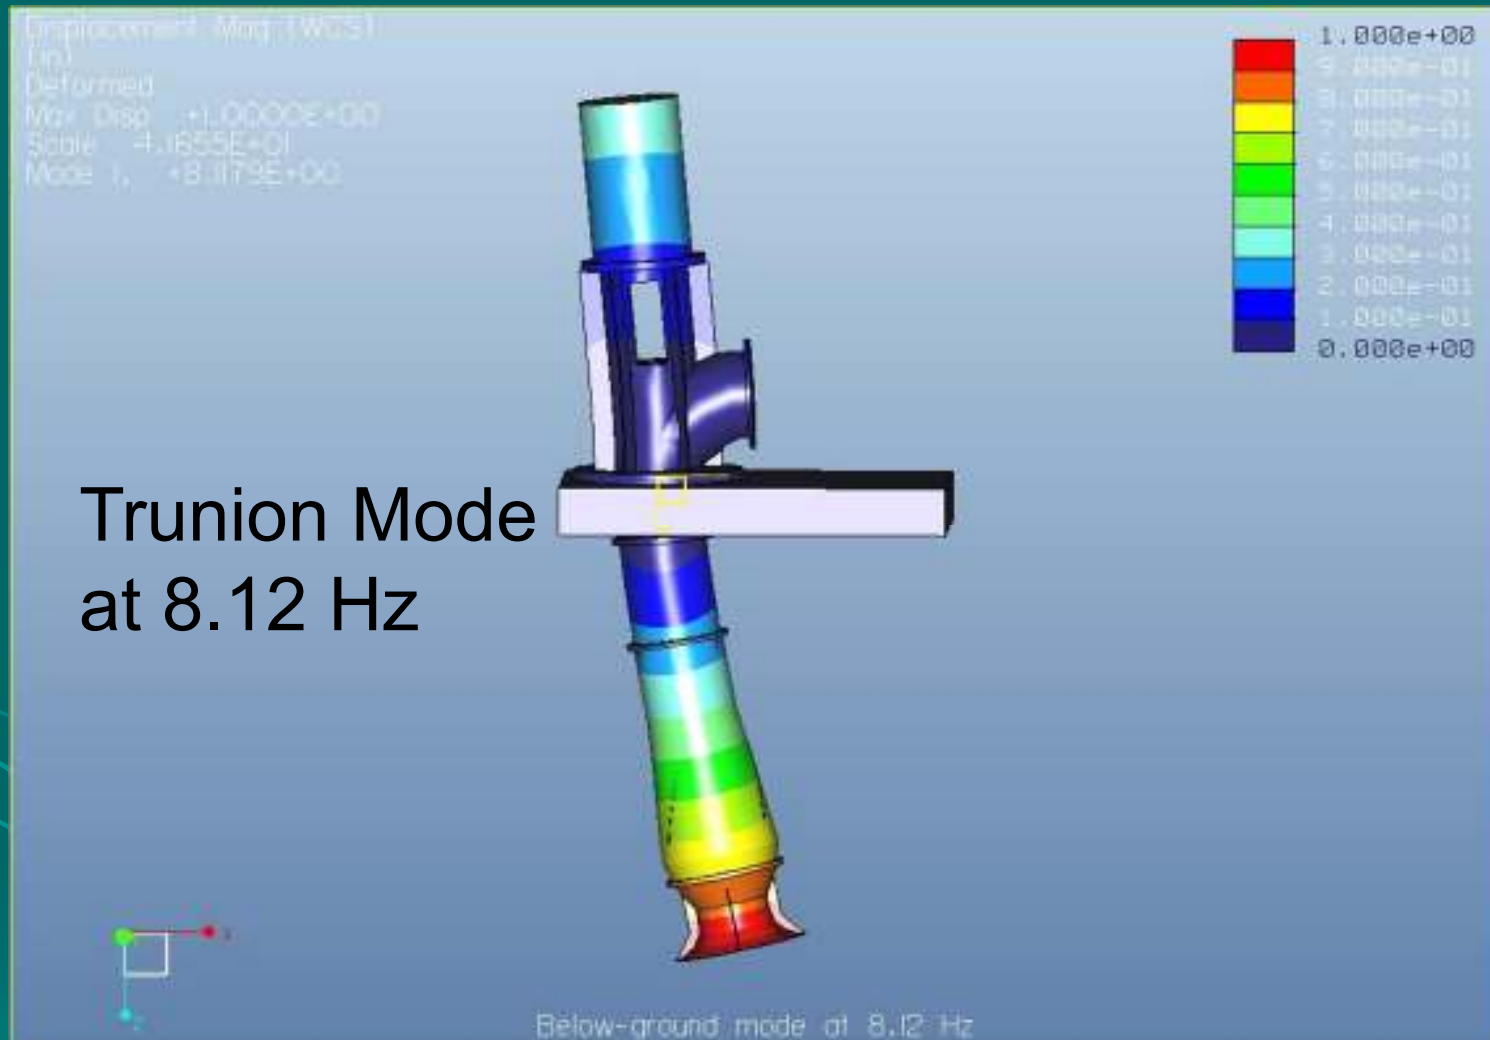
Calibrated FEA model for original pump

- The root cause of the high vibration at the top of the motor was due to a below-ground dominated mode (trunion mode) rather than the typical motor cantilever rocking mode. This is why the additional ribbing of the above ground structure did not significantly shift the offending natural frequency.
- The looseness between the discharge head mounting flange and the soleplate shifted the offending mode away from the 1x running speed frequency.
- The addition of weight to the bottom of the suction bell in conjunction with the increased added mass effect of the surrounding water lowered the offending below-ground natural frequency to have sufficient separation margin (~15%) from the running speed.

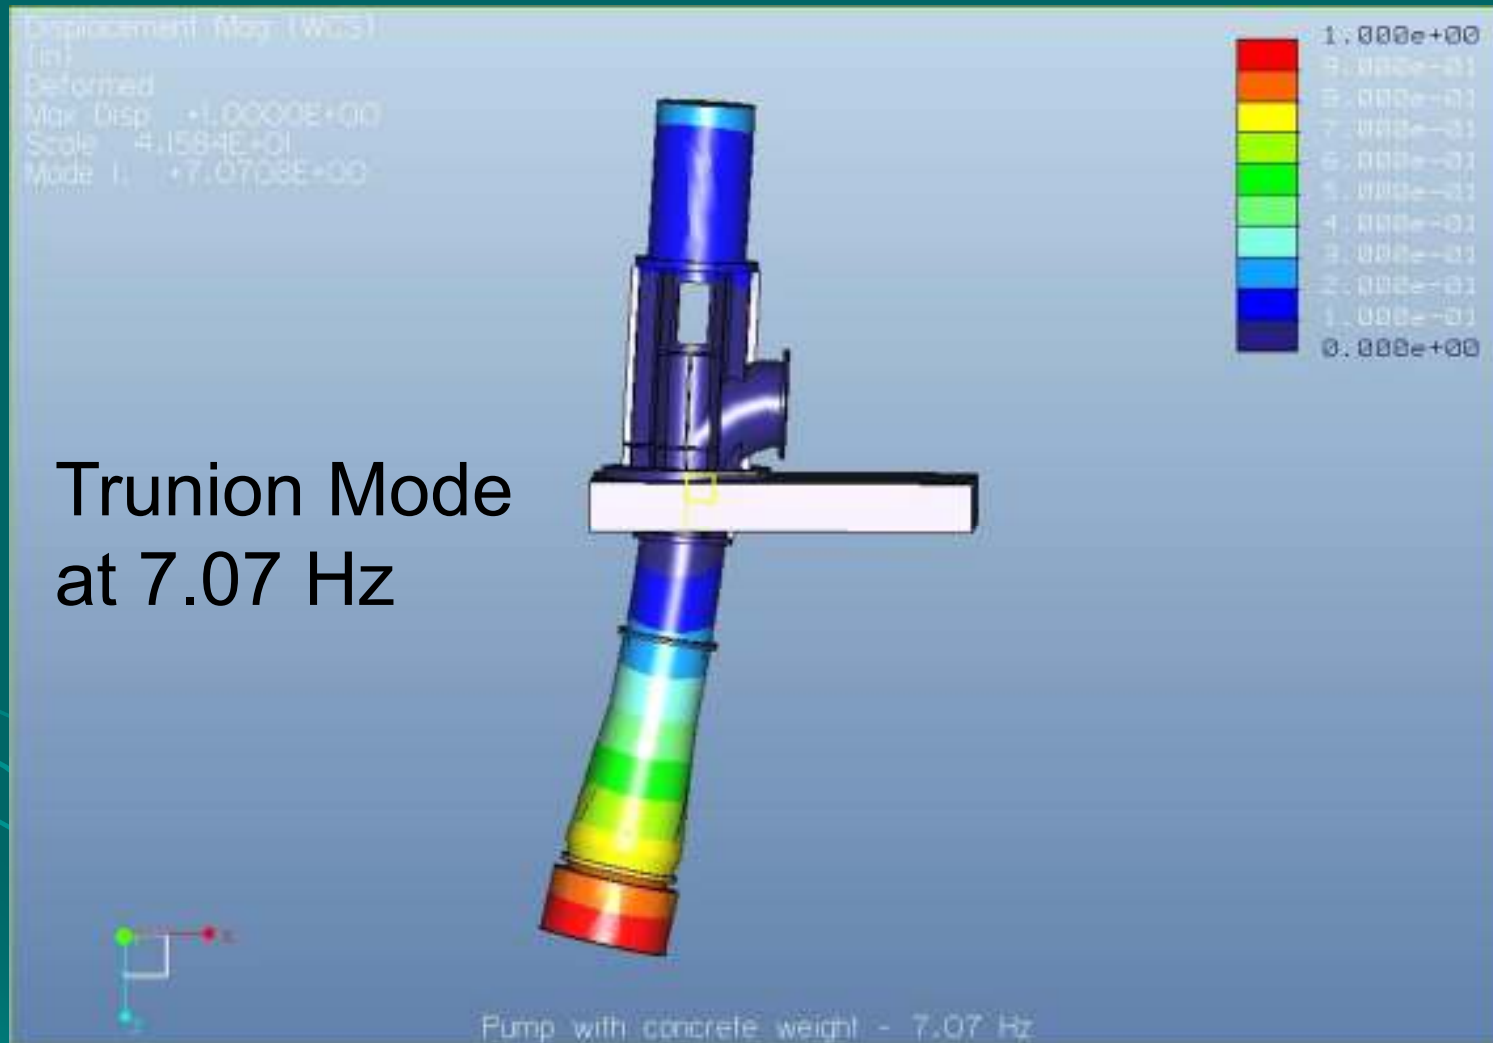
**Predicted modified structural natural frequency**
