Dramatic Vibration Improvement due to Ring-Section Pump Foundation Repair Based on ODS in a Power Plant

26th International Pump Users Symposium

Mechanical Solutions, Inc.

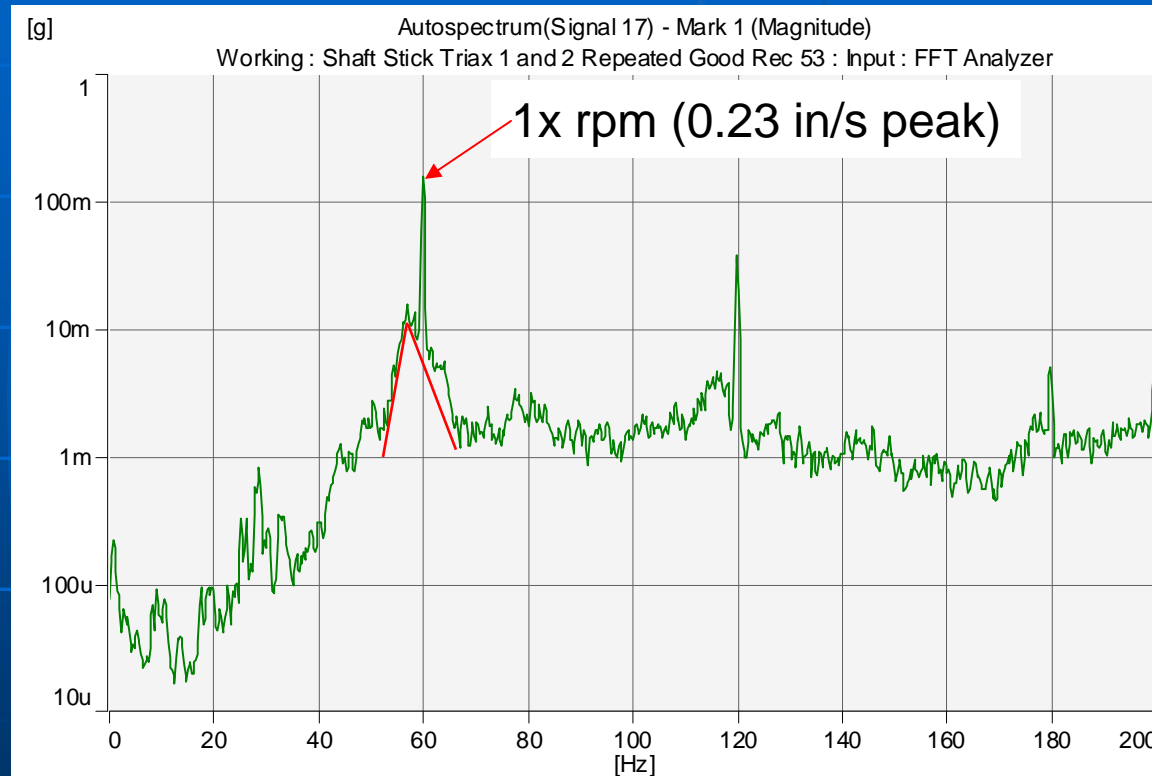
Pump #2 Typical Spectrum OBB in the Horizontal Direction

Closest Natural frequency at 56.8 Hz (5% below 1x rpm)

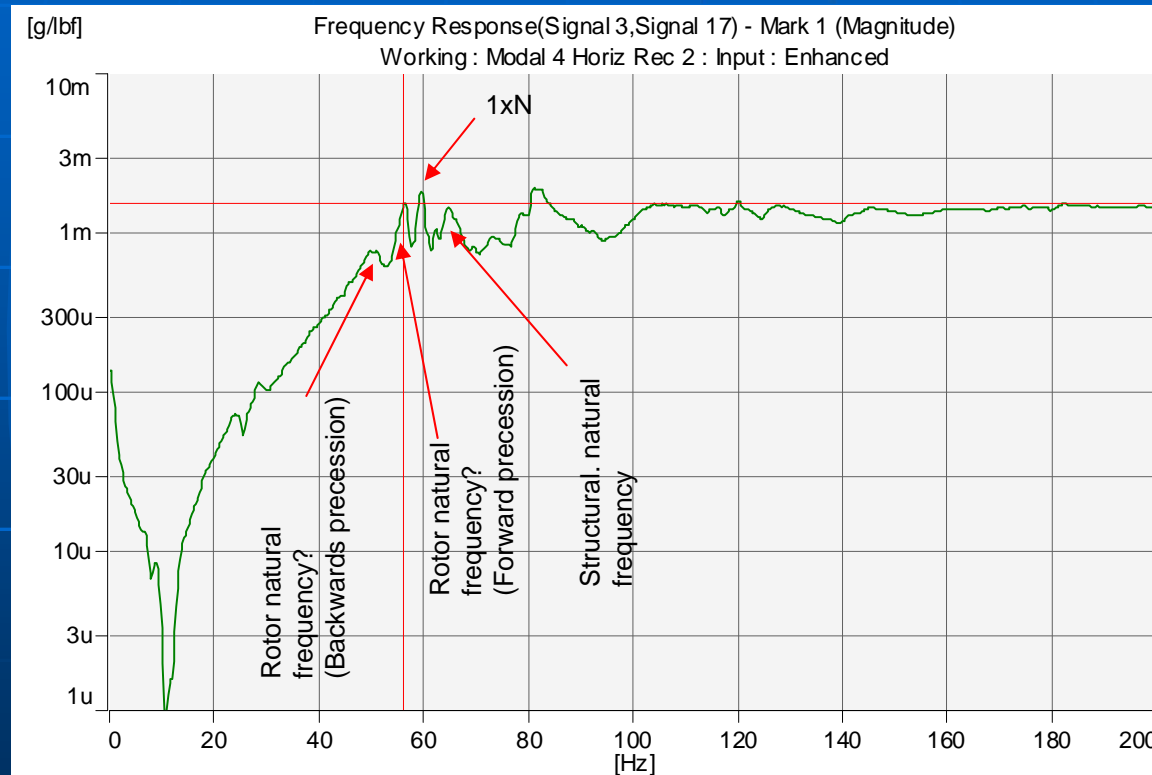
Pump #2 Modal (Operating) Spectrum in the Horizontal Direction at the Pump OBB Housing

Closest Natural frequency at 56.8 Hz (5% below 1x rpm)

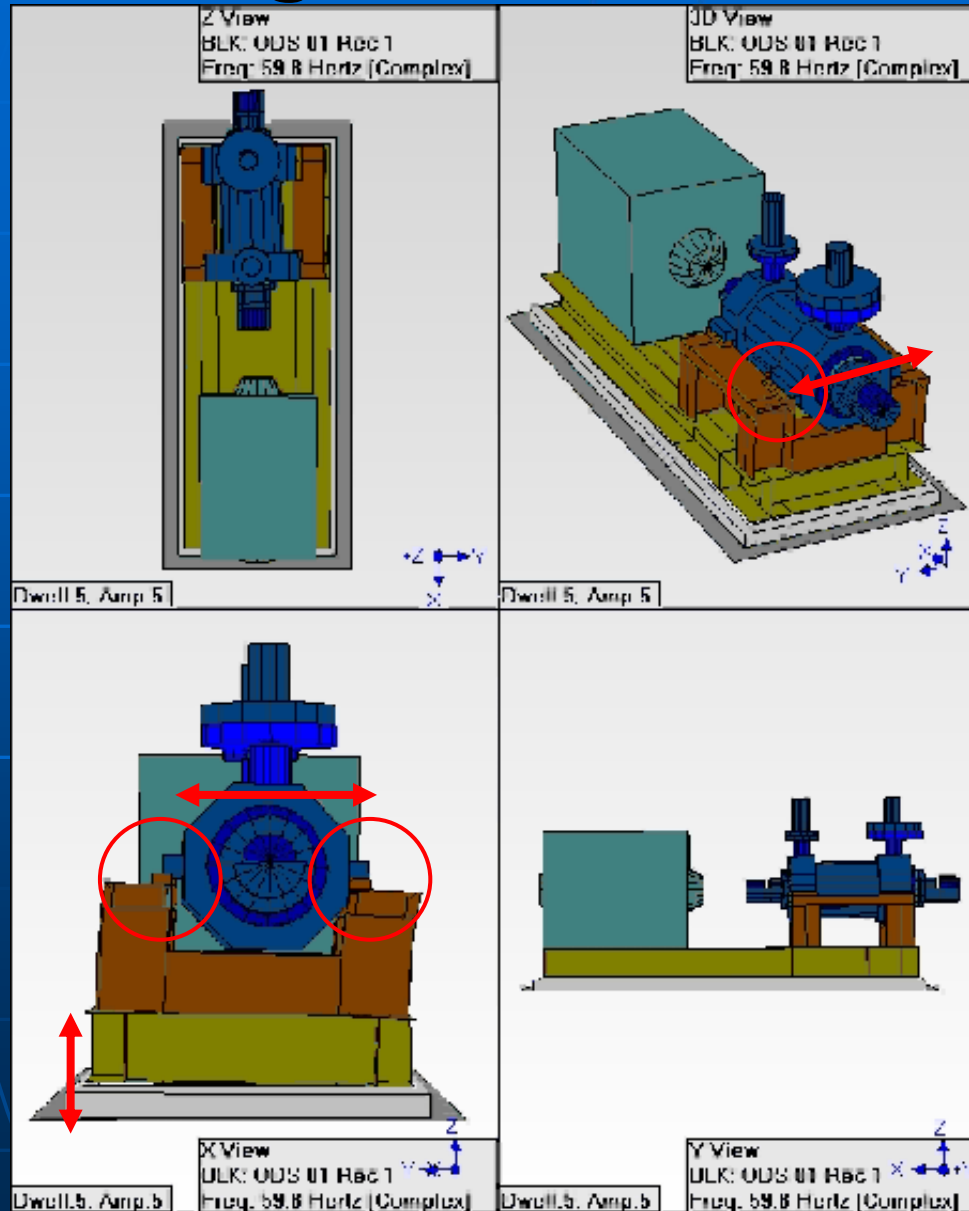
Baseline
data
Pump #2
@ 1x rpm

1. Excessive flexibility at the baseplate due to possible softness or delamination of the internal grout (Pump #2 moved 10x more than Pump #1).
2. OBB housing vibration increased almost 6 times in 4 hours of operation (from 0.06 in/s peak to 0.35 in/s peak @ 1x rpm), and 50% shaft vibration.
3. During the cold start up, 1x rpm spike located between two natural frequencies (57 Hz from the rotor lateral and 63.5 Hz from the structure). The structure became less stiff and reducing the damping of the system; therefore, the rotor natural frequency shifted upwards in the neighborhood of the running speed.
4. Shaft phase angle variation over time. (OBX -60 deg., OBY -20 deg., IBX -110 deg., and IBY -110 deg.)
5. Pumps #1 and #3 did not indicate rotor natural frequencies near the running speed. The lateral rocking mode was identified 13% above 1x rpm.

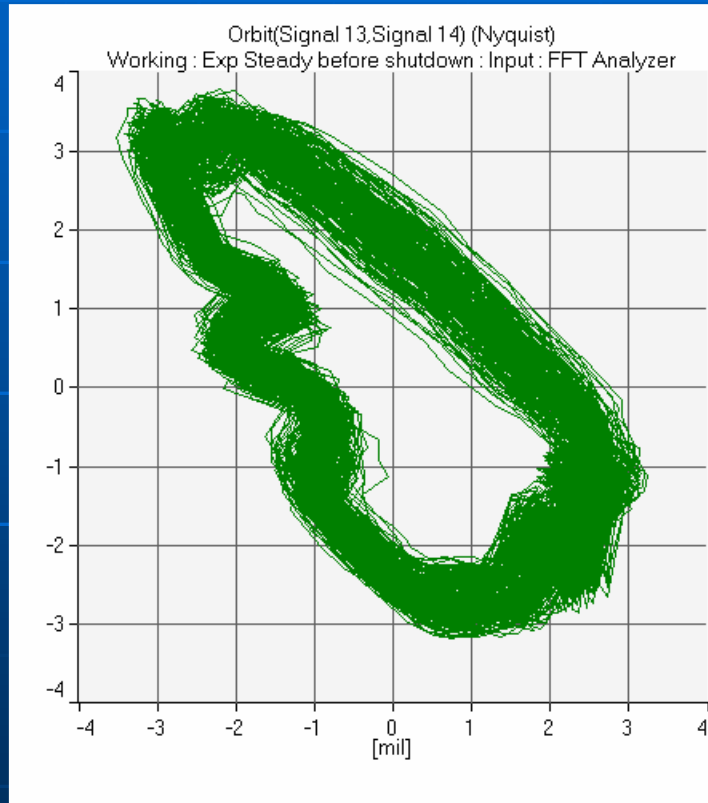
OBB

6.5 mils pk-pk

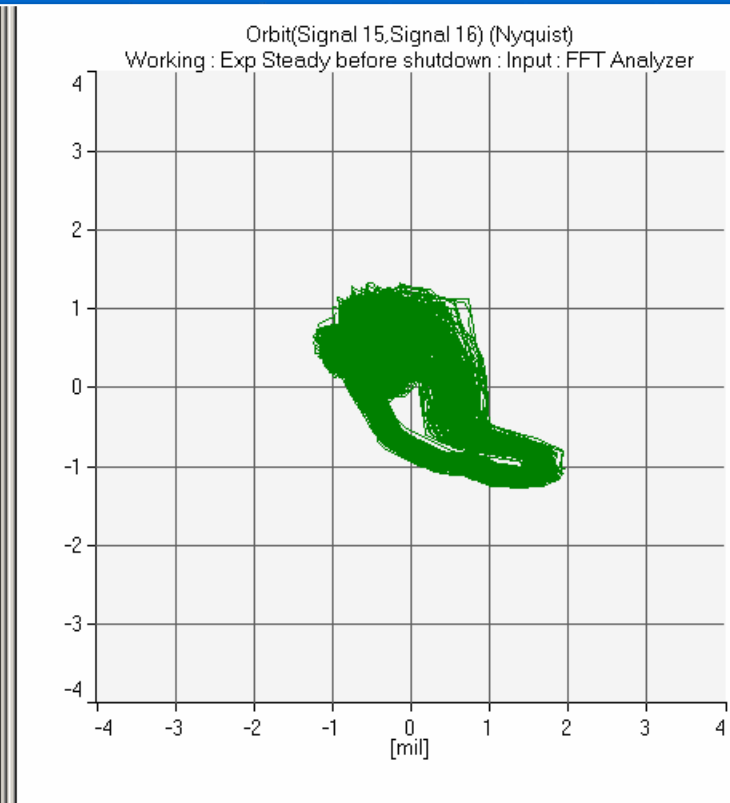
IBB

2.5 to 3.0 mils pk-pk

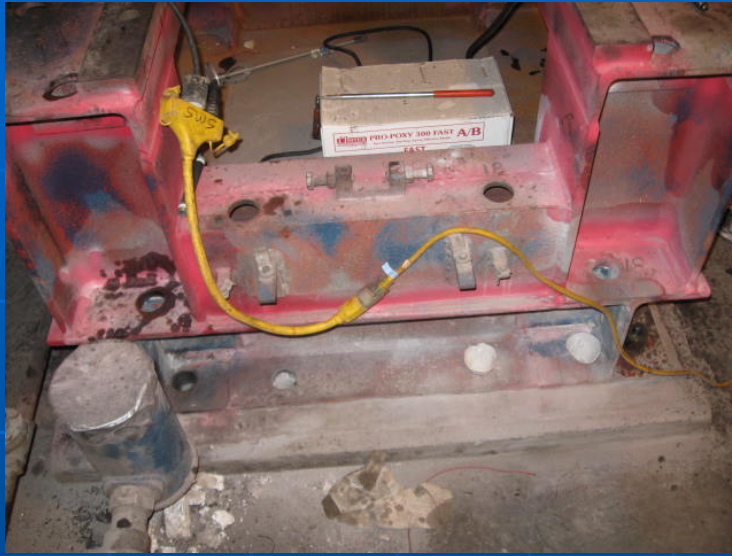
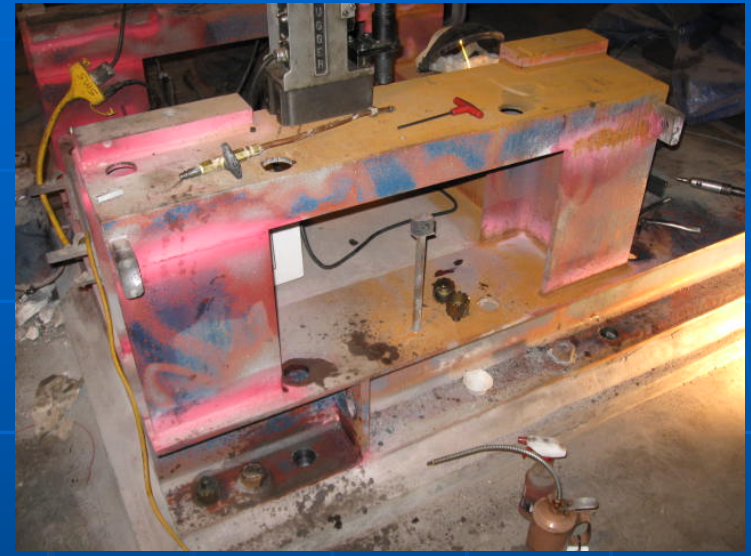
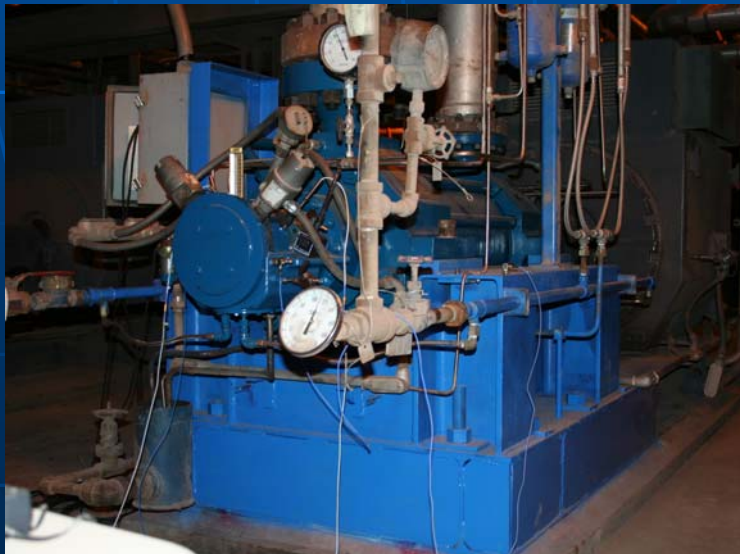
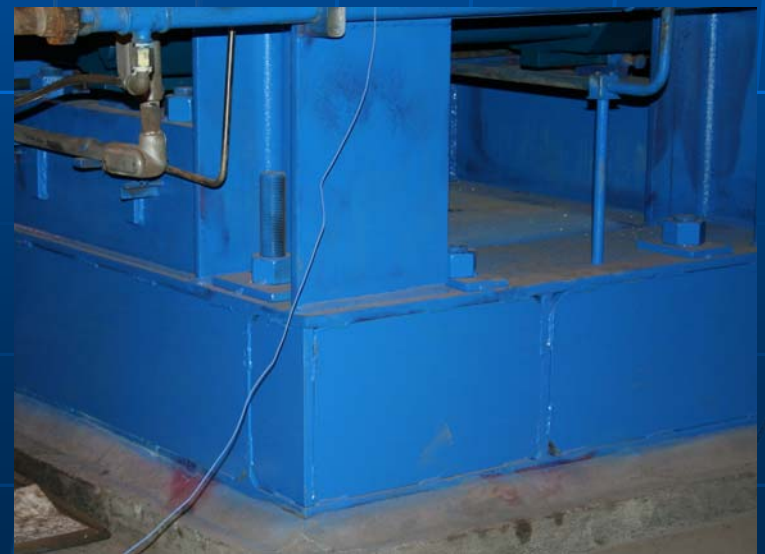
Pump Pedestal & Baseplate Modifications

- The root cause of the vibration on Pump #2 was due to excessive flexibility at the baseplate caused by softness or delamination of the internal grout. This phenomenon originated due to the looseness of the anchor J-bolts.
- After all modifications performed on the baseplate, the maximum vibration amplitude at the OBB housing in the horizontal direction was reduced from 0.35 in/s peak to a greatly improved value of 0.09 in/s pk @ 1x rpm.
- The ODS is a powerful troubleshooting tool to facilitate and visually understand most common vibration problems in any pumping system or turbomachine.

1. Inspect the welding areas of the pedestal and the baseplate for potential cracks.
2. As a short term fix, increase the stiffness of the baseplate.
3. As a long term fix, the baseplate should be re-grouted to assure rigid connection with the foundation and proper structural damping.

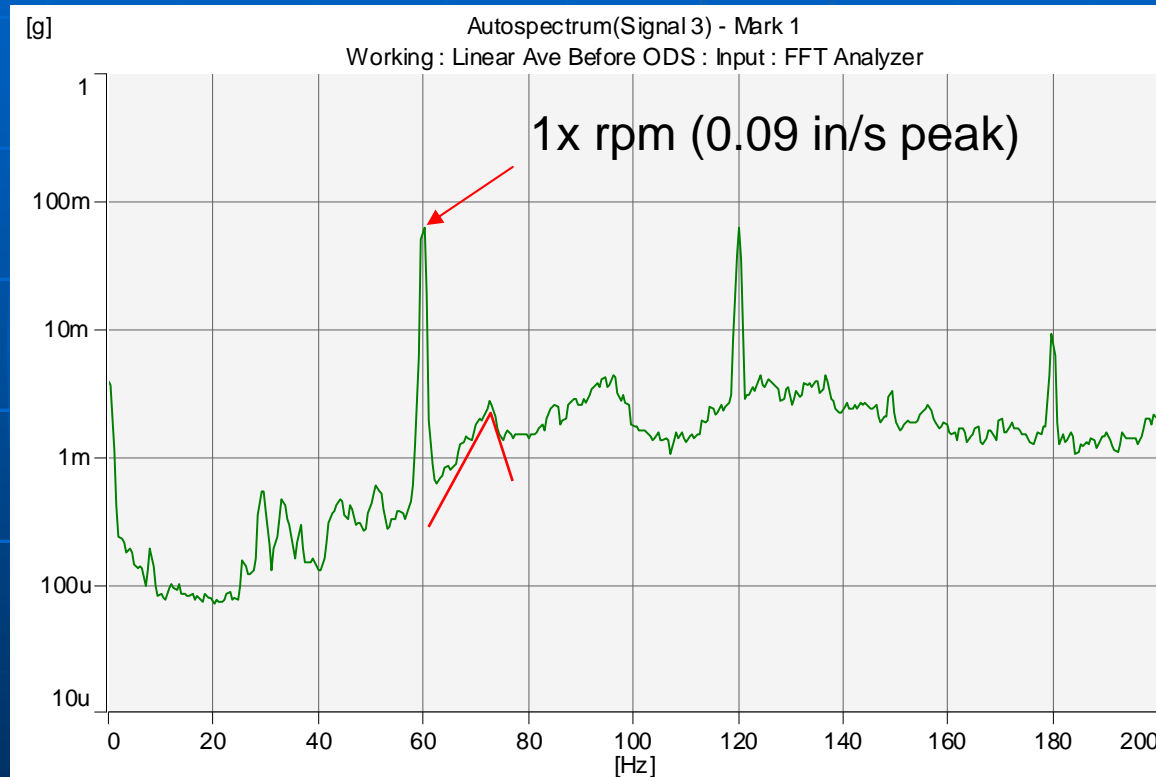
Pump #2 Typical Spectrum OBB in the Horizontal Direction After Implementing Modifications

Natural frequency at 73 Hz (23% above 1x rpm)
