**43rd Turbomachinery
30th Pump SYMPOSIA**

**DRIVE SHAFT FAILURE ANALYSIS ON A MULTISTAGE VERTICAL TURBINE
PUMP IN RIVER WATER SUPPLY SERVICE IN A NICKEL AND COBALT MINE IN
MADAGASCAR - BASED ON ODS AND FEA**

Juan Gamarra
Mechanical Solutions, Inc.

Paul Behnke
ITT Industries, Industrial Process

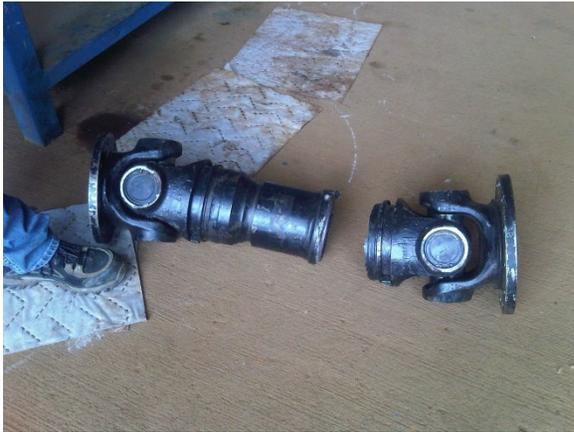
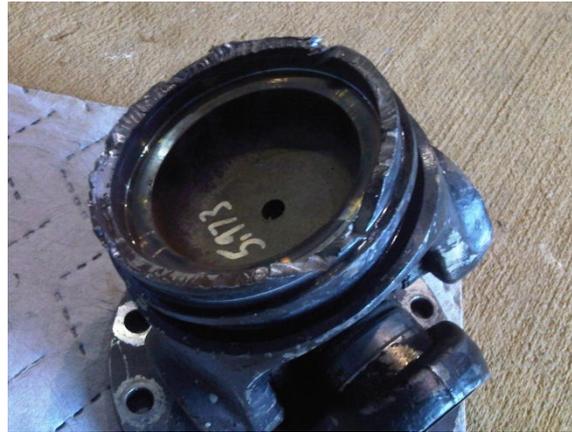
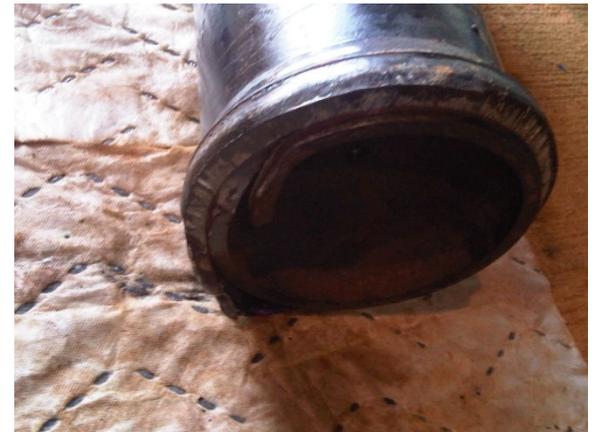
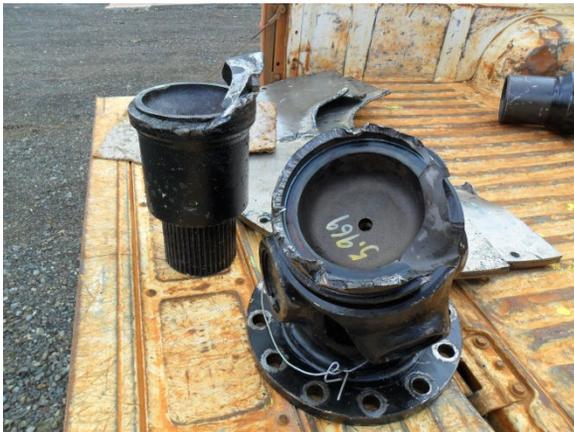
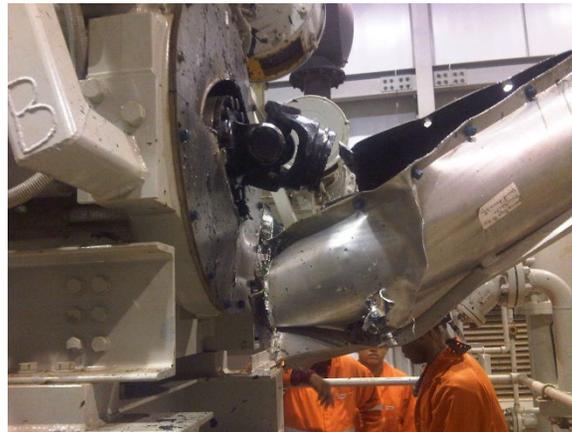
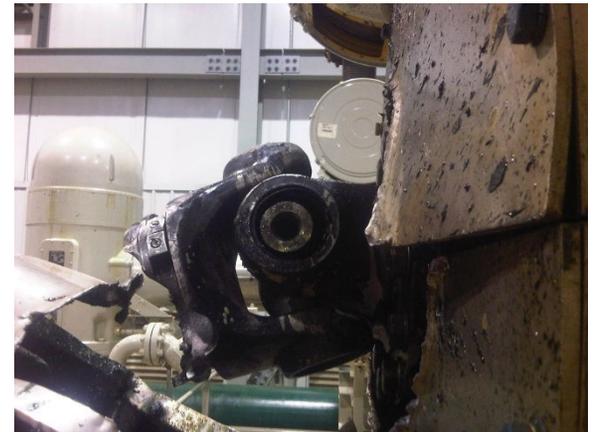
Photos Drive Shaft Failures

Failures located at the male end weld (same location each incident) at the engine-side of the assembly.

1. The failure mechanism of the drive shaft was caused by the elevated axial and torsional oscillation loads in combination with the jammed driveshaft spline.
2. The situation became severe because an axial (horizontal parallel to the crankshaft) pump natural frequency and torsional shaft assembly natural frequency were simultaneously in resonance with an unexpectedly high 1.5x running speed harmonic, which appeared due to a poorly tuned engine (resulting in a 1/2x rpm fundamental and its harmonics).
3. The 2nd torsional natural frequency of the drive shaft was determined to be at 42.0 Hz (Pump C). The separation margin from 1.5x running speed is within 5% from both the pump and engine speed.
4. The torsional oscillation was observed to be as high as 94% zero-to-peak of the mean torque value.

5. The measured axial force oscillation imposed on the drive shaft peaked at 11,000 lbf pk-pk.
6. Since the weld on the driveshaft did not penetrate to the inner diameter of the material the region near the weld, this created effectively a crack around the circumference of the shaft. This resulted in a high stress concentration at the edge of the weld. The peak oscillating membrane plus bending stress amplitude located at the region near the “crack” was calculated from the FEA model to be 3118 psi due to the observed alternating torque and axial loading.
7. For carbon steels, exceeding a critical stress intensity factor of 8,000-10,000 indicates the effective initiated crack length “a” has the ability to propagate under alternating load. This analysis calculated a stress intensity factor value of 11,040 which explained the failure from fatigue loading on the weld bead.

1. The engine was re-tuned due to the observed mis-firing, since it was providing unusually strong torque impulses or "shocks" at the rate of $1/2x$ RPM, which caused strong frequency harmonics. This left no place to "park" the system natural frequencies to avoid resonance.
2. A torque shock absorbing coupling between the engine and the drive shaft was implemented. The entire drive shaft and coupling assembly was replaced including the u-joints at each end.
3. The highest vibration level dropped from 24 mm/s pk at the gearbox horizontal measurement location near the input shaft to 7.8 mm/s pk after change to a flexible coupling. Failures ceased.

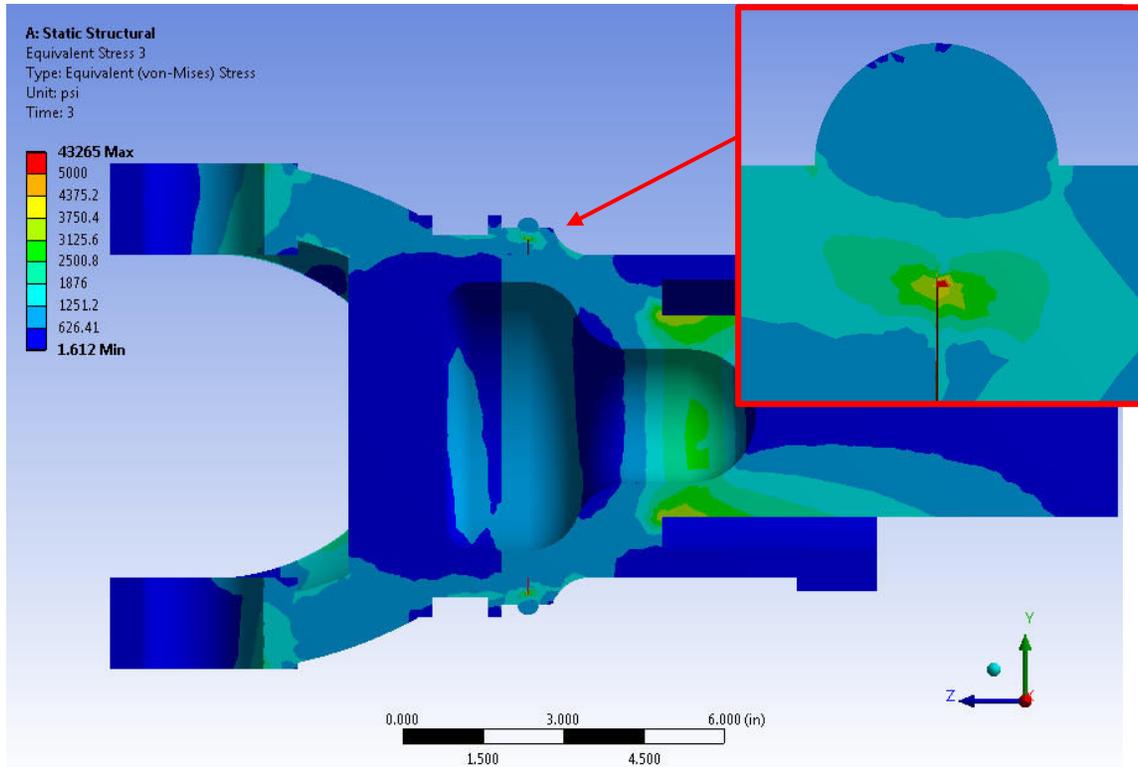
Finite Element Analysis

If the weld on the driveshaft did not penetrate to the inner diameter of the welded components in the region near the weld, this would create a geometry that is basically a crack around the circumference of the shaft. This creates a high stress concentration at the inner edge of the weld. Such a circumstance can be quantitatively evaluated with Linear Elastic Fracture Mechanics (LEFM).

The peak membrane plus bending stress located at the region near the “crack” was calculated from the FEA model to be 3118 psi due to the observed alternating torque and axial loading.

For carbon steels, exceeding a critical stress intensity factor of about $10,000 \text{ psi(in)}^{0.5}$ indicates that the crack or material flaw of radial length “a” has the ability to propagate under alternating load. This analysis calculated a possible k_I value of 11,040 which indicates significant but “borderline” probability of failure from fatigue loading of the weld bead.

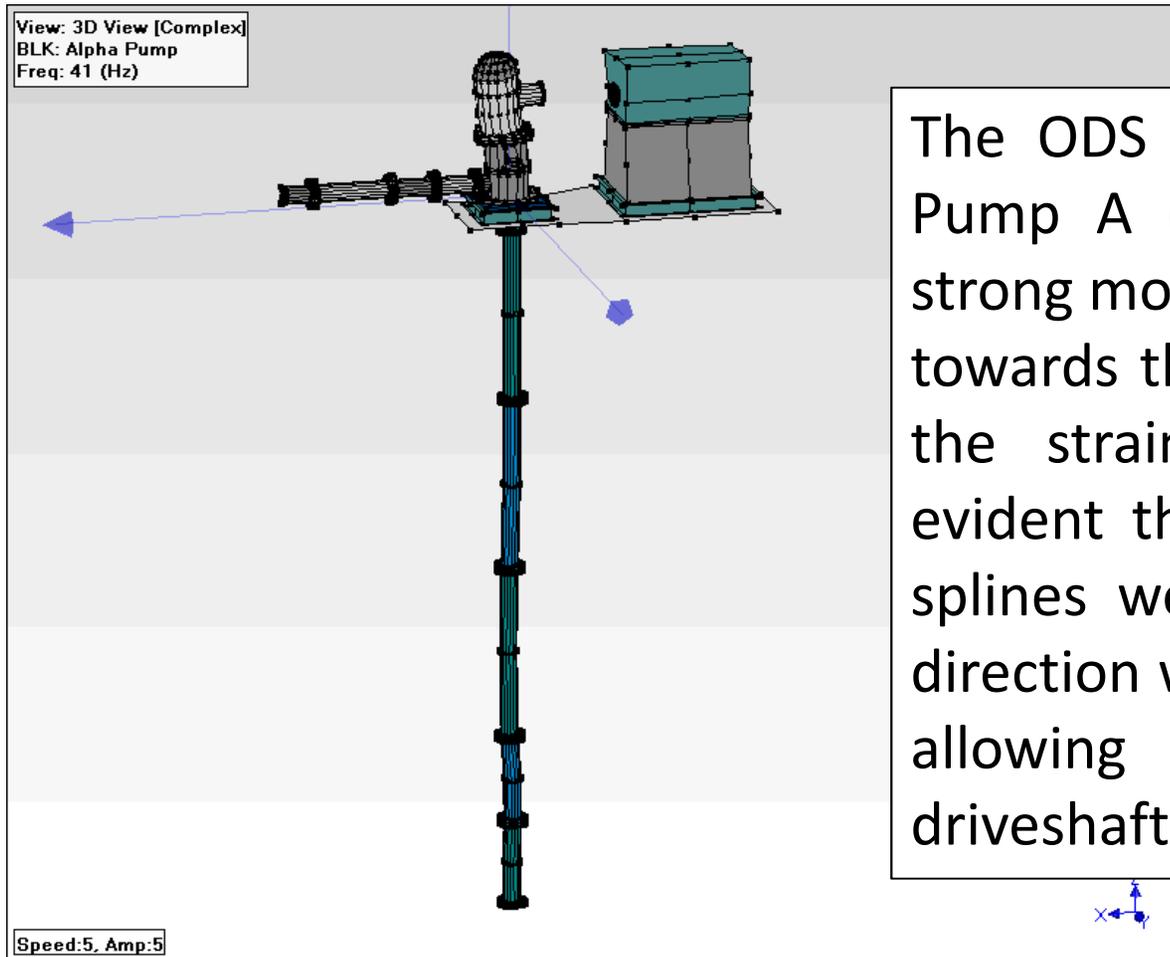
Computer Model Using ME'Scope Program Plotting ODS Test Results

The ODS animation at 41 Hz on Pump A (1.5x RPM) indicated a strong motion of the gearbox head towards the engine. According to the strain gauge data, it was evident that the drive shaft axial splines were binding in the axial direction when under torque load, allowing this mode to enable driveshaft failure.

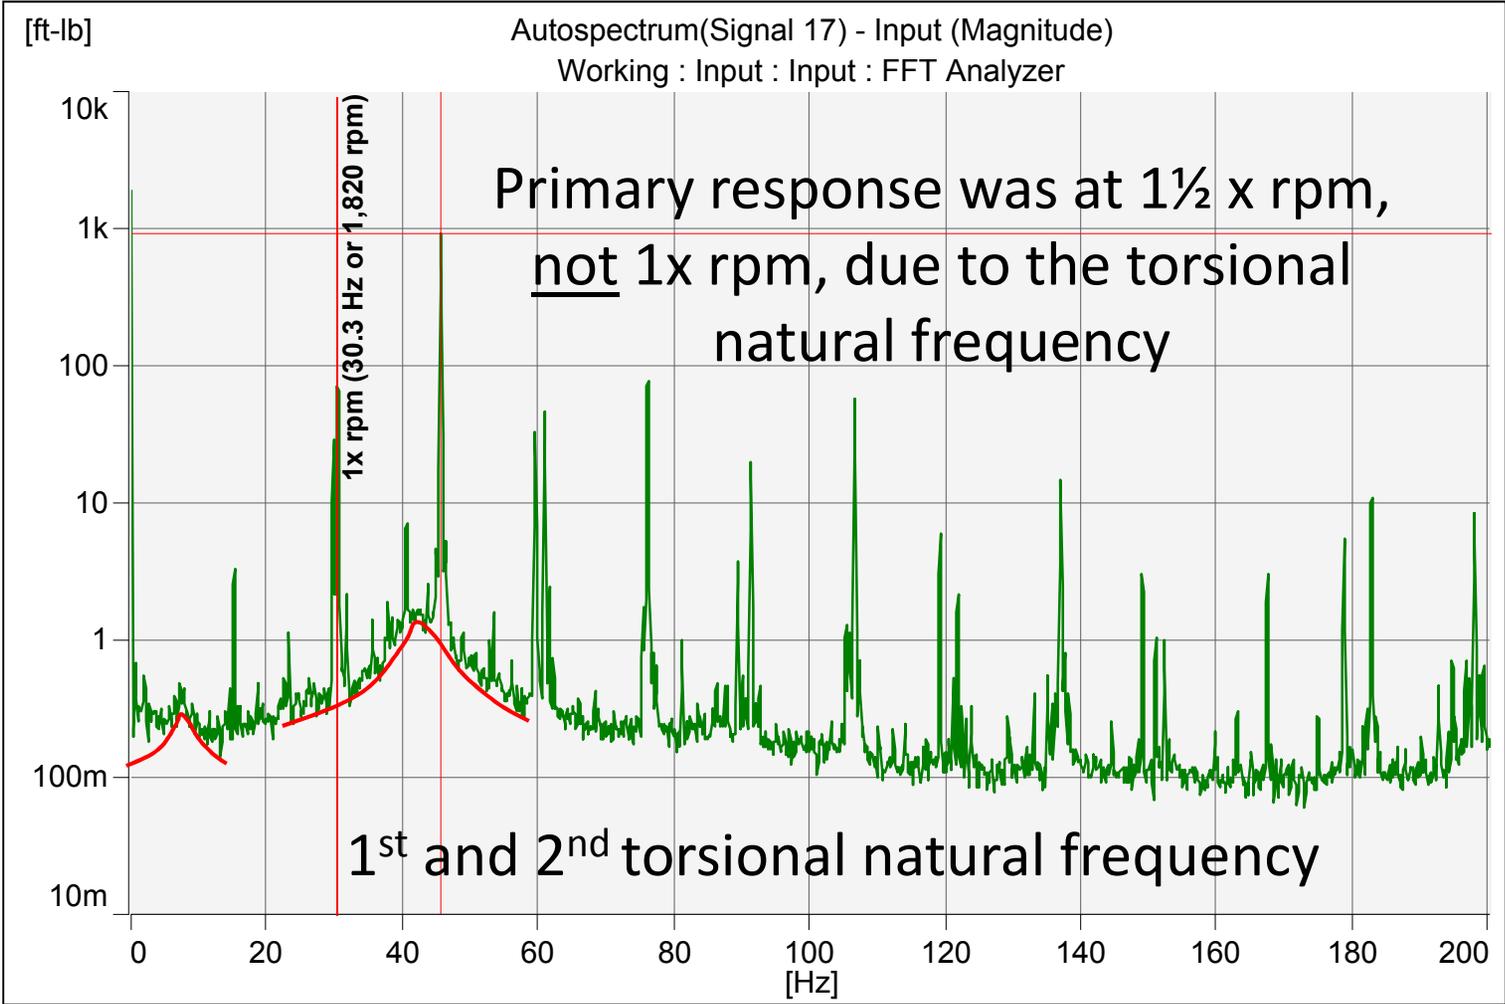
Strain Gage Test

Drive Shaft Torque Spectrum and Torsional Natural Frequencies
Natural frequencies at 7.25 Hz and 42 Hz.

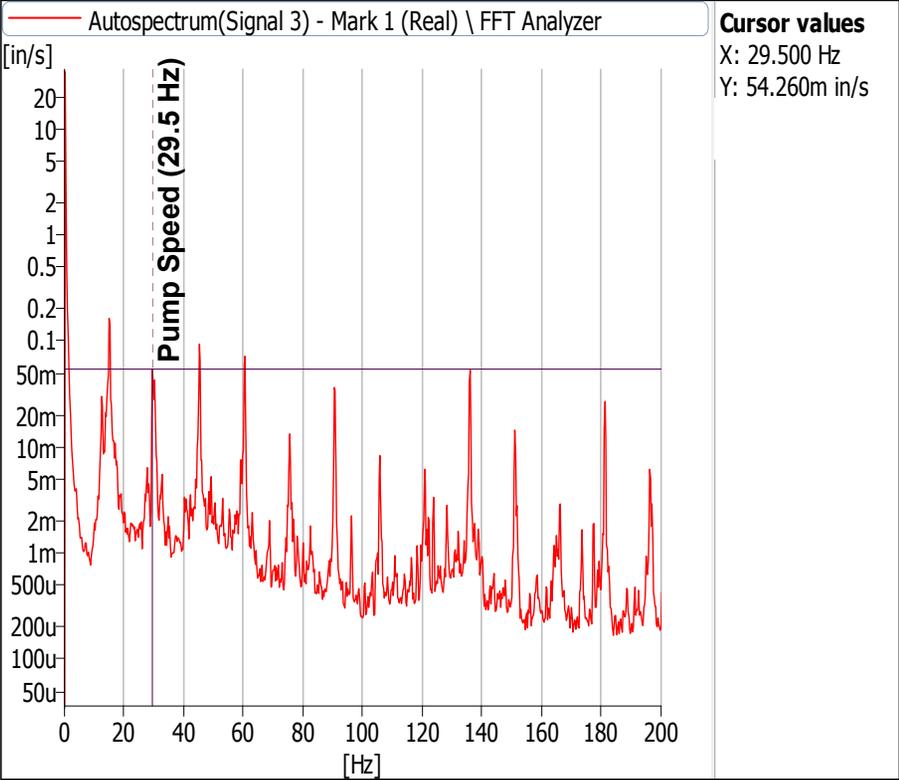
Gearbox Top,
Input Shaft End

Notice that the $\frac{1}{2} \times \text{rpm}$ harmonics appear in both the engine and gearbox.
