Latest Advancements in Mechanical Seal Technology Using Laser Machined SiC Faces to Withstand Electro Kinetic Driven Corrosion

25th Pump User Symposium

Some facts on power plant Jänschwalde, Vattenfall Europe Generation AG & Co. KG:

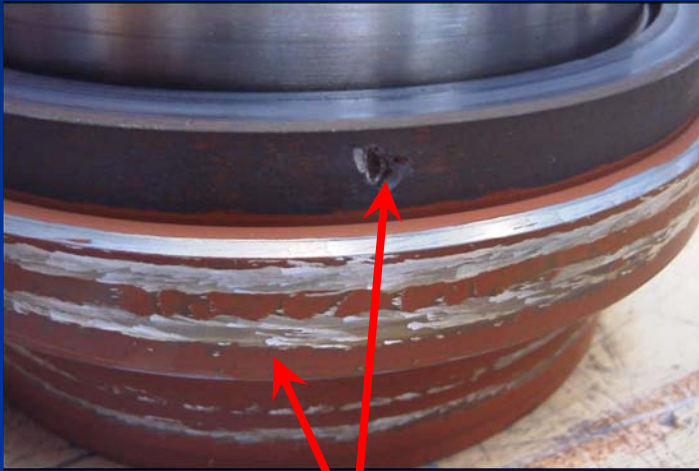
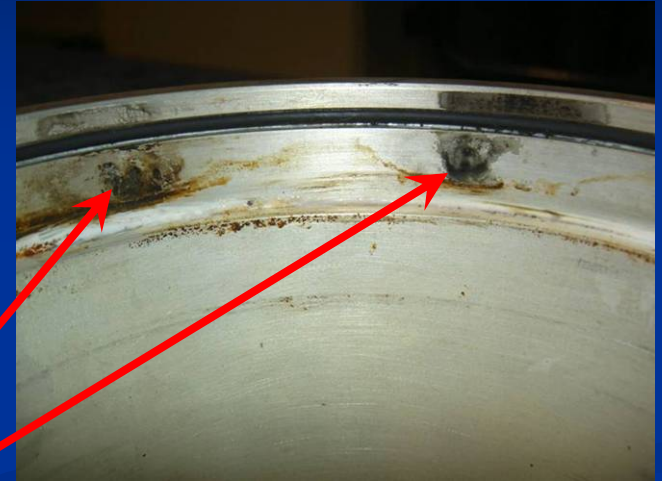
Signs of electrical currents discharging at seal metal parts (sleeve bore) as well as at the seal faces

Material research indicates that electro corrosion initiates material fatigue by extracting binder material from the carbon graphite, leading to subsequent failure

- Key to the solution to avoid electro-corrosion in mechanical seals, is to minimize / eliminate the existence of difference in electrical potential of the 2 seal face materials applied
- Keeping the sealing water temperature as cold as possible, provides a more stable fluid film for the seal faces and also reduces the electro corrosion phenomenon
- Practical experiences have proven that positively grounding the pump rotor, diminishes the electro-corrosion phenomenon.
- Reduction of pump speed also alleviates the problem, but is not regarded as a true practical solution, since it directly influence plant operation/output
- Increasing feed water conductivity by ammonia dosing can increase seal MTBM, but was not allowed by Vattenfall Europe Generation AG & Kg Co. during this specific field trial

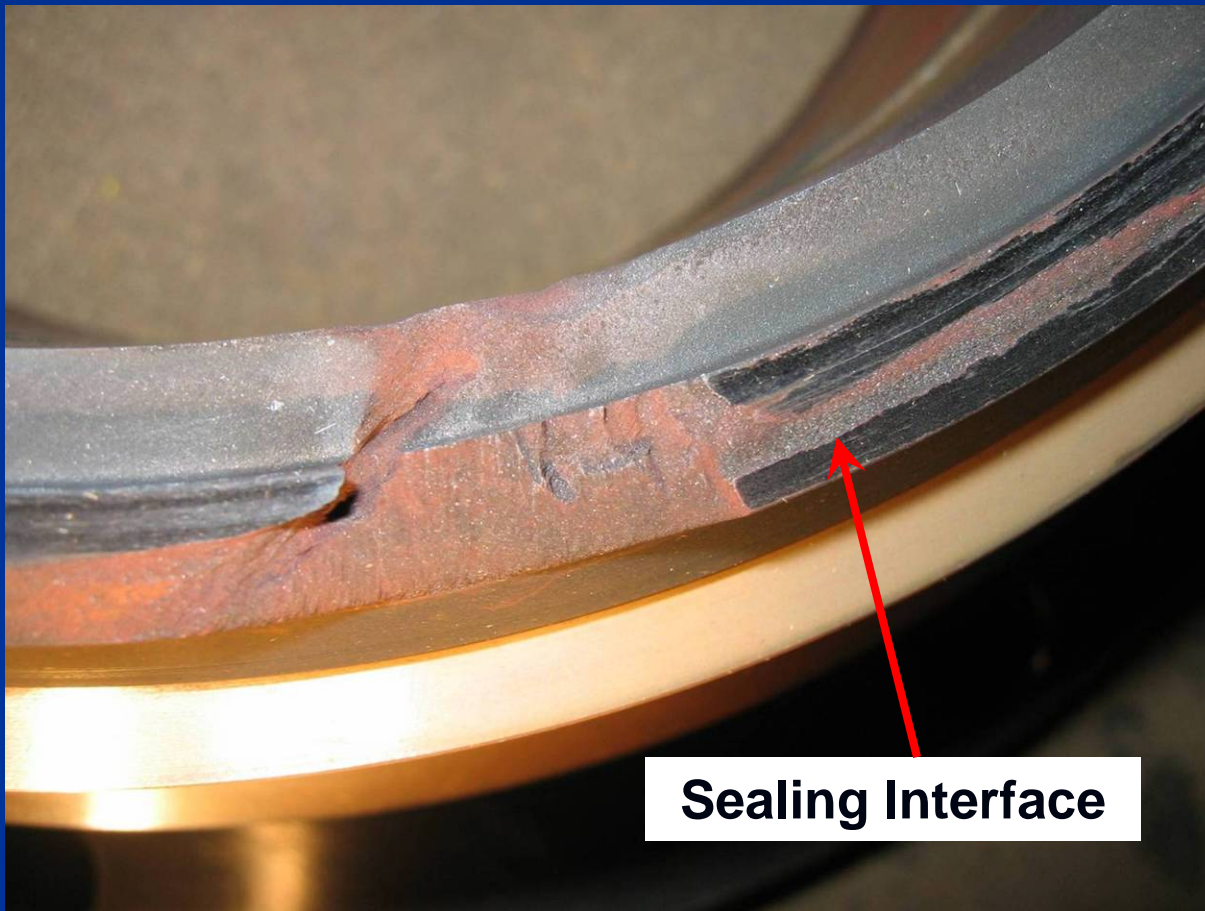
Sealing Interface

Carbon graphite seal ring losing mechanical integrity.

Building of a so-called 'flow channel' at one specific location on the ring's circumference.

Resulting in increasing seal leakage and temperature rise of the seal loop

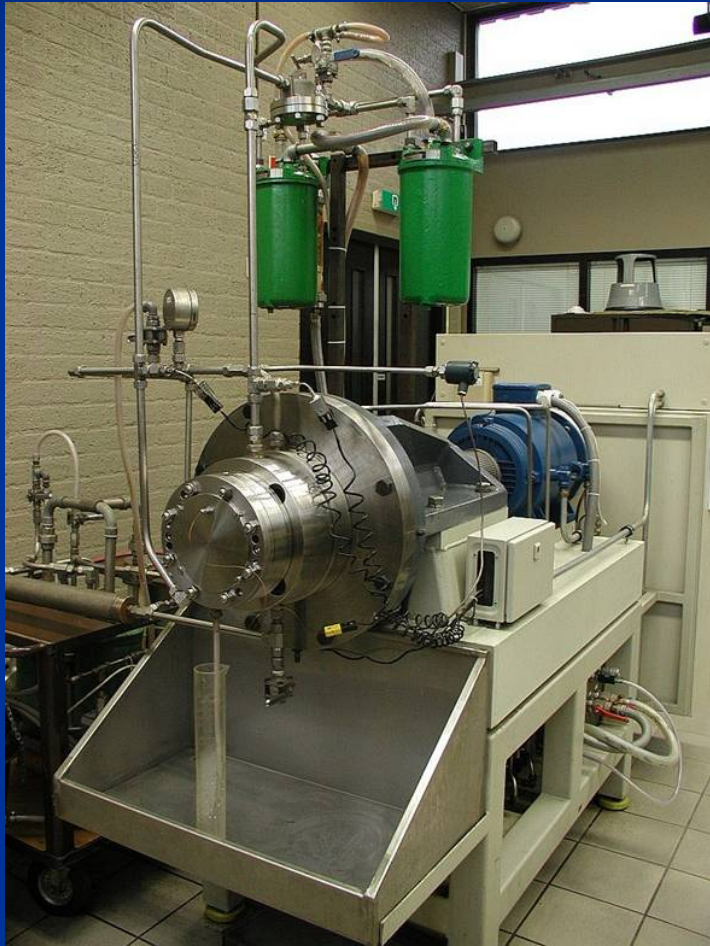
Three differently lasered faces combinations were tested

- Seal faces with leakage rates below 500 cc/hr showed wear tracks
- Face with highest leakage rate (1400 cc/hr at 5400 rpm) passed all tests at both 300 and 5400 rpm. These faces looked also excellent after slow roll testing
- Only mechanical seals were exchanged, pump and seal cooling system were not altered in any way

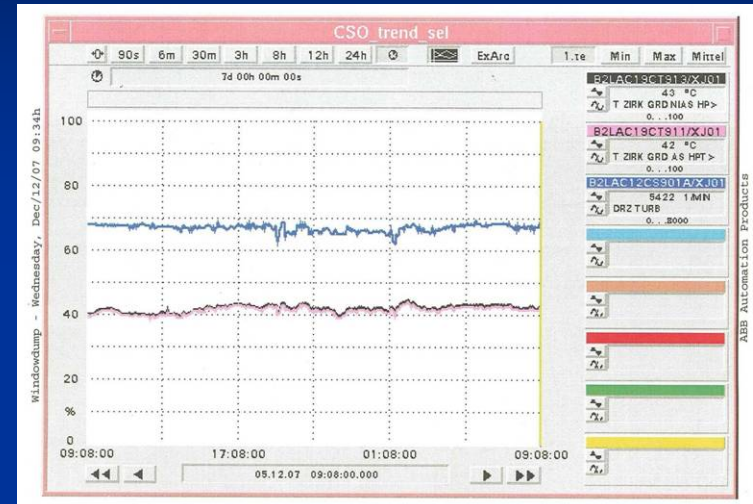
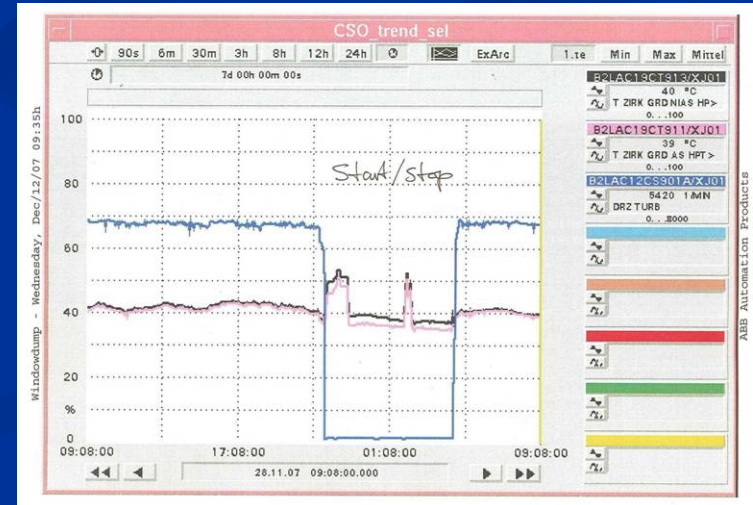
- Seals were running for 15,623 hours, when they were removed on request (used to be only 3,000 hrs. for this particular pump!)
- Initial start up March 2006.
- Reported leakage between 1,000 and 1,500 cc/hr
- Seal loop temperatures very stable, between 40 – 45 °C
- More than 20 starts / stops (local wind turbine feed into grid)
- After 400 hours no signs of electro corrosion found on seal faces!
- No visible leakage is passing the lift off bushing towards bearings

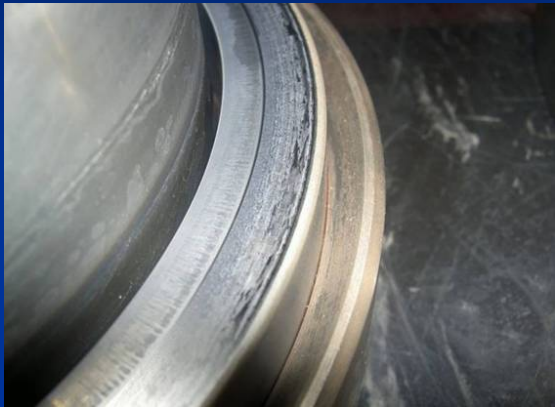
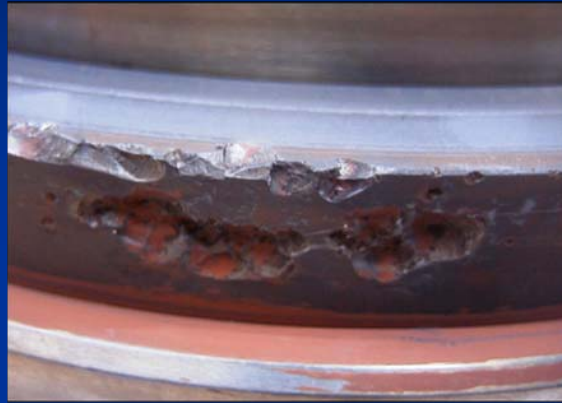
Original seals:
3,000 hrs and failed

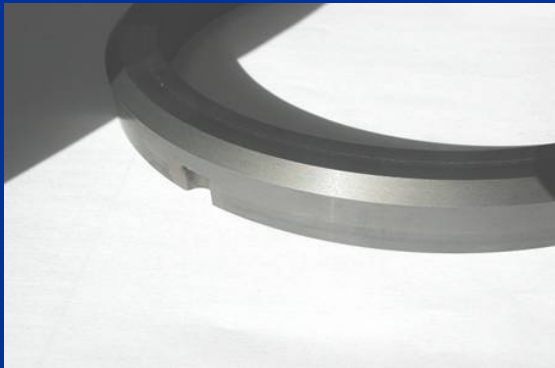
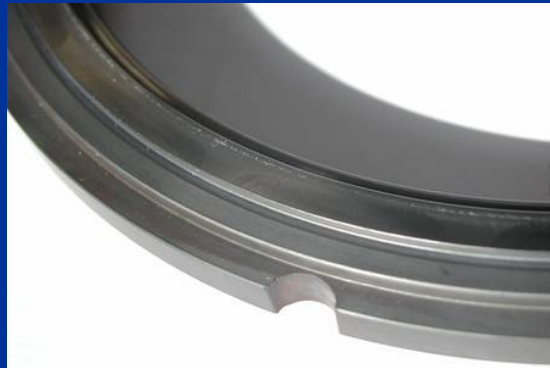
Wavy Face seals:
15,623 hrs, no failure

Applied solution eliminates 95% of the electro-corrosion problem, sealing areas faces are almost EC free, no evidence of heavy damages.
