# MATERIALS PROBLEMS AND SOLUTIONS—A METALLURGICAL PERSPECTIVE

**Colin McCaul**

**Senior Consultant Materials Technology  
Ingersoll-Dresser Pump Company  
Phillipsburg, New-Jersey**

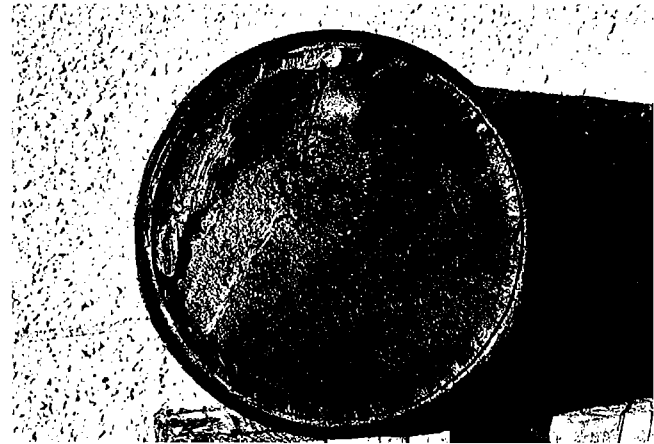
moving sewage pump failed after about one year of service. The fracture occurred at a 0.06 in radius between a smaller and a larger diameter. The fracture surface is shown in Figure 1. It should be noted that this is a relatively short stubby shaft, not subject to excessive bending and with no history of fatigue failures. The material is 1045, a medium carbon steel. The microstructure consists of pearlite with a network of grain boundary ferrite, which suggests that the material probably received a normalizing heat treatment. Metallographic examination at the radius, where cracking initiated, disclosed fine branched transgranular cracks adjacent and parallel to the main fracture surface. These cracks are shown in Figures 2 (unetched), and Figure 3, etched to show that the cracks are independent of structure, that is, they traverse both the harder pearlite and softer ferrite phases.

Figure 1. Fracture Surface, Steel Sewage Pump Shaft. Crack propagated, by low stress high cycle mechanism through almost entire cross section before failure.

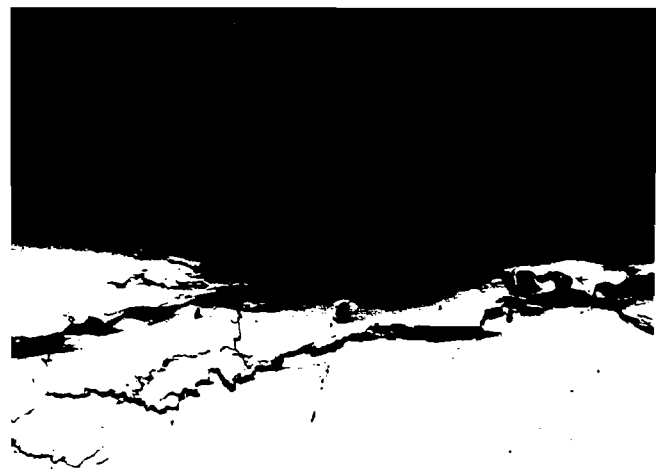
Figure 2. Fine Cracks in Shaft Radius, Adjacent to Fracture Surface.

There are a very few conditions that will cause this type of cracking in normalized medium carbon steel. The evidence indicated localized overheating during manufacture. The final sizing operation would have had to be grinding in order to hold tolerance on the diameter. It appears that excessive grinding resulted in overheating, transformation at the surface to austenite, which cooled rapidly to form brittle crack prone untempered martensite. The fine

cracks that formed increased the stress concentration in the radius sufficiently to allow fatigue cracks to initiate and propagate. This example highlights the need for adequate controls on the final grinding of pump shafts. Adequate cooling is important, as is the instruction of shop personnel who may have some incentive to finish the job quickly and not appreciate the danger associated with abusive grinding.

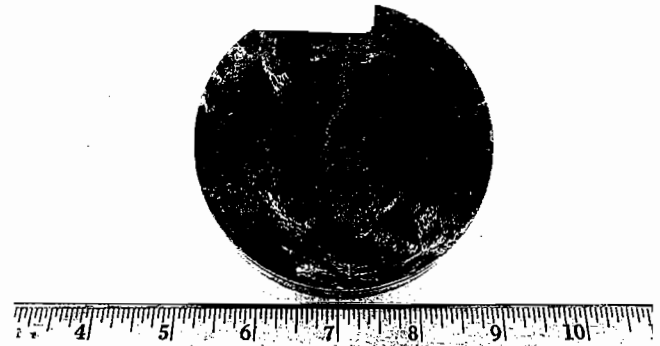
A large boiler feed pump shaft, in service for many years, failed in fatigue. The fracture surface is shown in Figure 5. Crack initiation appears to have been at several points on the periphery of the

shaft and propagated in a single plane perpendicular to the central axis. At low magnification, the several origins appear to be small pre-existing cracks. The crack front propagated through the entire thickness of the shaft before fracture occurred. Visual examination indicated the shaft was coated, presumably with hard chromium. This was apparently done during overhaul some years back when the pump was converted from packing to a mechanical seal. Fatigue occurred under the mechanical seal sleeve. Fatigue occurred at a location where it would not normally be anticipated, since there is no change in section, keyway or other stress raiser. Metallographic examination showed radial cracks, entirely through the thickness of the chrome plate. These, shown in Figure 6, are very significant stress raisers. Also, lack of deformation of the base metal surface indicates that the shot peening was not performed. This example demonstrates that chrome plating, applied without prior shot peening, is capable of inducing eventual cracking even in locations subject to low nominal cyclic stress.

Figure 5. Fracture Surface of Chrome Plated Boiler Feed Pump Shaft.

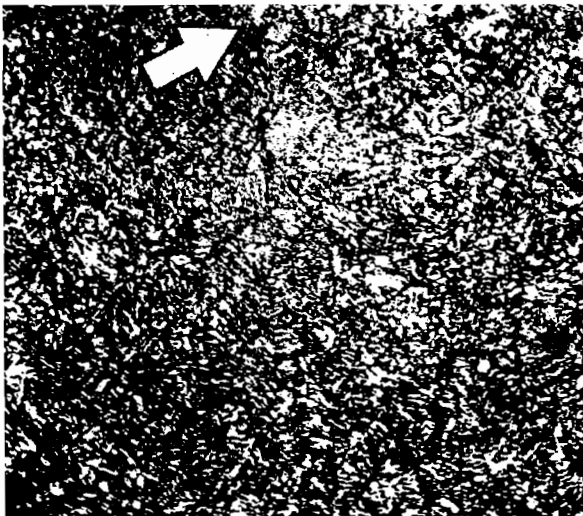
zone containing many small cracks under the plate. Chrome plate evident in some of the cracks (Figure 8) proved that these were present prior to plating. Grinding cracks and burns, such as these, can be readily detected by magnetic particle inspection and etching after grinding and prior to plating.

Figure 8. Chrome Plate in Pre-existing Crack.

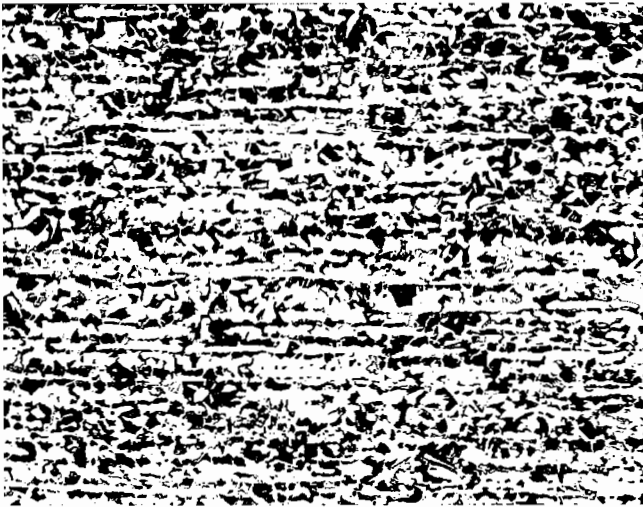
Figure 16. Banded Structure in Medium Carbon Steel Shaft, Attributable to Inadequate Hot Work.

A banded structure is shown in Figure 16 in a medium carbon steel shaft that failed in fatigue after about one year of service handling a brine solution. Failure was attributed to the banded structure, tool marks that acted as stress risers, and corrosion.

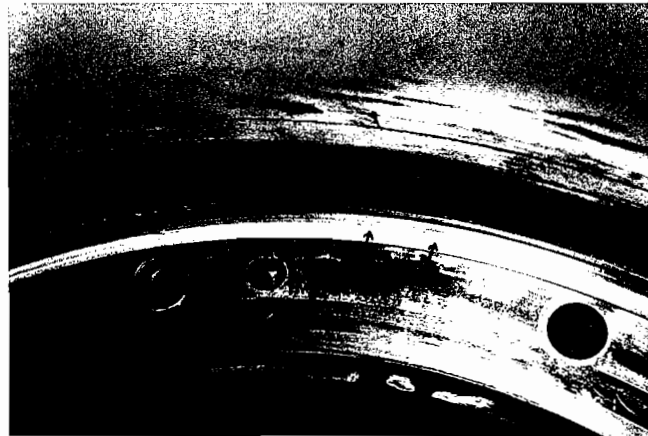
Intermittent cracks were found (Figure 22) around the circumference of a large forged carbon steel barrel at the edge of a stainless steel weld overlay. The pump handles boiler feedwater and had been in service for some 25 years. Metallurgical evaluation revealed the cracks were fatigue, propagating transgranularly along the carbon steel-heat affected zone interface. They were caused by service induced cyclic thermal stress generated by the

difference in coefficient of thermal expansion between the carbon steel barrel and the austenitic stainless steel pressure face weld overlay.

Figure 22. Circumferential Cracking at Weld-base Metal Interface in Forged Barrel.

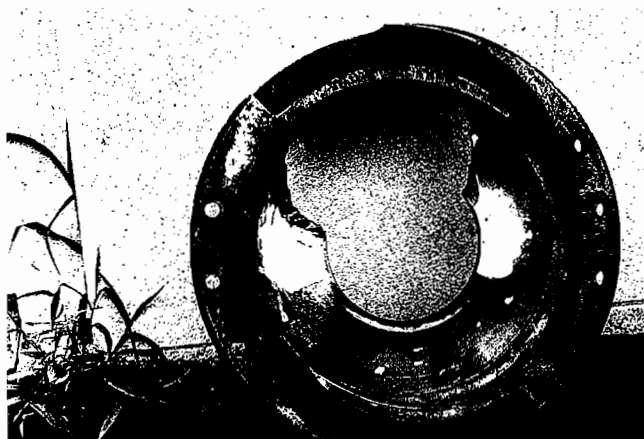
A diffuser from a large barrel pump is shown in Figure 23 with a section broken out of the casting. The diffuser fractured after some twenty-five years of service. After cleaning, a large austenitic repair weld was found at the site of crack initiation. This was one of several austenitic welds, evidently made at some previous time to repair cracks. Cracking propagated, by a fatigue mechanism, along the fusion line between austenitic weld and martensitic base metal (Figure 24), eventually causing fracture. These welds produce hard brittle heat affected zones, which act as notches and can induce fatigue cracks in components that are cyclically stressed. This approach to repair should be discouraged in most instances, in favor of repair with a matching filler metal followed by postweld heat treatment. Although this may involve additional welding and remachining to accommodate dimensional changes, it is the preferred method for making a sound and durable repair.

Figure 23. Diffuser, Fractured Due to Fatigue Cracking after Long Service.

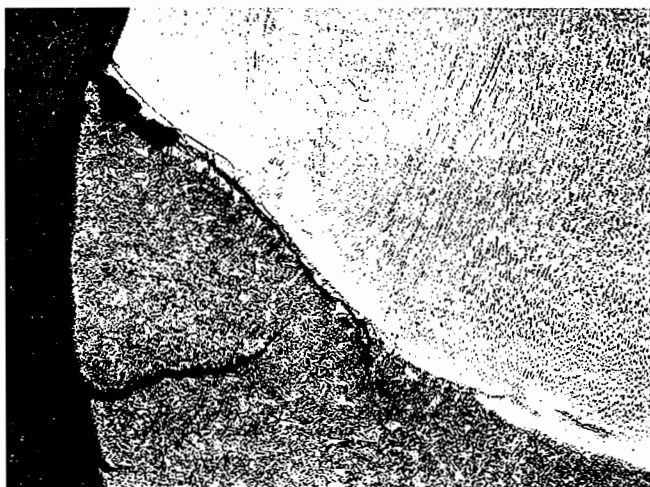
Figure 24. Crack Propagation along Fusion Line in 13 Percent Chrome Diffuser Weld Repaired with Austenitic Filler Metal.
