# Modeling and Simulation Transient Analysis Case Study of a Liquids Gathering System

Southwest Research Institute®

#### Description & Outline

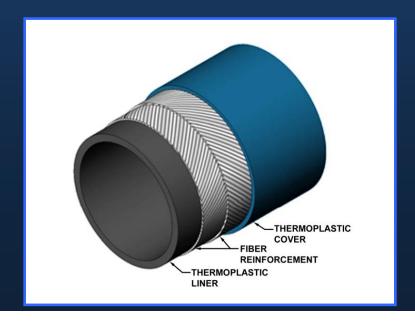
Flexible Pipe Structural Components

Failures appeared to increase after check valve

installed

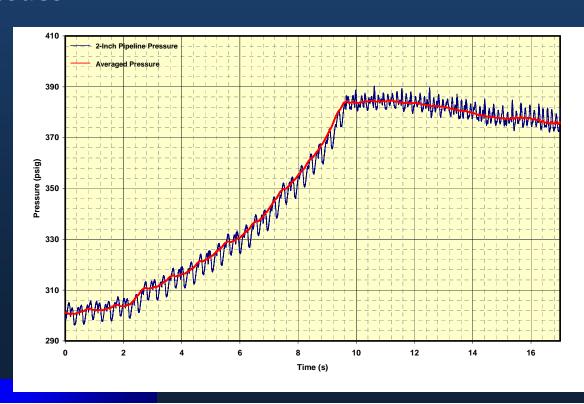
2-in pipe Ramp-up from 20%-100%

- Startup & shutdown transients not a problem
  - Several test cases were run which resulted in significant transient responses but were not enough to lead to a pipeline failure
  - There was no significant response related to the addition of the check valve half way up the hill
- Pulsation while small may play a significant part in the flexible composite pipeline failure

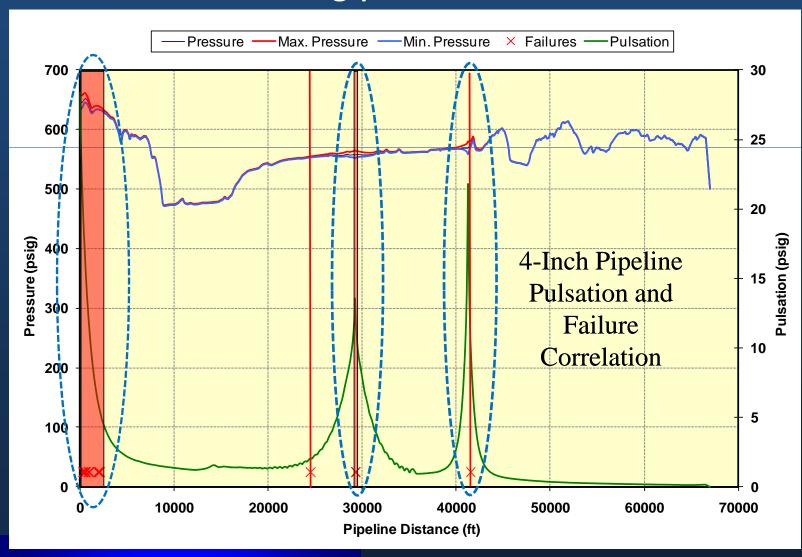
## Pulsation Analysis

Pulsations are strongly correlated failure sites

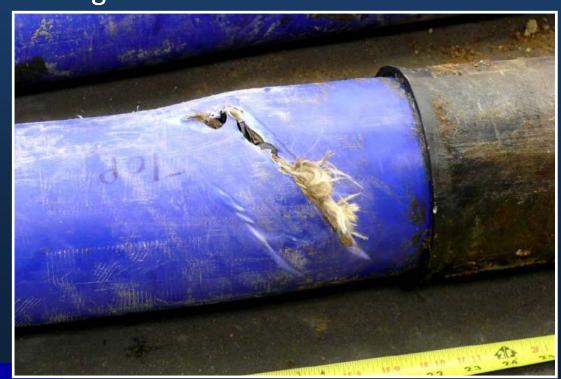
#### Failure Analysis

- Analysis of failed segments revealed failure from inside outward
- Inner-liner erupted through outer liner with little evidence of water between layers
- Hydro-testing of adjacent segments met or exceeded

Glass fibers near the inner liner tended to have jagged breaks where as fibers near the outside tended to be clean breaks
