# RELIABILITY IMPROVEMENTS TO A HIGH PRESSURE, HIGH TEMPERATURE, THIRTEEN STAGE CHARGE PUMP

Dave A. Johns

Shell Oil Company

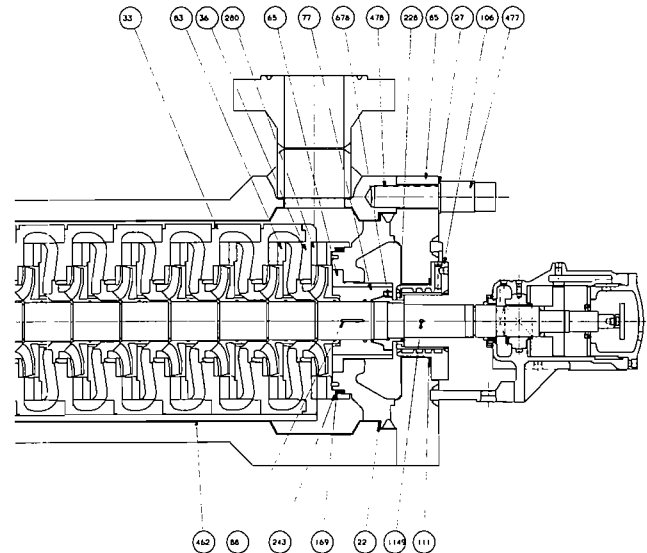
Figure 2. Discharge Head Assembly.

The head to case joint has been a leakage area in the past.

The original pump assembly specifications called for clearance between the pump head and casing. Designers of the pump, in an effort to maintain rotor to case alignment, also wanted the head parallel to the case within 0.002 in. Asking a machinist to tighten 24, 2.0 in studs holding a 500 lb chunk of steel and keep the surfaces parallel within 2.0 mils is like winding a Rolex with an impact wrench. This is a challenging task under ideal laboratory conditions, and nearly impossible under field conditions. The metal to metal case fit has several advantages:

The modification required machining the discharge head, the mating surface of the casing, and the inner discharge head. All other machined faces and bores were welded and remachined so that the entire case was brought back to factory specifications.

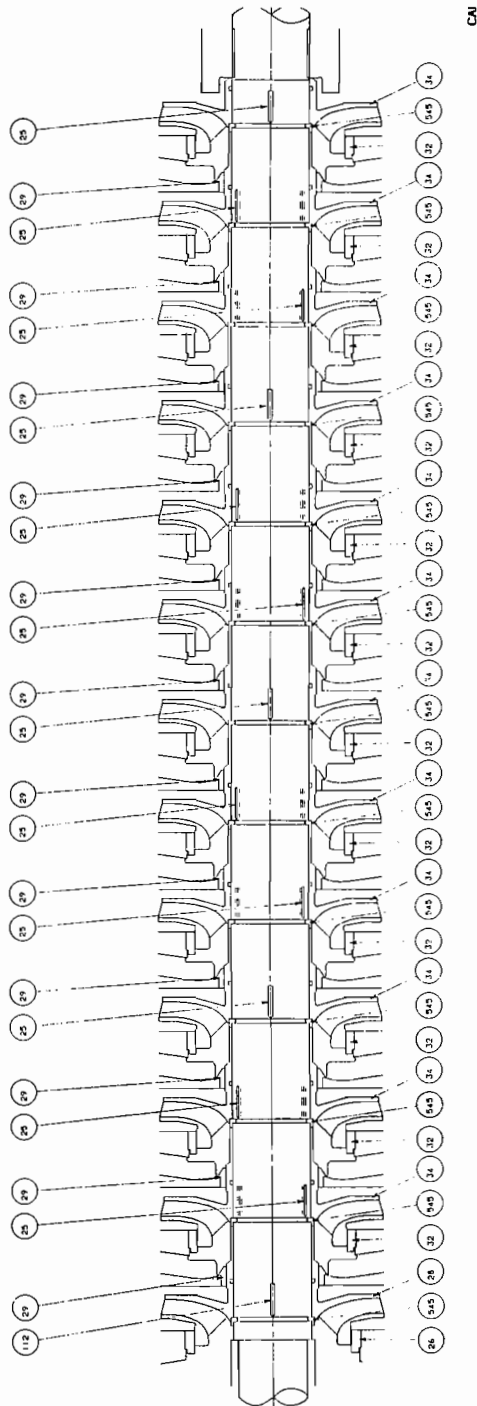
Figure 3. Rotor Assembly.

The original shaft was the same diameter from the first to the last impeller, with each impeller driven by a single key. Proper axial impeller position was established by a shaft shoulder on one end with impellers and sleeves stacked from this shoulder.

- Galling probability during rotor assembly increases with the length of same diameter shaft that impellers and sleeves have to pass over.
- Axial stack-up errors are likely, because everything is referenced from one point, the shaft shoulder.
- Difficulty maintaining rotor straightness, which depends upon the squareness of the impeller hub and spacer sleeve faces when the components butt together.

The new design shaft has several features to ease assembly and increase stack-up accuracy. Starting from the first stage, the shaft diameter under each impeller is progressively smaller. Therefore, the impeller has clearance on all fits except the mounting fit. Each shrunk fit impeller is individually located by split rings which fit into machined grooves on the shaft. The impeller is machined to retain the rings. The sleeves are fabricated as part of the impeller instead of each being a separate item.

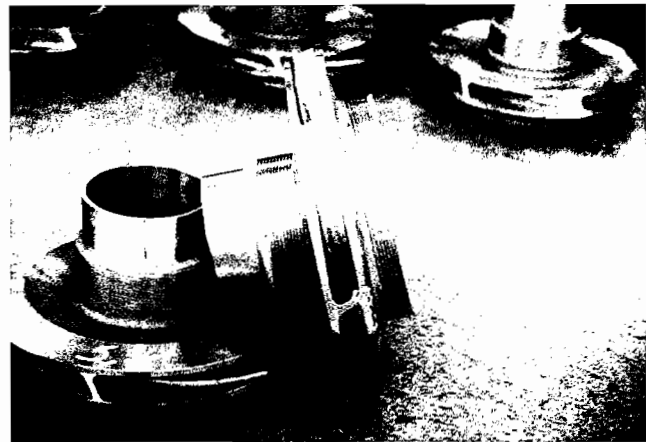
Figure 4. Impeller with Counter Rotating Spiral Grooves.

Standard wear rings attached to the impeller by tack welds or set screws were originally supplied. These separate impeller wear rings tend to crack and come off of the impeller if suddenly heated, such as during mechanical contact or the pump running dry. These loose metal parts then go on to cause further damage in the pump. The following modifications were made to minimize the potential damage to the pump due to wear ring touch off or failure.

- The rings and mating bushings were made with spiral grooves on the surface instead of the typical smooth surface (Figure 4). The grooves in the rotating part are in the opposite direction of the grooves in the stationary part. The counter spiral grooves have two benefits:

- The rotating wear rings and balance piston were coated with tungsten carbide to create a greater surface hardness differential between the rotating and stationary parts.

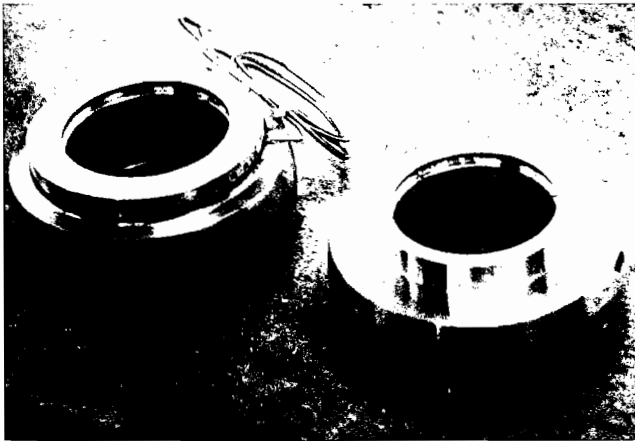
Figure 6. Spherically Seated Babbitt Lined Journal Bearings.

The pump's radial bearings are spherically seated babbitt lined sleeve bearings (Figure 6). Original design required the bearing crush to be adjusted by varying the gasket thickness on the bearing housing horizontal split line. This is a time consuming task and end results were of questionable accuracy. Present day precision bearing manufacturing techniques eliminate the need for an "adjustable" bearing housing split line. Elimination of the split line gasket required machining of the horizontal split line and reboring of the spherical seat. After machining, the housings were centered and doweled into position on the pump case.

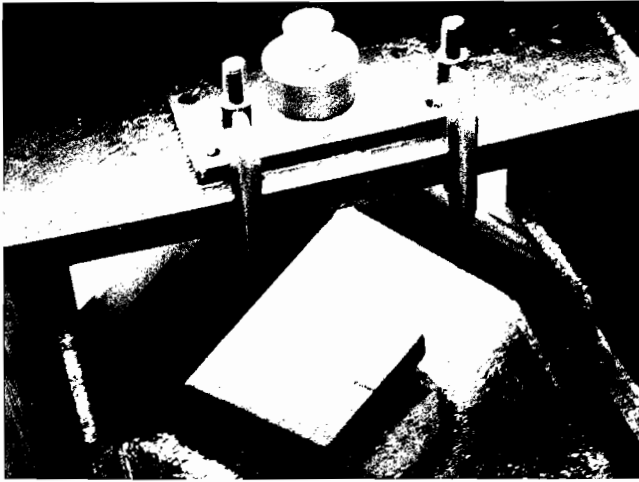
Figure 9. Typical Coupling End Centering Pin.

- One centering pin at the bottom of the coupling end (Figure 9).
- An axial key under the thrust end (Figure 10).
- Both the centering pin and the axial key had the female part on the case and the male section mounted on the pump base.
