**REPETITIVE SHAFT CRACK FAILURE ANALYSIS
ON A MULTISTAGE CENTRIFUGAL PUMP IN REACTOR CHARGE SERVICE
IN A NUCLEAR POWER PLANT - BASED ON ODS AND FEA**

Maki M. Onari

Victor G. Arzani, P.E.

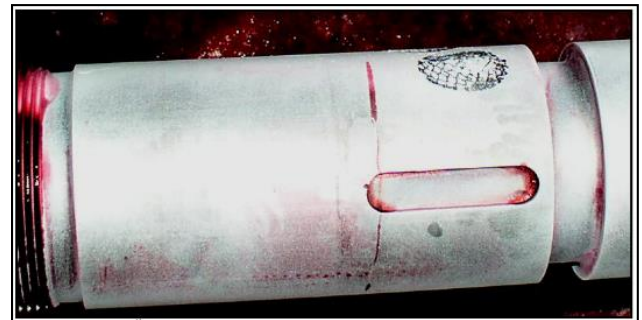
Figure 4. Detail of 11th Impeller Area with Circumferential Crack by Color-Contrast LPT. Redmond, 2008, Duke Power "Evaluation of CNS 1B NV Pump Shaft and Related Components – Metallurgy File #3917".

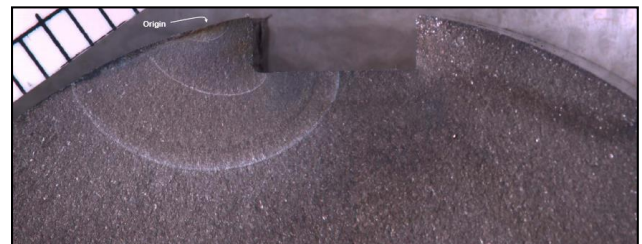
Figure 5. Fracture Overview Showing the Origin and the Crack Propagation. Redmond, 2008, Duke Power "Evaluation of CNS 1B NV Pump Shaft and Related Components – Metallurgy File #3917".

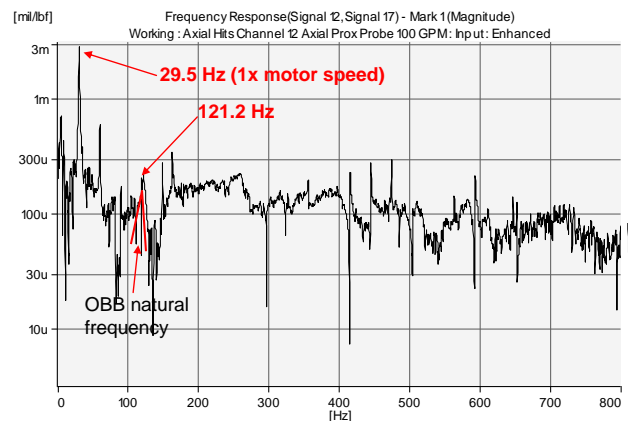
Figure 13. 1B NV Pump EMA Test - FRF Plot from the Axial Proximity Probe at the OBB (mil/lbf versus Frequency in Hz)

The Time Averaged Pulse (TAP™) technique was used to take into account the operating fluid film stiffness for the thrust bearing. This test was performed with the pump operating at 145 gpm (32.9 m³/h) to determine if there are any potentially relevant axial natural frequencies of the pump shaft. After several hundred impacts, the final FRF plot (Figure 13) did not indicate any natural frequency in the vicinity of the running speed of the pump (81 Hz). In contrary, a strong excitation at the motor running speed was observed (29.5 Hz). The only natural frequency identified was at approximately 121 Hz. However, this natural frequency is difficult to be excited. The 4x rpm of the motor is the closest harmonic and it is considered a weak excitation source, especially in the axial direction. The same test was performed while the pump was operating at 160 gpm (36.3 m³/h) of capacity indicating a similar frequency response.

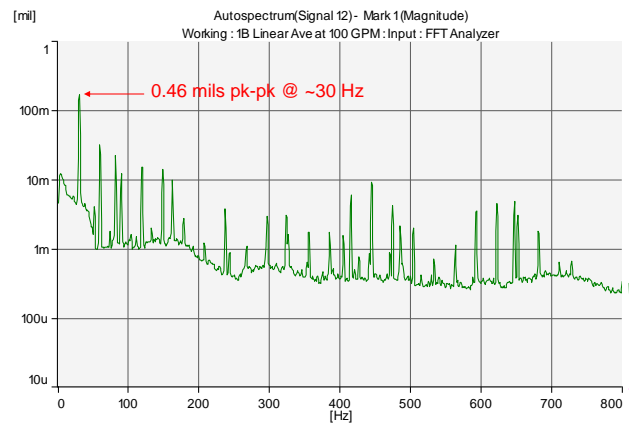
Figure 17. 1B NV Pump Axial Proximity Probe Vibration Spectrum (mils rms versus Frequency in Hz)

The axial proximity probe installed at the OBB of the 1B NV pump indicated an interesting narrow band peak at approximately 30 Hz, which represented the running speed of the motor. The amplitude of this spike was measured to be almost 0.5 mils pk-pk (12.7 microns pk-pk). Figures 17 and 18 show the FFT and the time waveform plots from the axial probe, respectively. CNP had reported that the axial motion of this pump had been detected as high as 1.7 mils (43.2 microns) pk-pk, while the other three charge pumps only showed mostly displacement at the running speed of the pump (81 Hz) likely due primarily to mechanical axial run-out of the target plate of the probe.
