RESOLVING VIBRATION ISSUES OF DIESEL ENGINE DRIVEN FIRE WATER PUMPS

Sherief Mekawey
Principal MDS Engineer
GE-Bently Nevada

42nd Turbomachinery
29th Pump SYMPOSIA

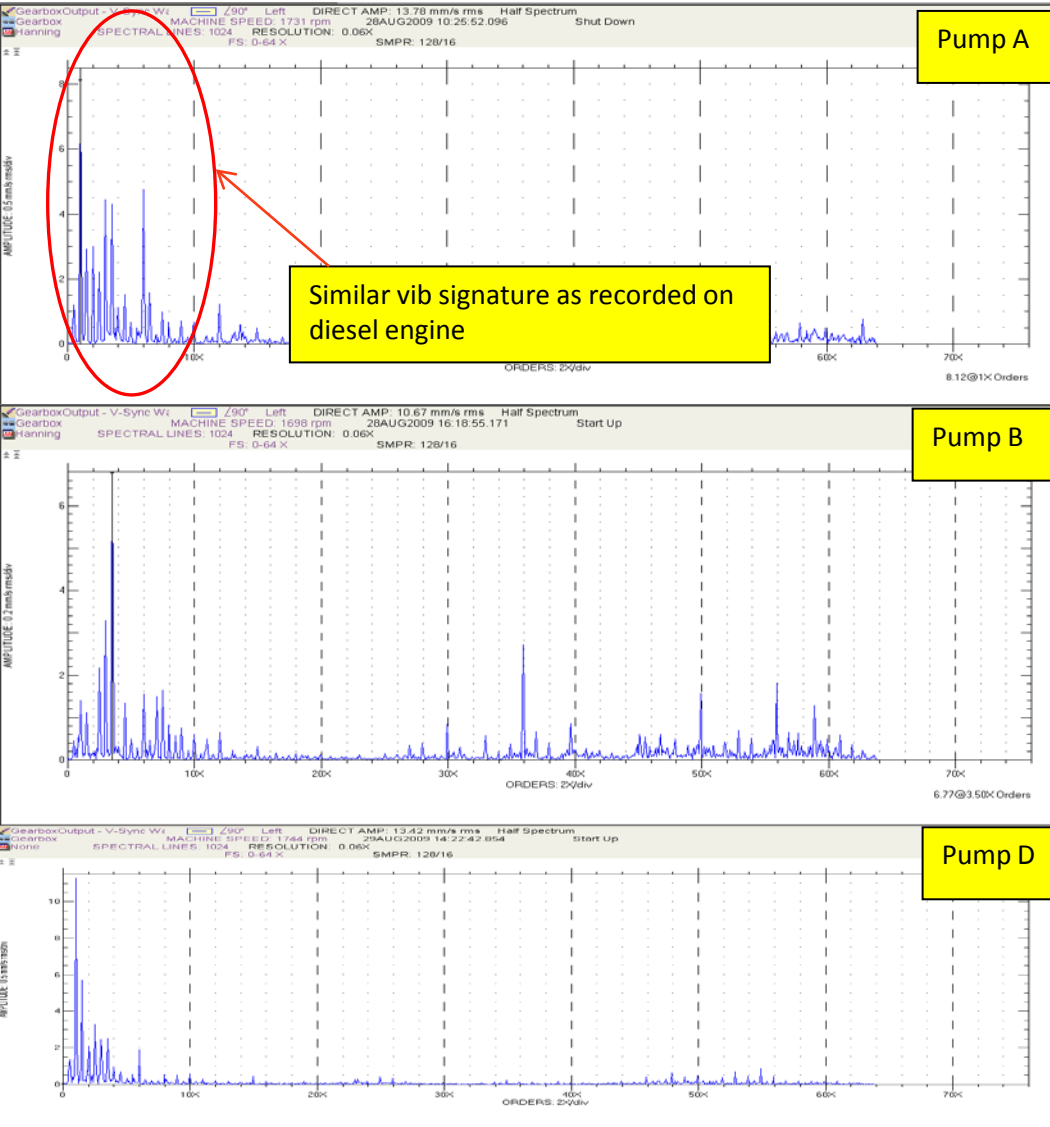
Comparison of vibration signatures of Pumps A, B & D on the GB output Vertical location

Observation#1: Vibration signature on Gearbox indicated that a significant energy components getting transmitted from the Diesel Engine at 1X, 3X, 3.5X and 6X

Reason could be: vibration isolators are not installed either under the engine feet nor under the frame on which the engine is mounted.

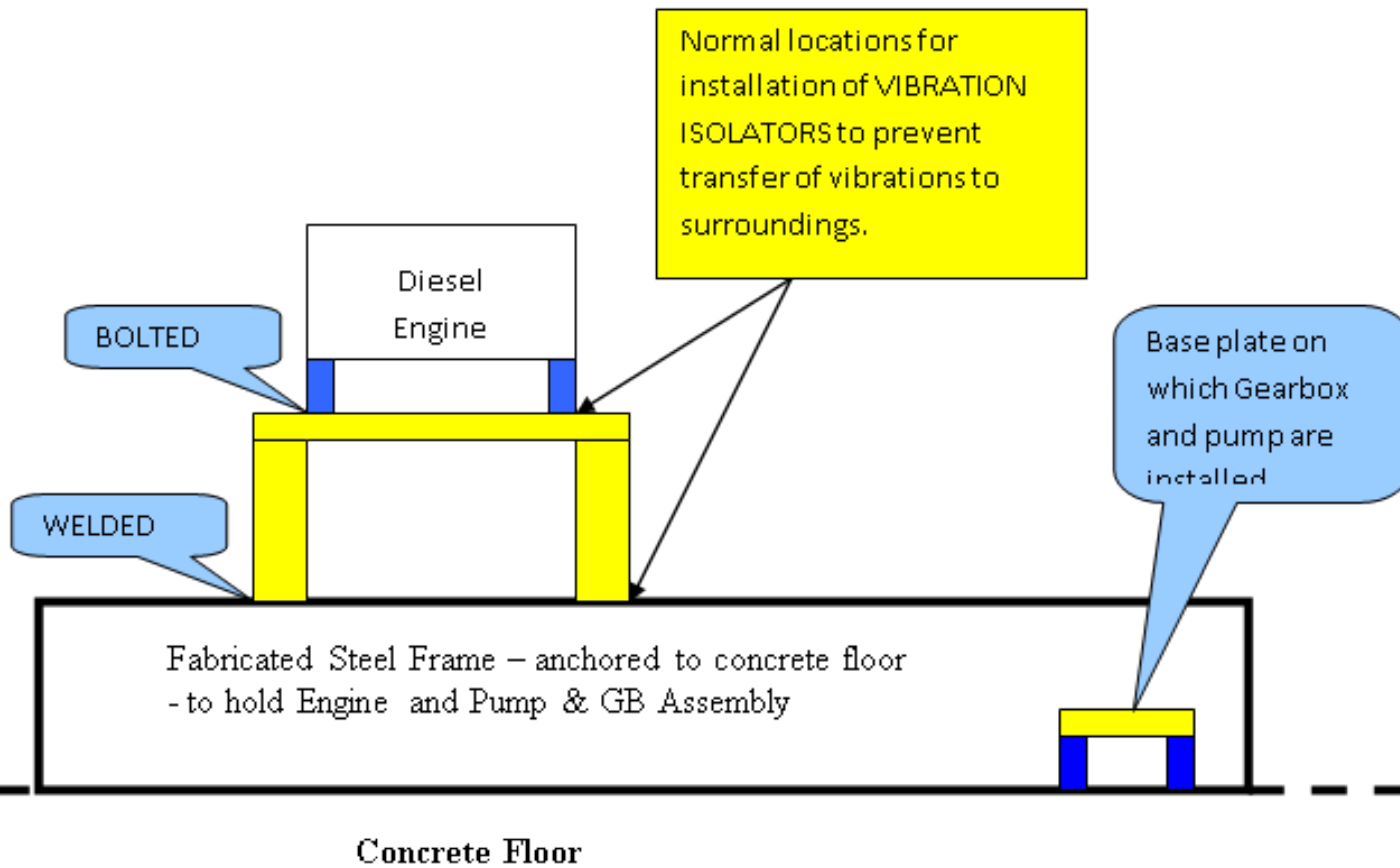
Foundation/supporting arrangement for Diesel Engine, Gearbox and Pump.

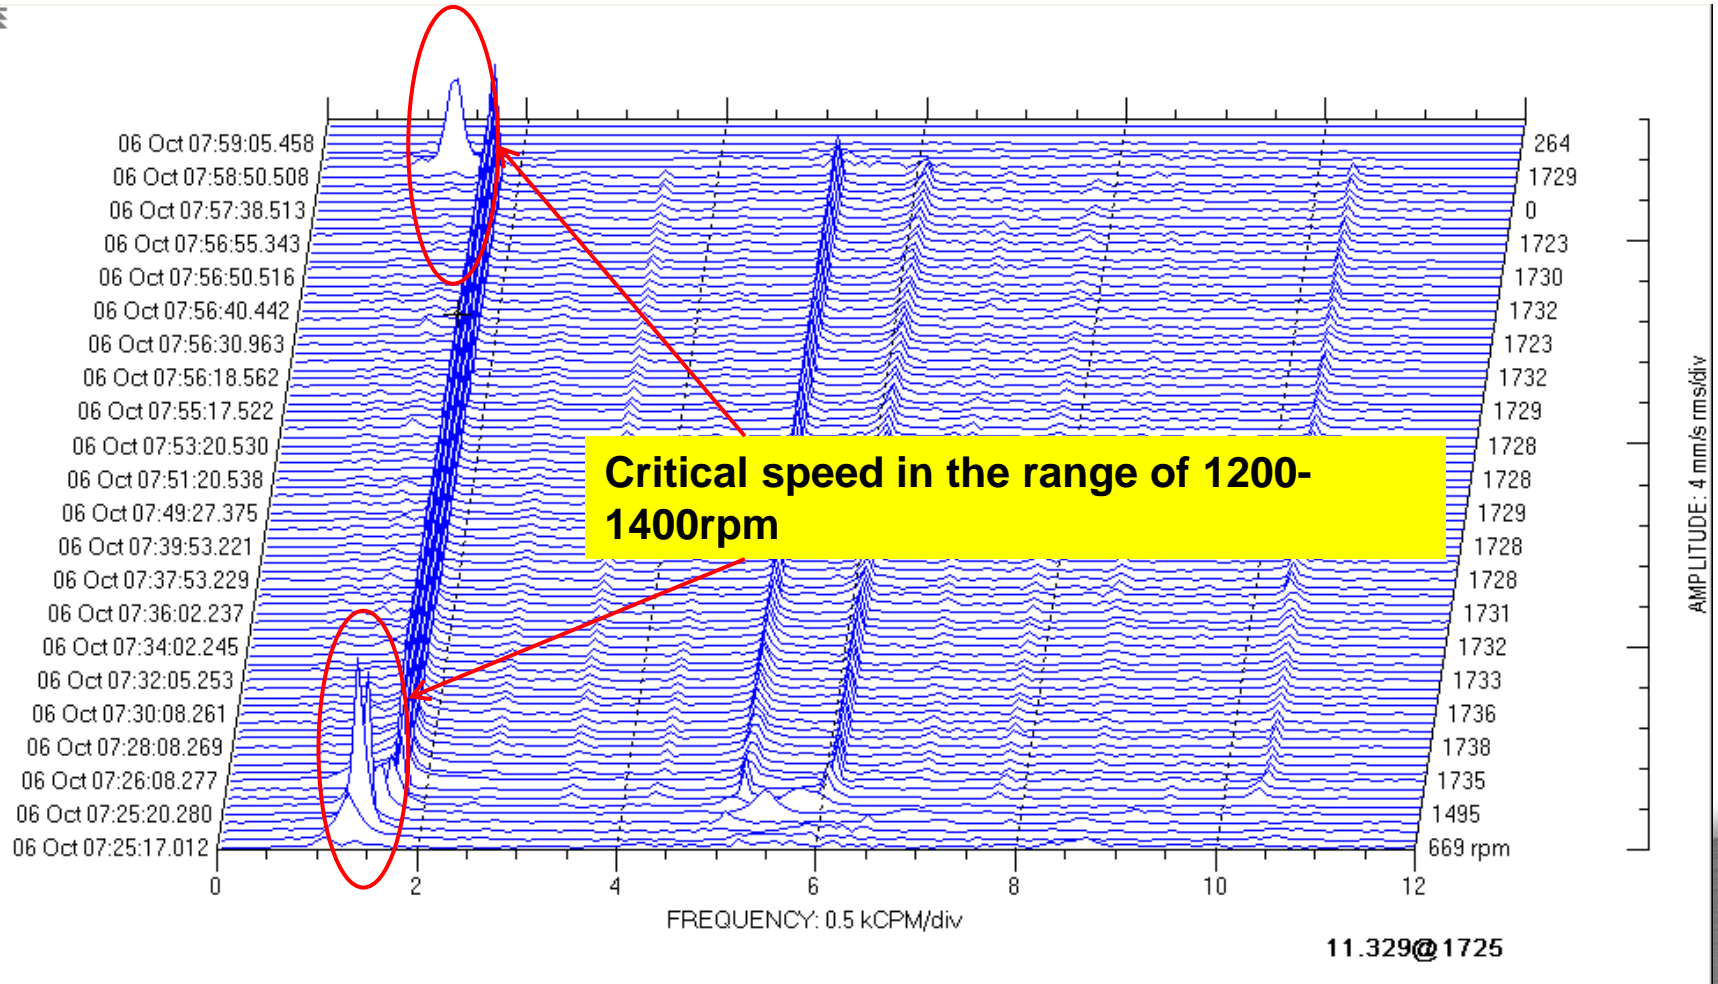
Observation#2: Startup/coast down waterfall indicated resonance in the speed range 1200 to 1400 rpm

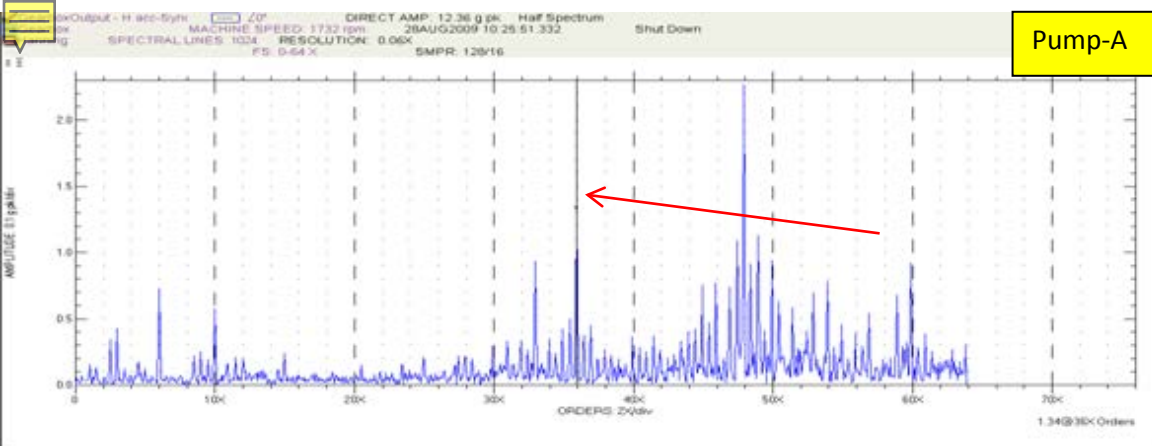
Pump-A

Observation#3: Bump test data on the Gearbox structure indicated a resonance at 22.5Hz and 33 Hz, which is less than 20% separation margin (Pump Running speed 28.75cps)

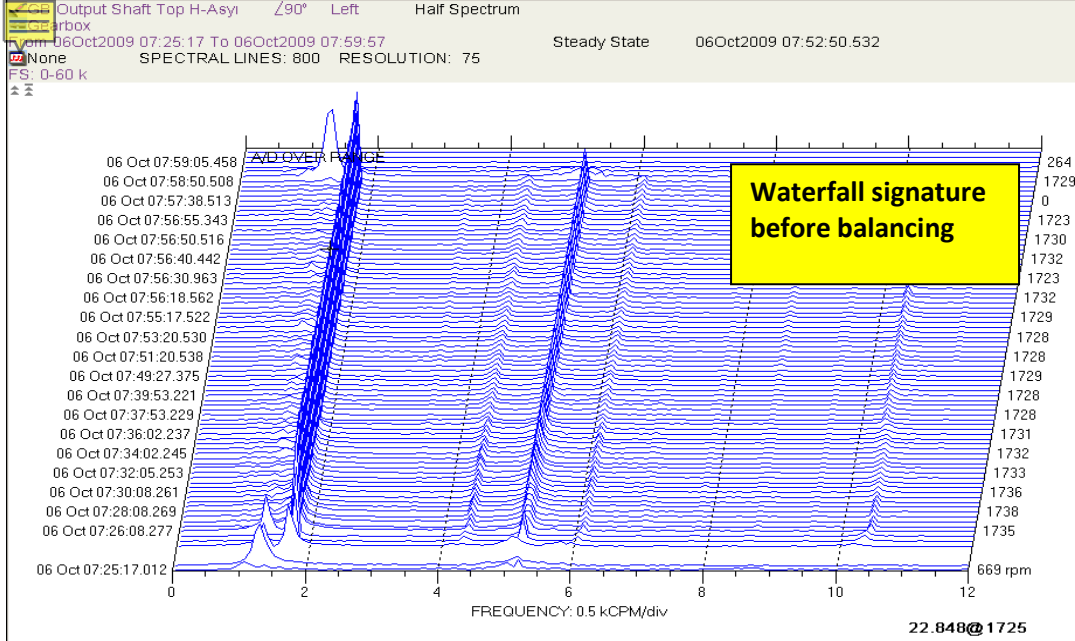
Action#1 (contd): In-situ balancing resulted in reduction of 1X. However the 22Hz resonance component was excited

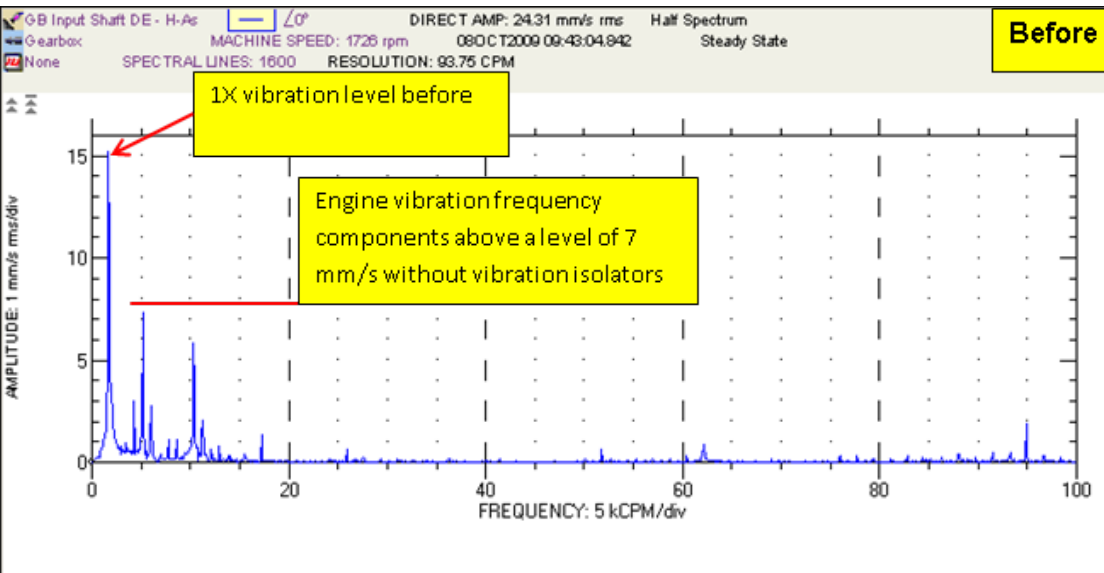
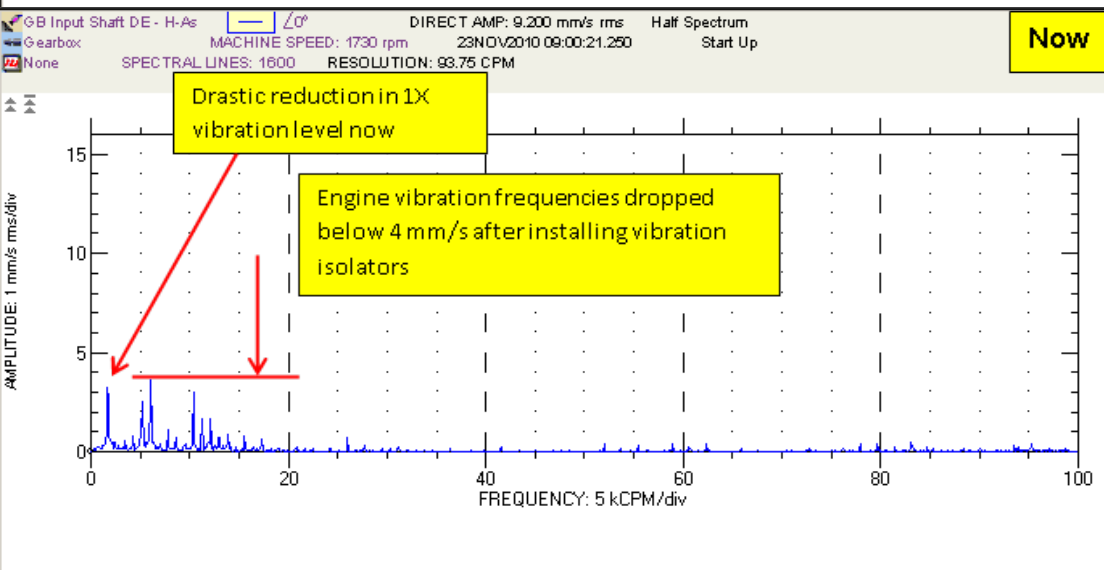
Comparison of vibration spectrum before and after the modification of engine base frame with vibration isolators

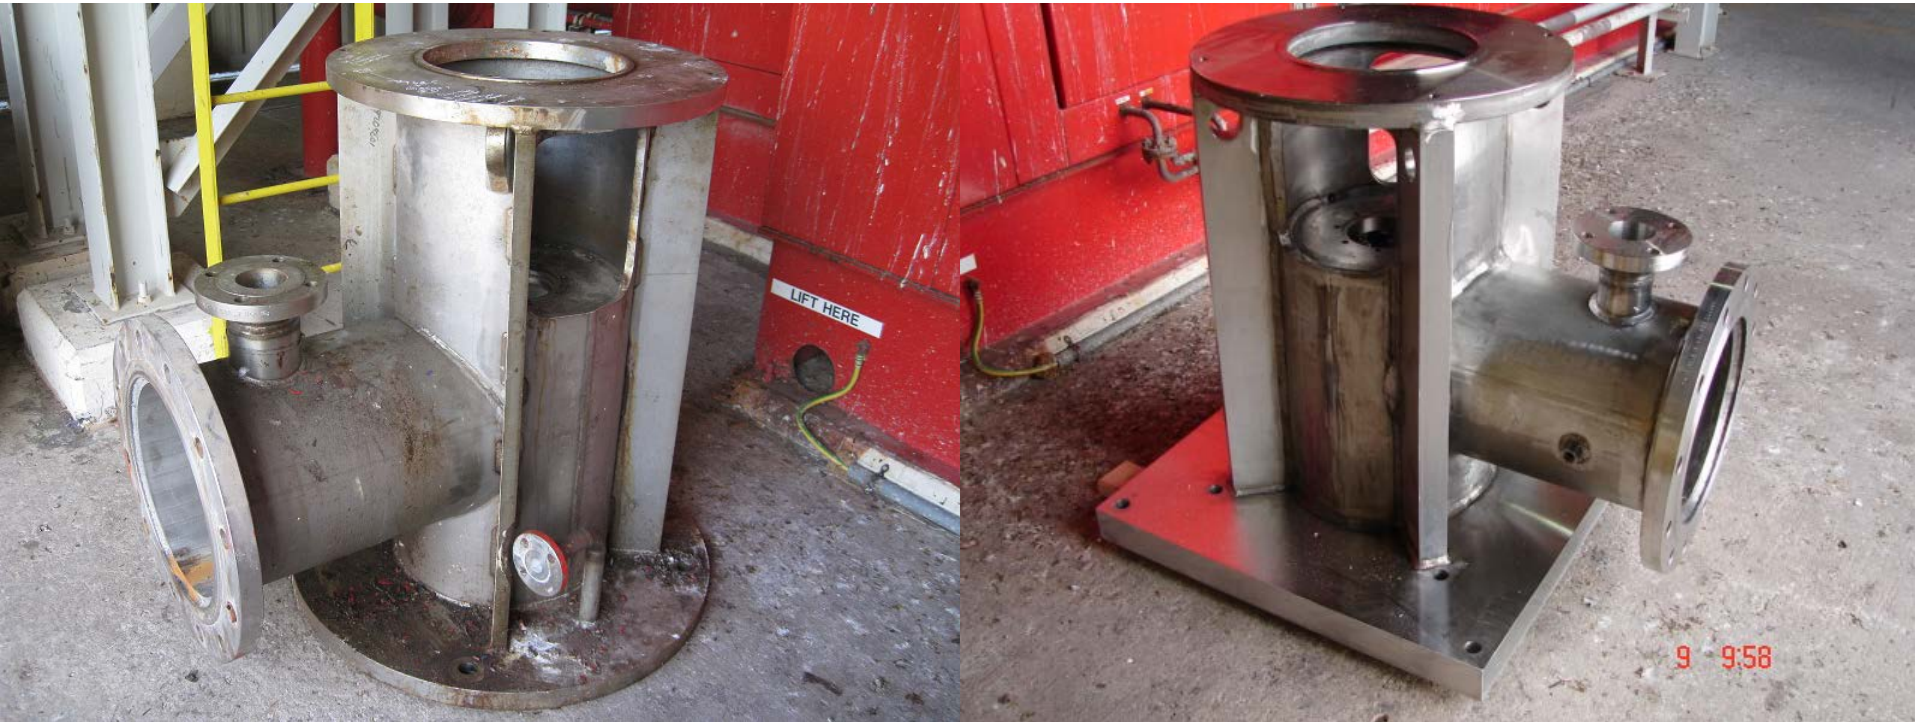
Old Pump head

New Pump head

Action#3: Pump Head structure modified

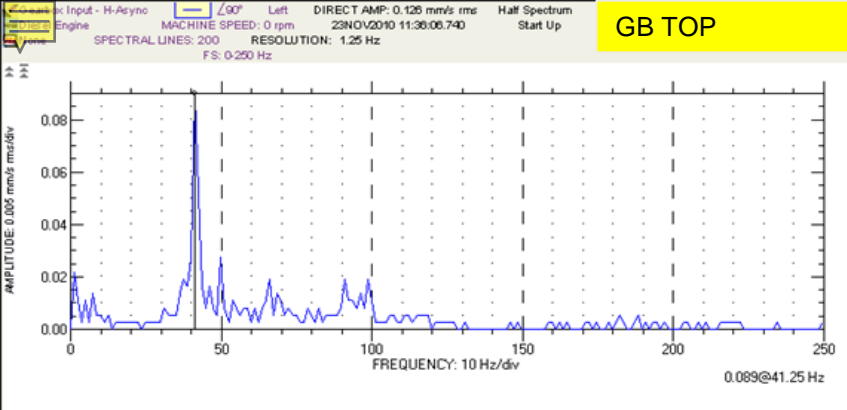
Bump test on the GB and pump head (with modified head) showed natural frequency at 41.25 Hz (achieved 41% separation margin)

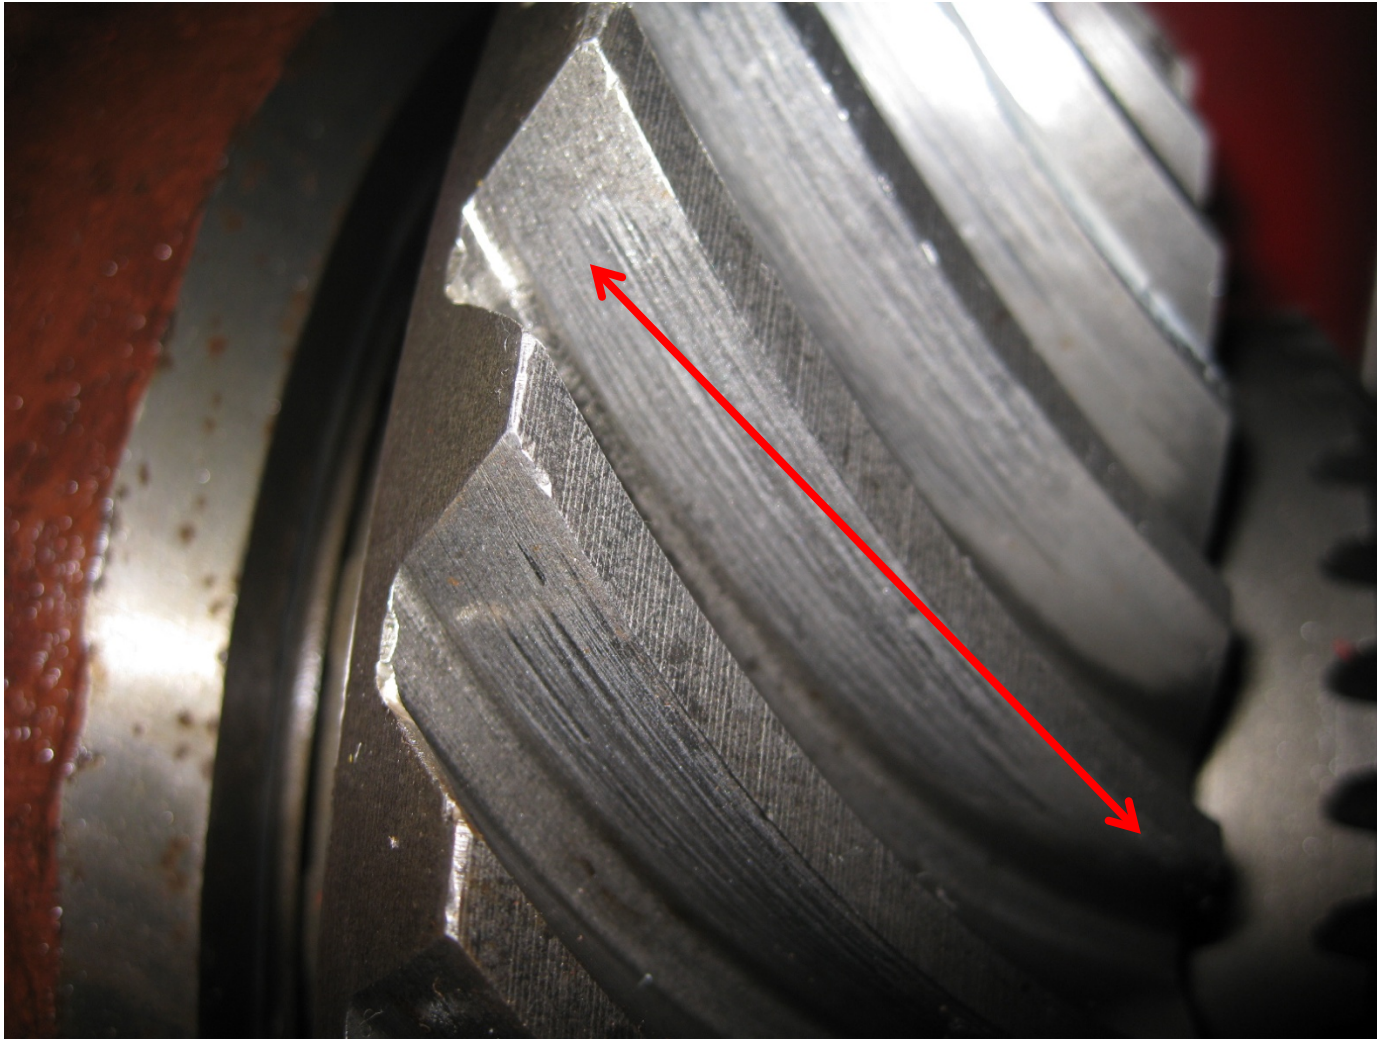
Action#4: Gearbox inspected and found only 70% teeth contact. GB OEM brought to site, gear backlash was checked and adjusted to conform to OEM specifications

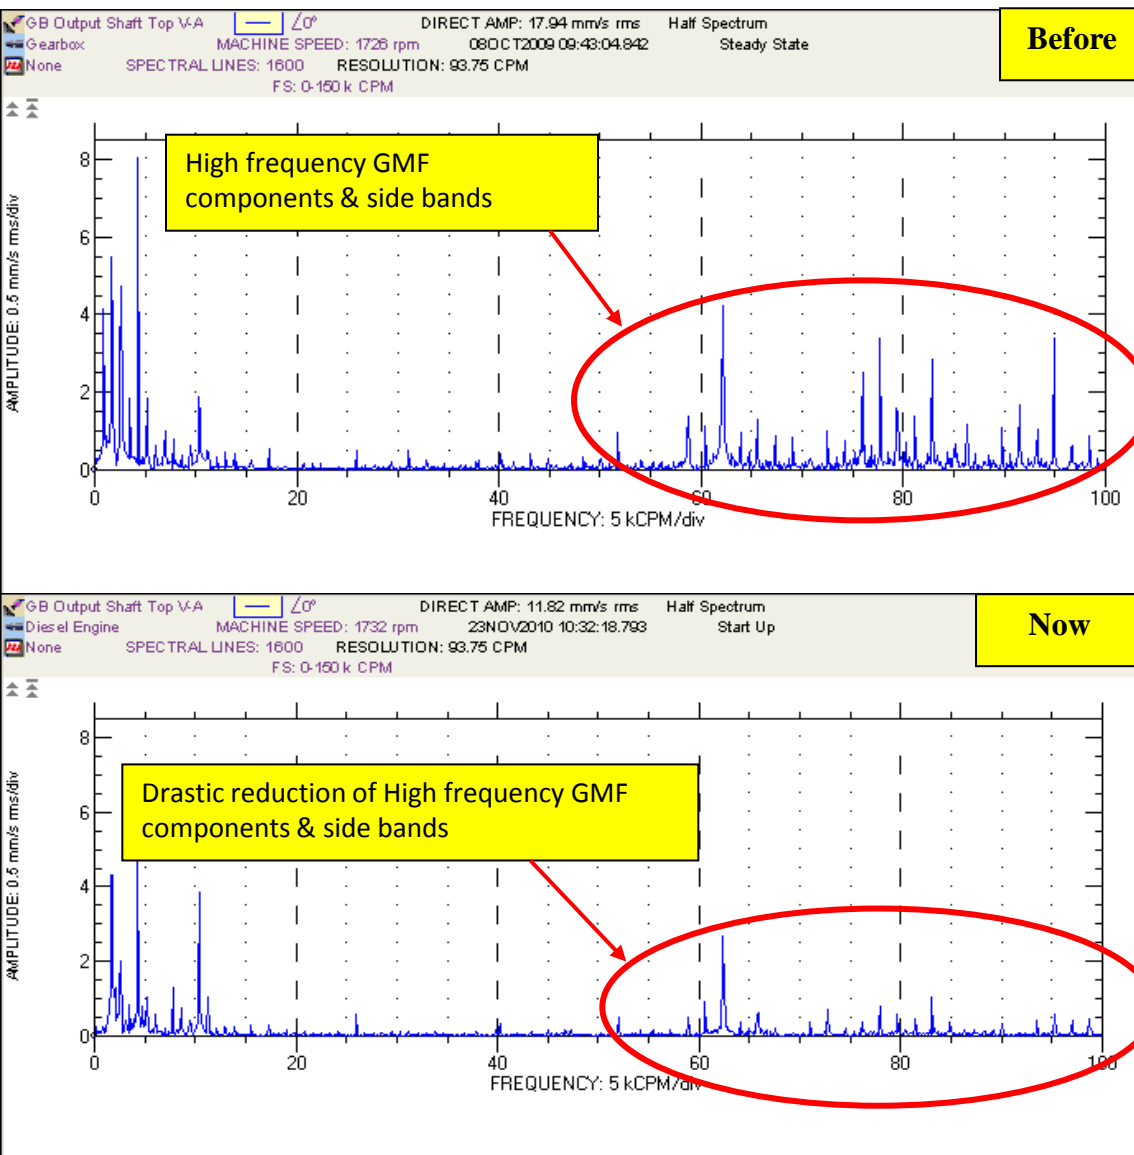
Comparison of vibration spectrum before and after the backlash adjustment on the Gearbox
