# ROTATING EQUIPMENT PUMP RELIABILITY UPGRADING PROJECT

**Ed Ringstead**

**Shell U.K. Limited**

**Stanlow Manufacturing Complex**

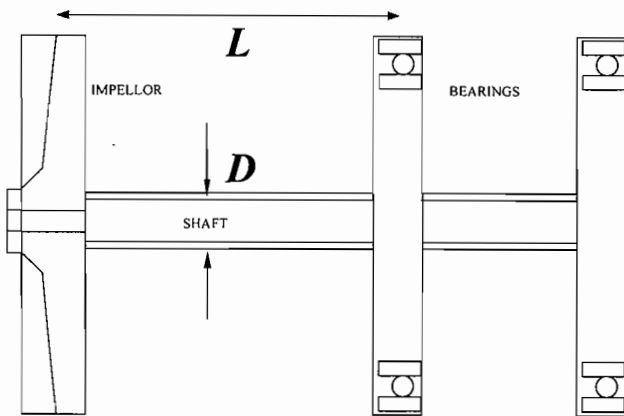
Figure 2. Standard Bearing Type.

A significant proportion of the department's pump inventory were horizontal single stage overhung impellers which had relatively slender shafts, typically 27 mm diameter, with 180 mm overhang.

A simplistic measure of shaft deflection, as seen in Figure 2, is a ratio of overhang to shaft diameter, i.e.,  $L^3/D^4$  ratio. Evaluation of the pump shaft population indicated at least 40 percent were in excess of the factor 300, while the recommended maximum factor is 75. Consequently, this inherent shaft flexing problem would lead to premature bearing and seal failures.

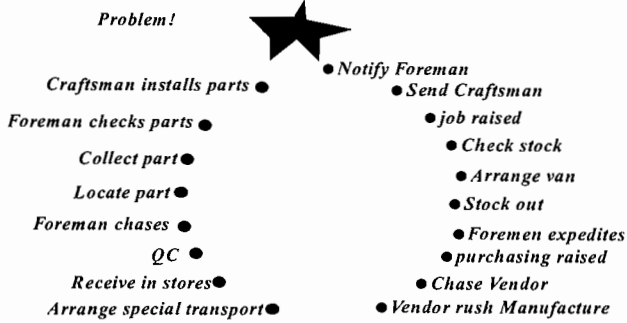
Figure 3. Firefighting.

A significant number of manhours was expended in repairing equipment failures. This was due to the method of failure reporting, i.e., operators would report via a computer job card system that a pump was noisy or leaking—typically the latter. This inevitably led to an unplanned maintenance outage for the pump as the fault had been detected at a stage at which the seal was leaking and required immediate attention. This resulted in fire fighting maintenance involving urgent requests to stores for spare parts, progress chasing with vendors for unavailable spares and overtime working to get the equipment back online (Figure 3).

The introduction of the Reliability Team, who condition monitored critical equipment (by vibration monitoring) on a planned

basis, flagged up defects at an early stage and resulted in a reduction in unplanned downtime.

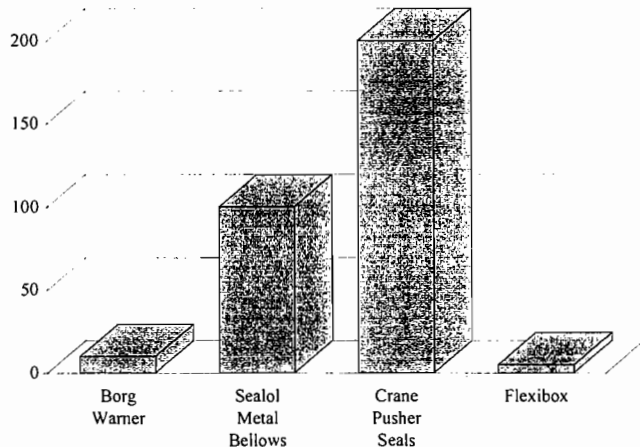
Figure 4. Mechanical Seal Distribution.

The existing mechanical seal distribution (Figure 4) across the department consisted of approximately 200 wedge type multi-spring pusher seals and 100 edge welded metal bellow seals, with a small number of single spring pusher seals. The metal bellow seals had been introduced with the recent addition in 1988 of a new operating unit. Previous maintenance supervision had also converted troublesome pusher seals with edge welded metal bellows.

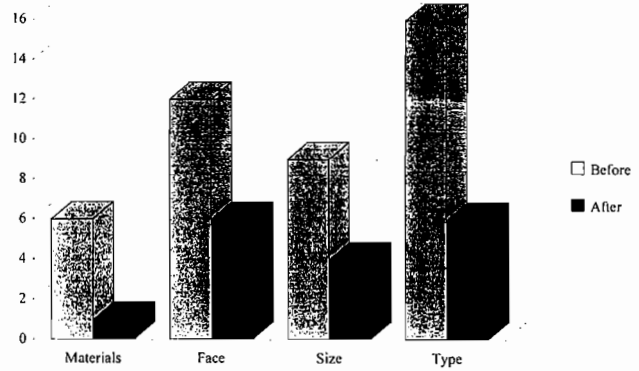
Figure 5. Seal Inventory Complexity.

An analysis of the seals population, shown in Figure 5, revealed a wide variety of design, size, material, and seat styles in the pusher type distribution, while the metal bellows population had a very small range of configurations. The only variation in the bellows seals was the use of silicon carbide as the rotating face in abrasive applications.

A consequence of the large number of seal variations and the fact that seal spares were held at individual component level, was the very high stock levels required (882 individual items).

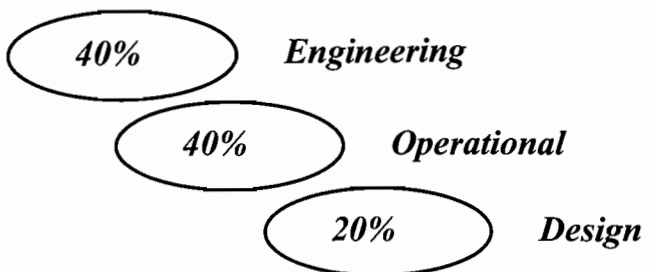
Figure 6. Causes of Failure.

Between January 1988 and April 1989, 259 seal failures occurred across the department. The Central Refinery Rotating Group had been monitoring seal failures and carried out a detailed survey on this specific department and had examined 57 seal failures as part of a refinery-wide reliability survey. To elaborate a little on these failure modes the following comments attempt to clarify some of the more significant failures. Of all of the failures an underlying fact was that 80 percent were associated with people problems (Figure 6).
