Rotor Retrofits Improve Pump Station Vibration

27th International Pump Users Symposium
September 12 – 15, 2011

By:
Jeffrey R. West P. E.
Udelhoven International Inc.

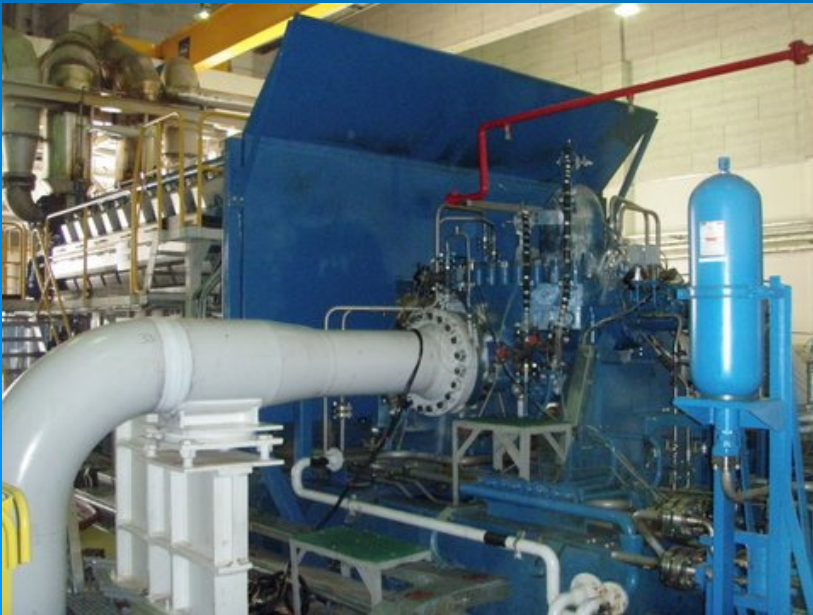
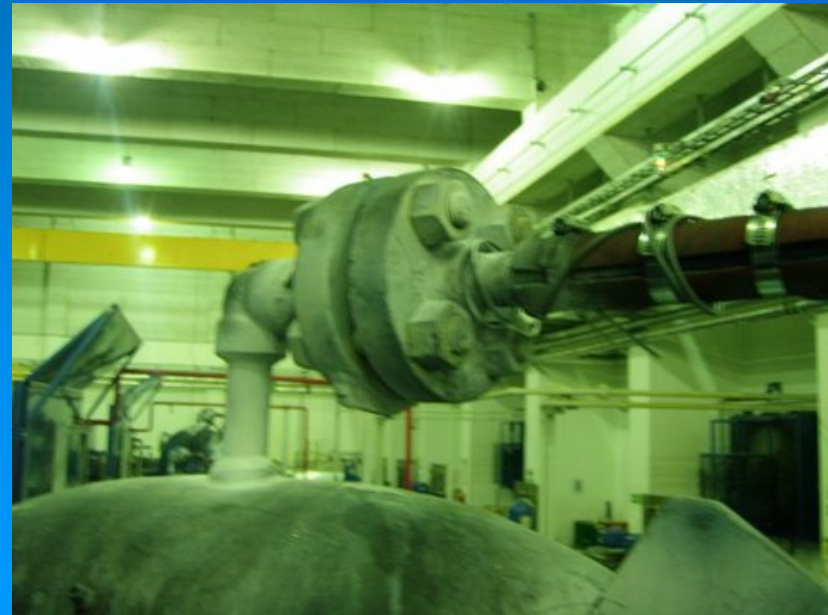
- Within months the annoying vibrations developed into a major system integrity problem due to failures at SBC welds
- Inspections confirmed high-cycle fatigue as cause
- New and repeat failures occurred

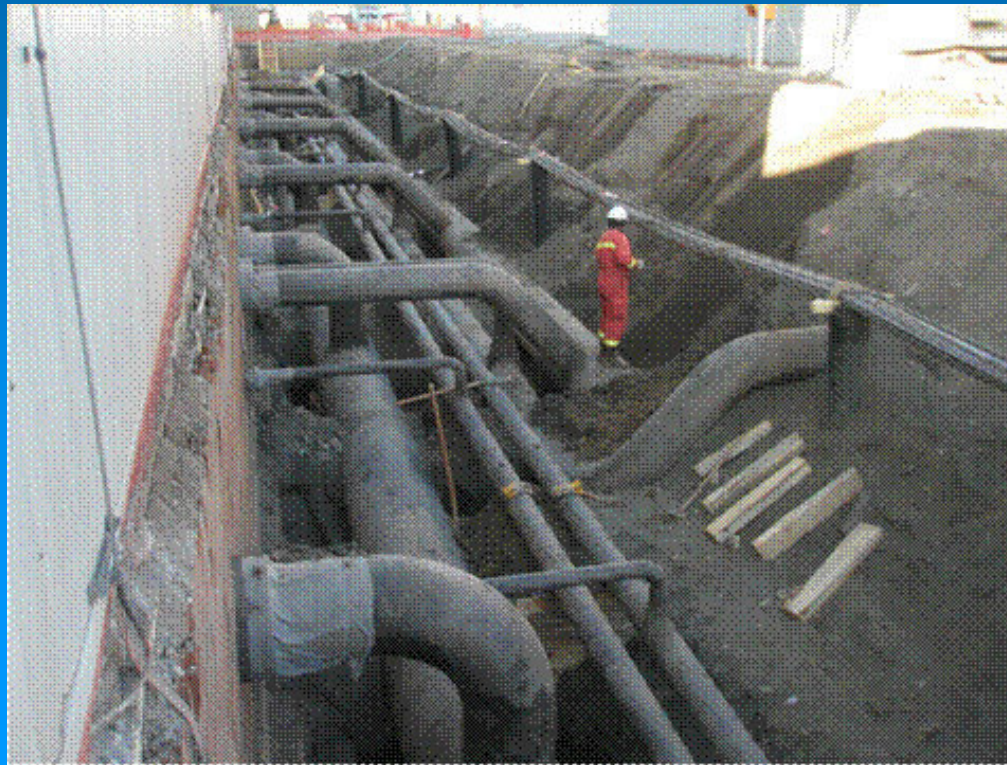
- Header subsidence discovered in buried headers outside pumphouse
- SBC weld failures continue, now numbering >100 causing huge integrity and availability issues

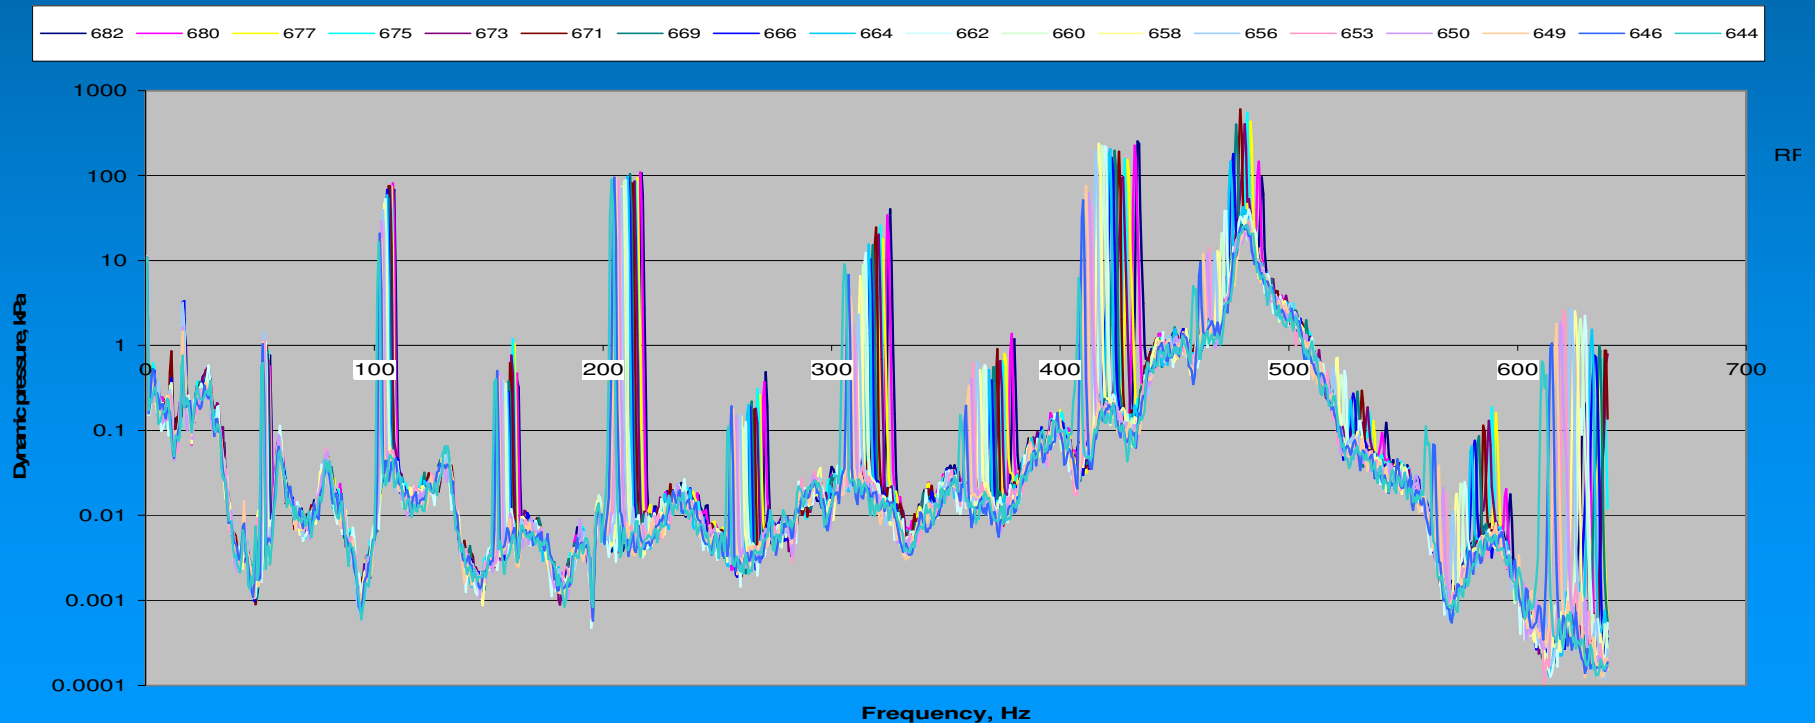
Suction pulsation spectrum

- High intensity pulsations discovered within pumped fluid column

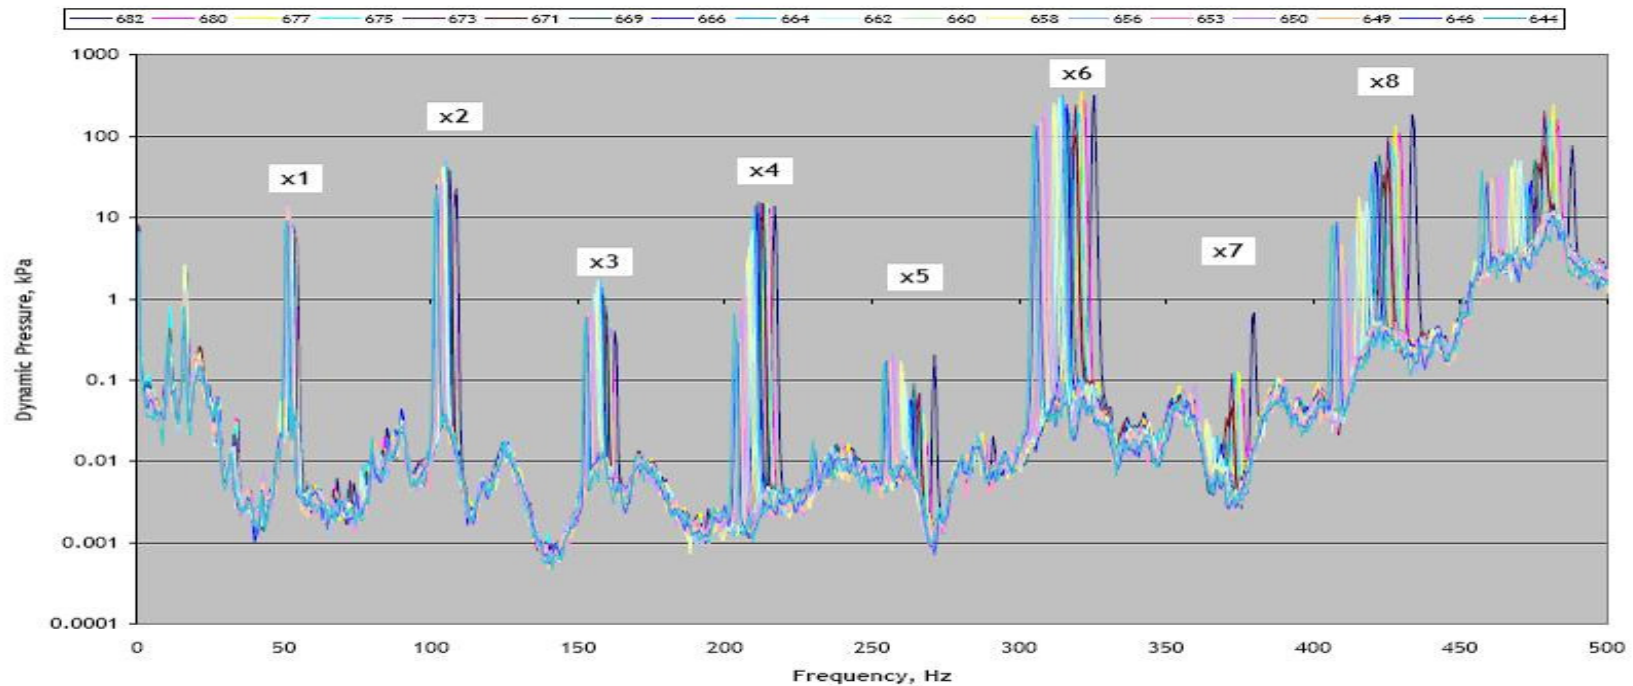
Discharge pulsation spectrum

- Discrete frequency spikes found “locked” to rotor speed

Measured Pressure pulsation spectra as a function of gas engine speed, discharge.

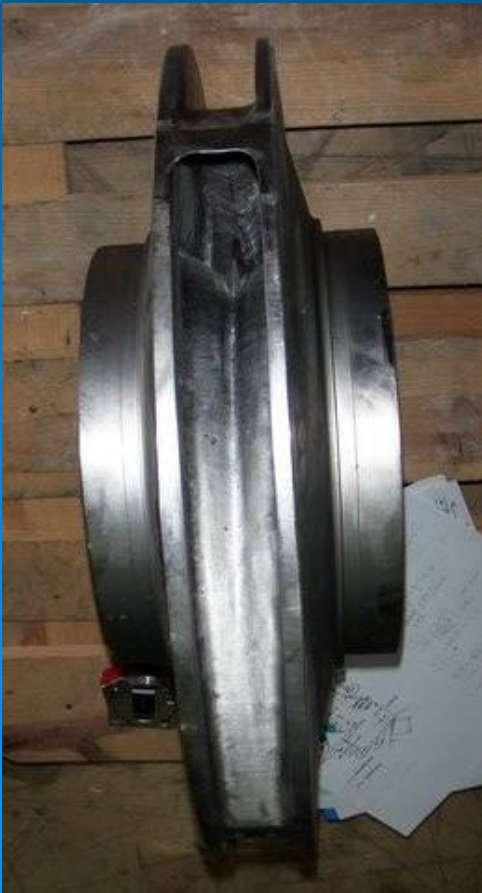
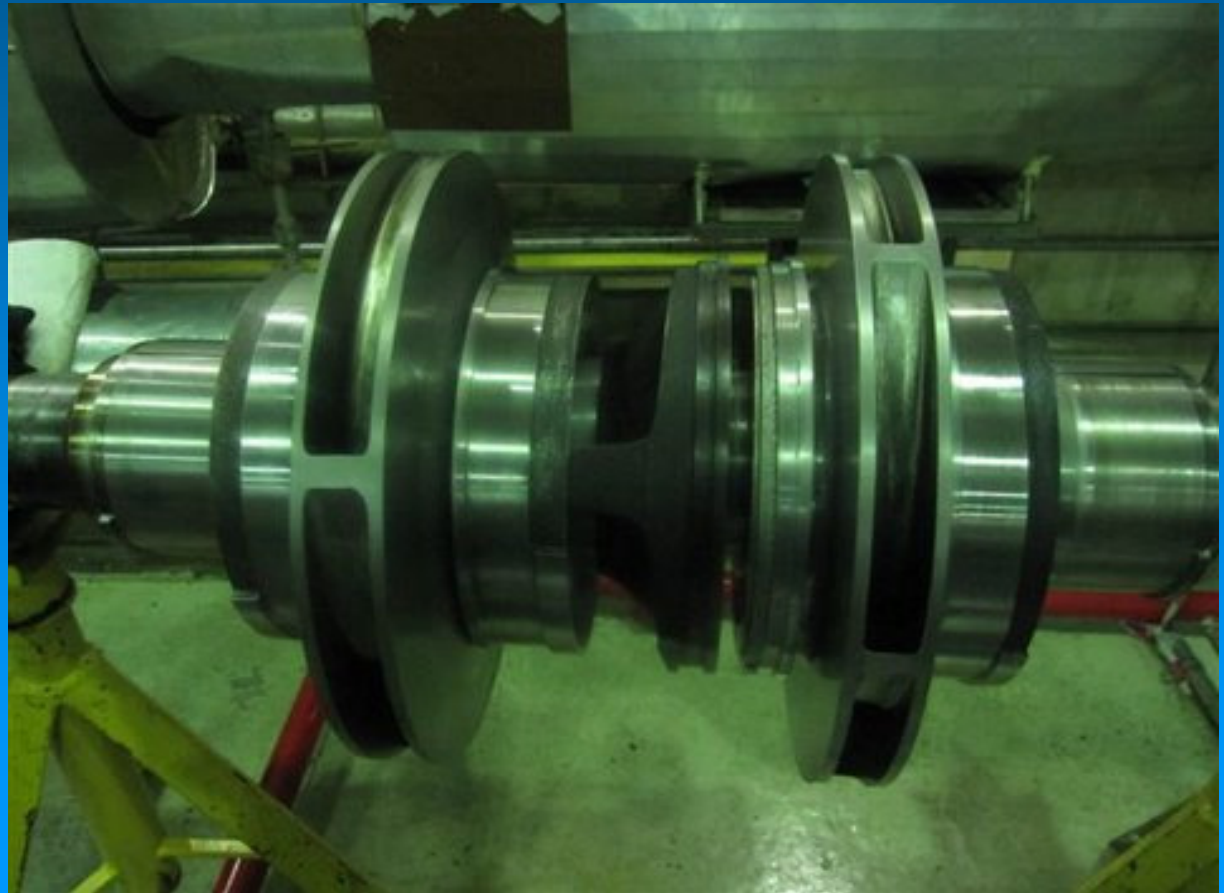
➤ Basic Design

- OEM discussions proved inconclusive
- Vane count: 4 and 6 (double volute case) promotes “phase resonance” or “constructive reinforcement” due to jet-wake / casing interactions: pulsations
- Concern that stage one inlet eye geometry promotes inlet recirculation
- Basic design – orthogonal vane features, no central rib / stagger on first stage etc.

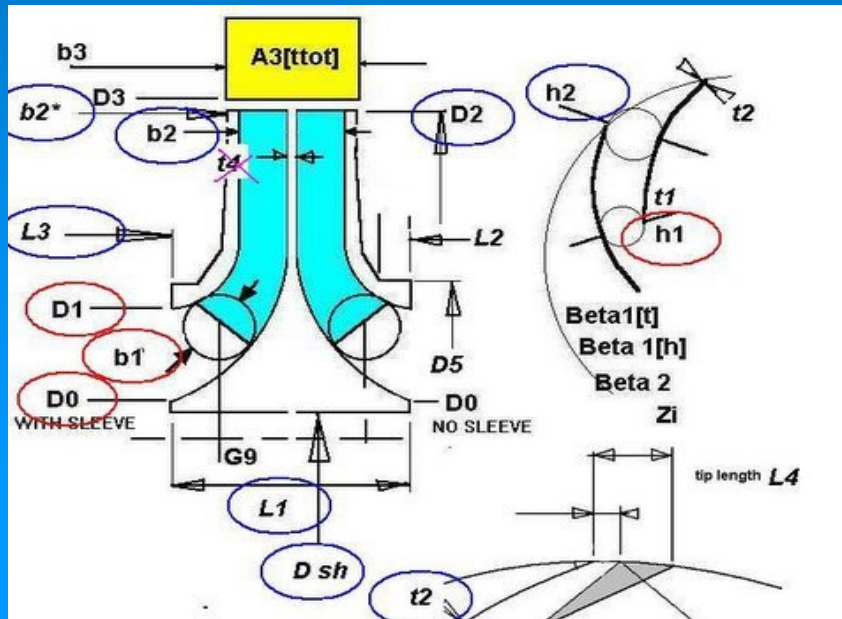
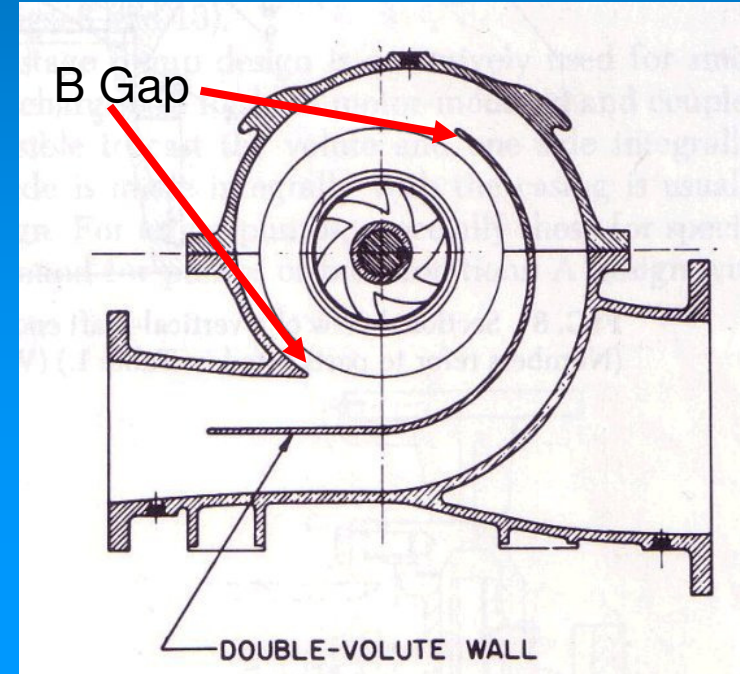
- Hydraulic gap “B-Gap” smaller than industry standard and not consistent
- Cutwater locations / profiles not as expected for high-energy pump
- Volute has “tight fit” relative to impeller width – limits redesign options

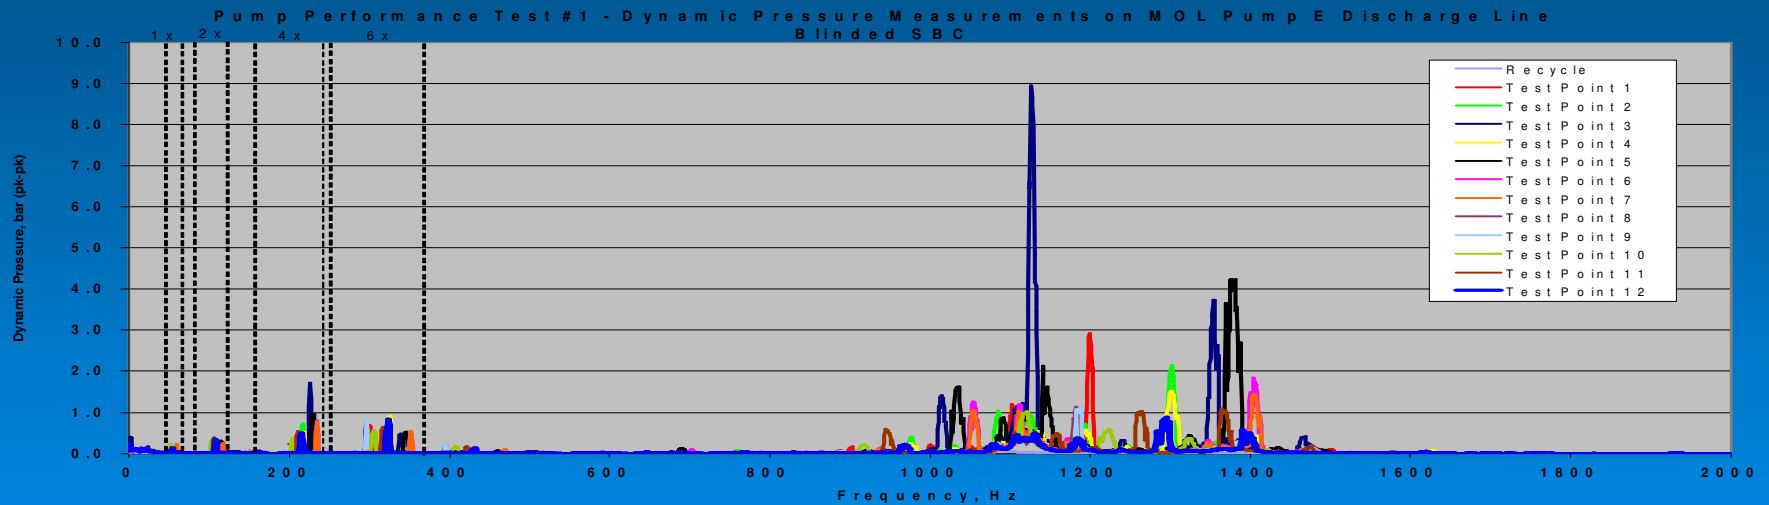
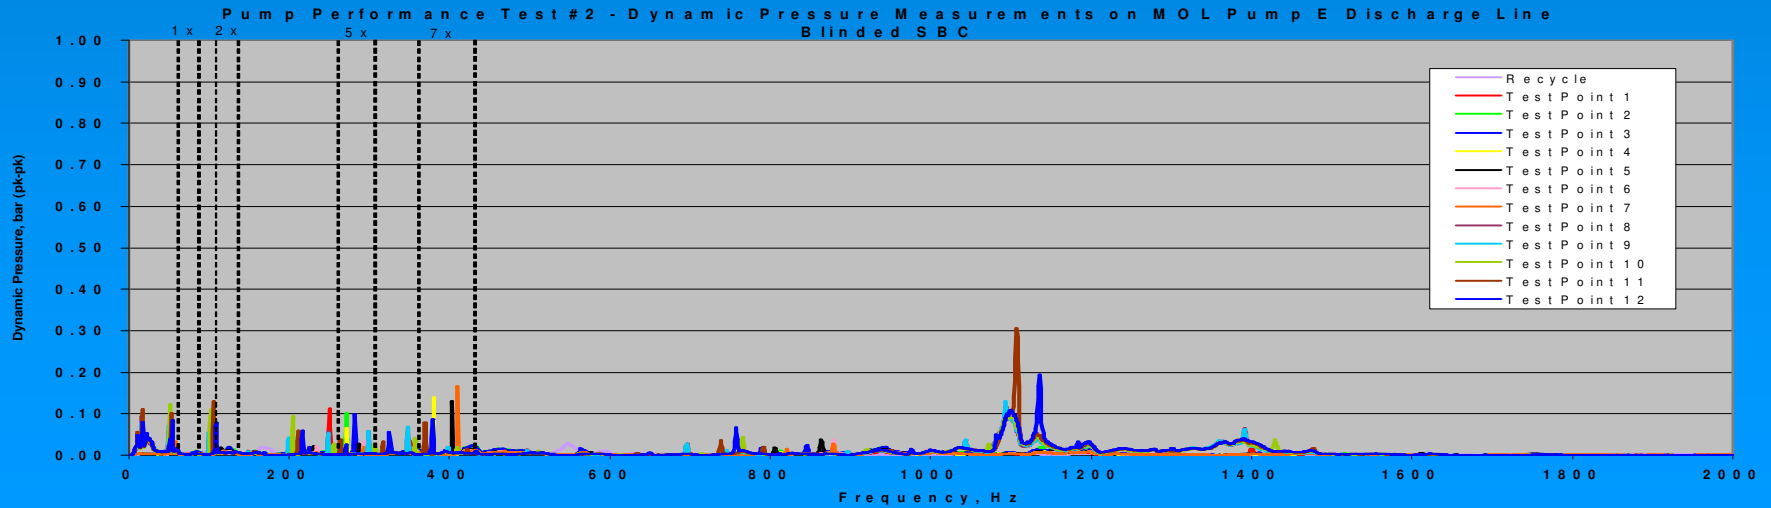
➤ Before and After Dynamic Pressure Levels

- Dynamic stress levels reduced to “acceptable” within normal operating range at all monitored locations
- Pulsation levels reduced > 50% with most locations >70%
 - Pulsation level at stage crossover location still borderline high at 100% speed although reduced >80% from original
 - Confirmed excitation of 7X acoustic resonance in crossover
 - Not normal operating speed
- Shaft movement (by proximity) and case vibrations reduced by approximately 50%
- Sound levels reduced 3 db in pump vicinity and 9 db at pump discharge
- Hydraulic output improved by 5% to 10% within normal operating range - correctable with 1% speed reduction
- Apparent pump efficiency improved about 1%
