# **Solving Vertical Pump Synchronous and Sub-synchronous Vibration Problems**

**Maki M. Onari & Matt A. Gaydon**

**Mechanical Solutions, Inc & Bechtel Power Corporation**

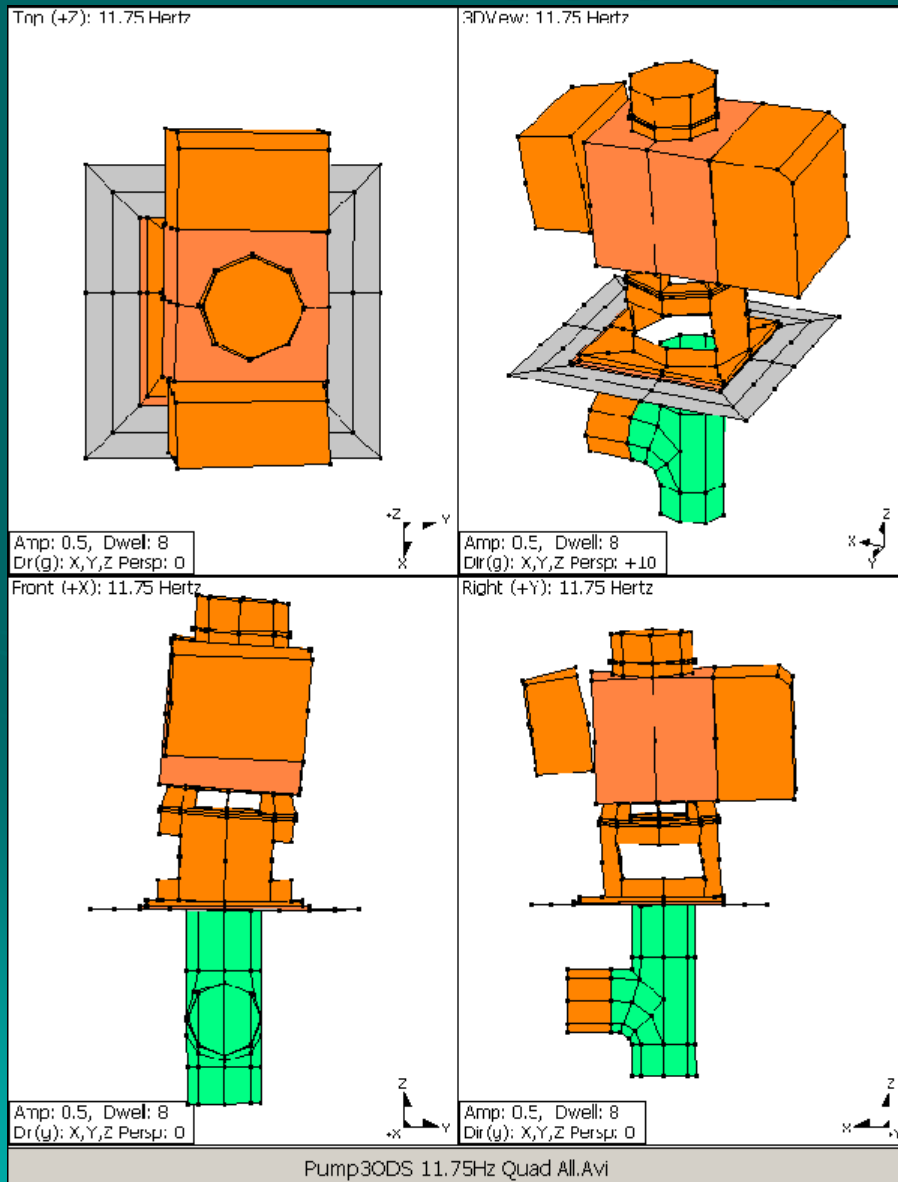
**Pump #3 ODS at 11.75 Hz  
(705 CPM or 1X running  
speed)**

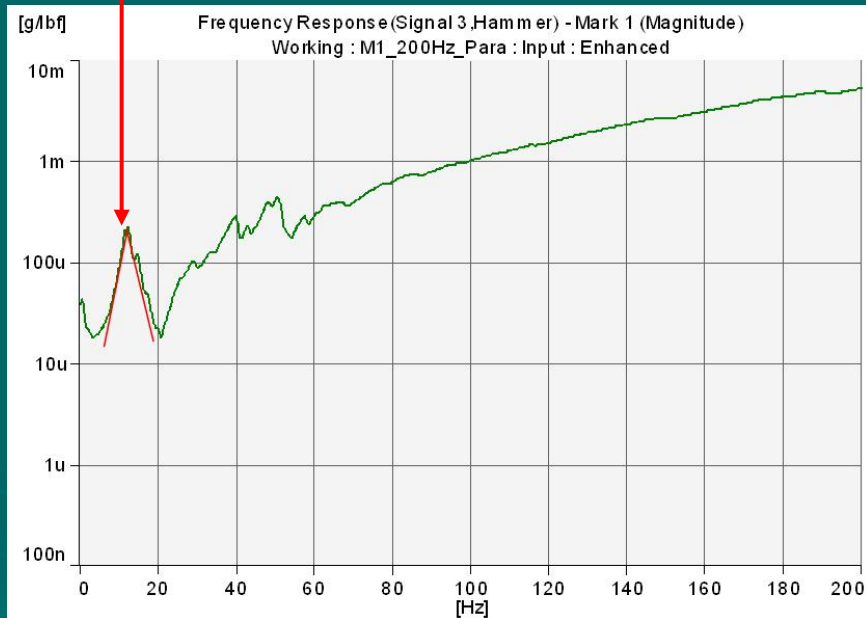
1<sup>st</sup> above-ground bending  
parallel to the discharge  
piping at 11.38Hz

- Increase the stiffness of the motor stand
- Improve motor rotor residual unbalance
- Improve the connection of the motor junction box
- Increase the building floor stiffness

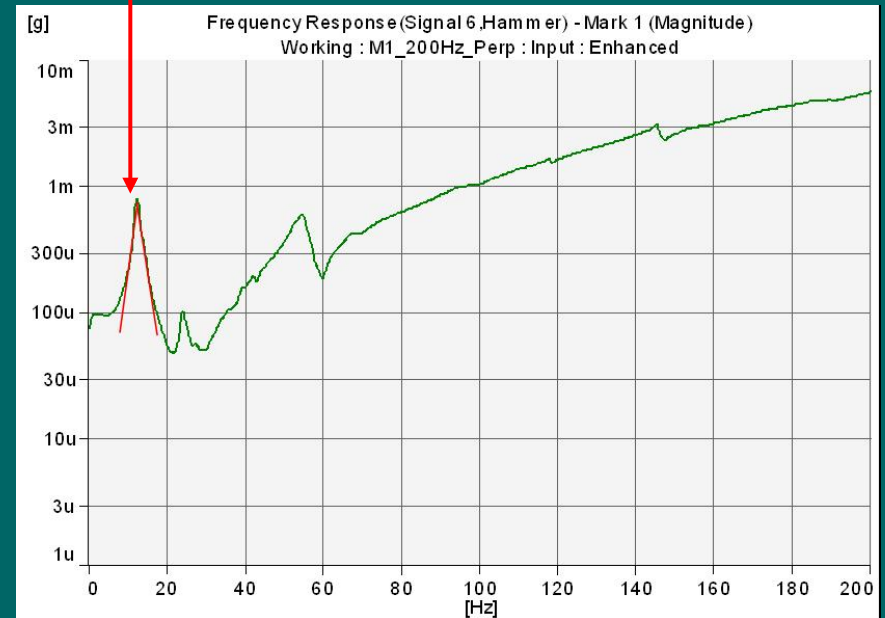
1<sup>st</sup> above-ground bending  
perpendicular to the  
discharge piping at 12.38Hz

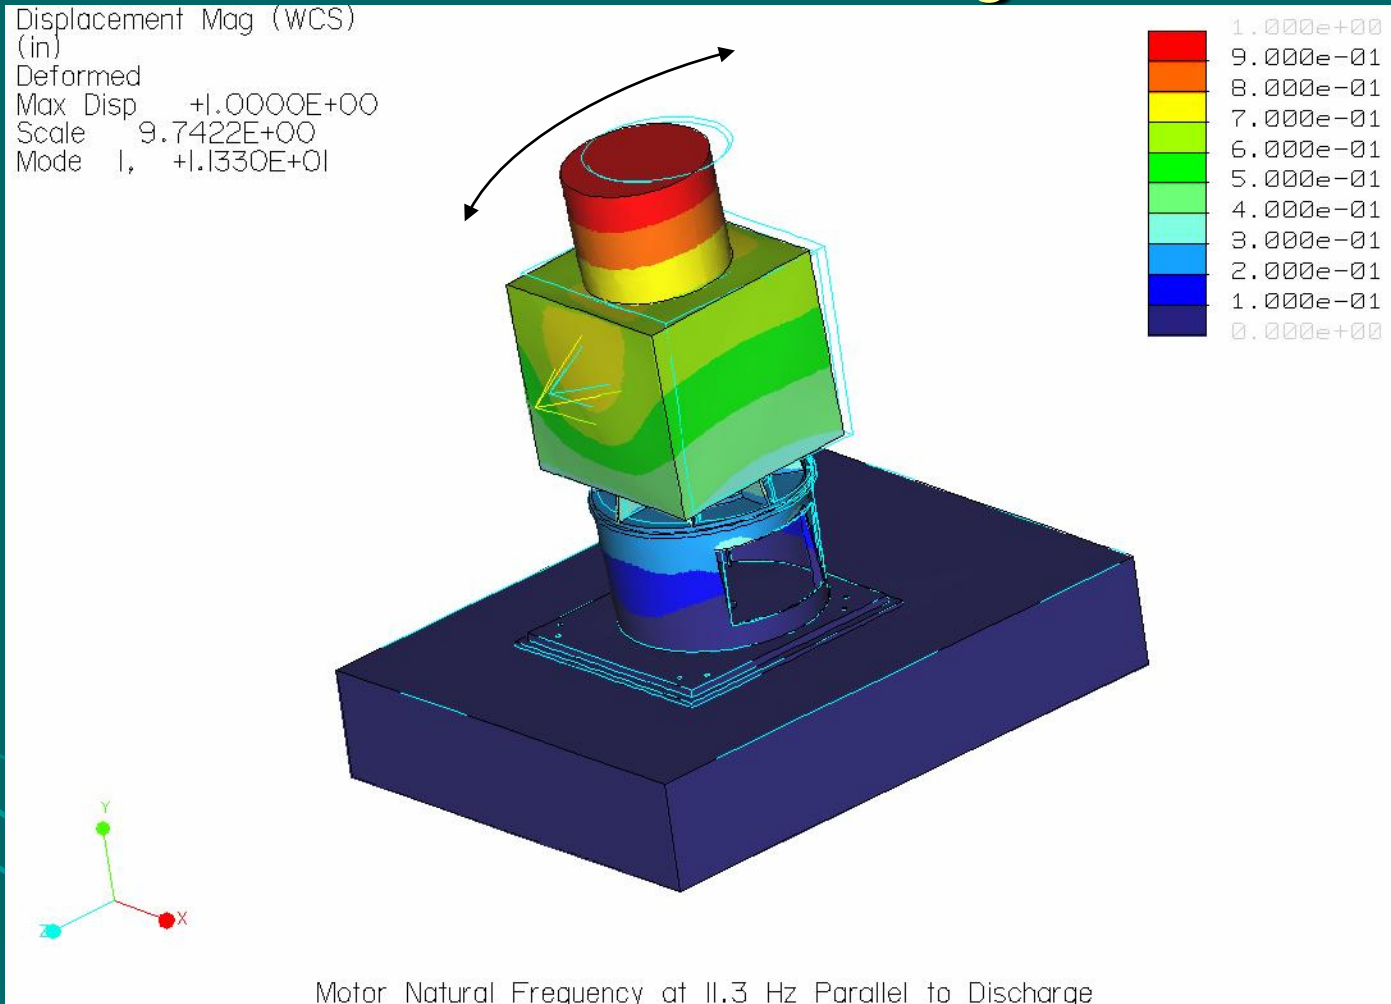
1<sup>st</sup> above-ground bending parallel to the discharge piping at 11.3 Hz

**Calibrated FEA model for original pump**

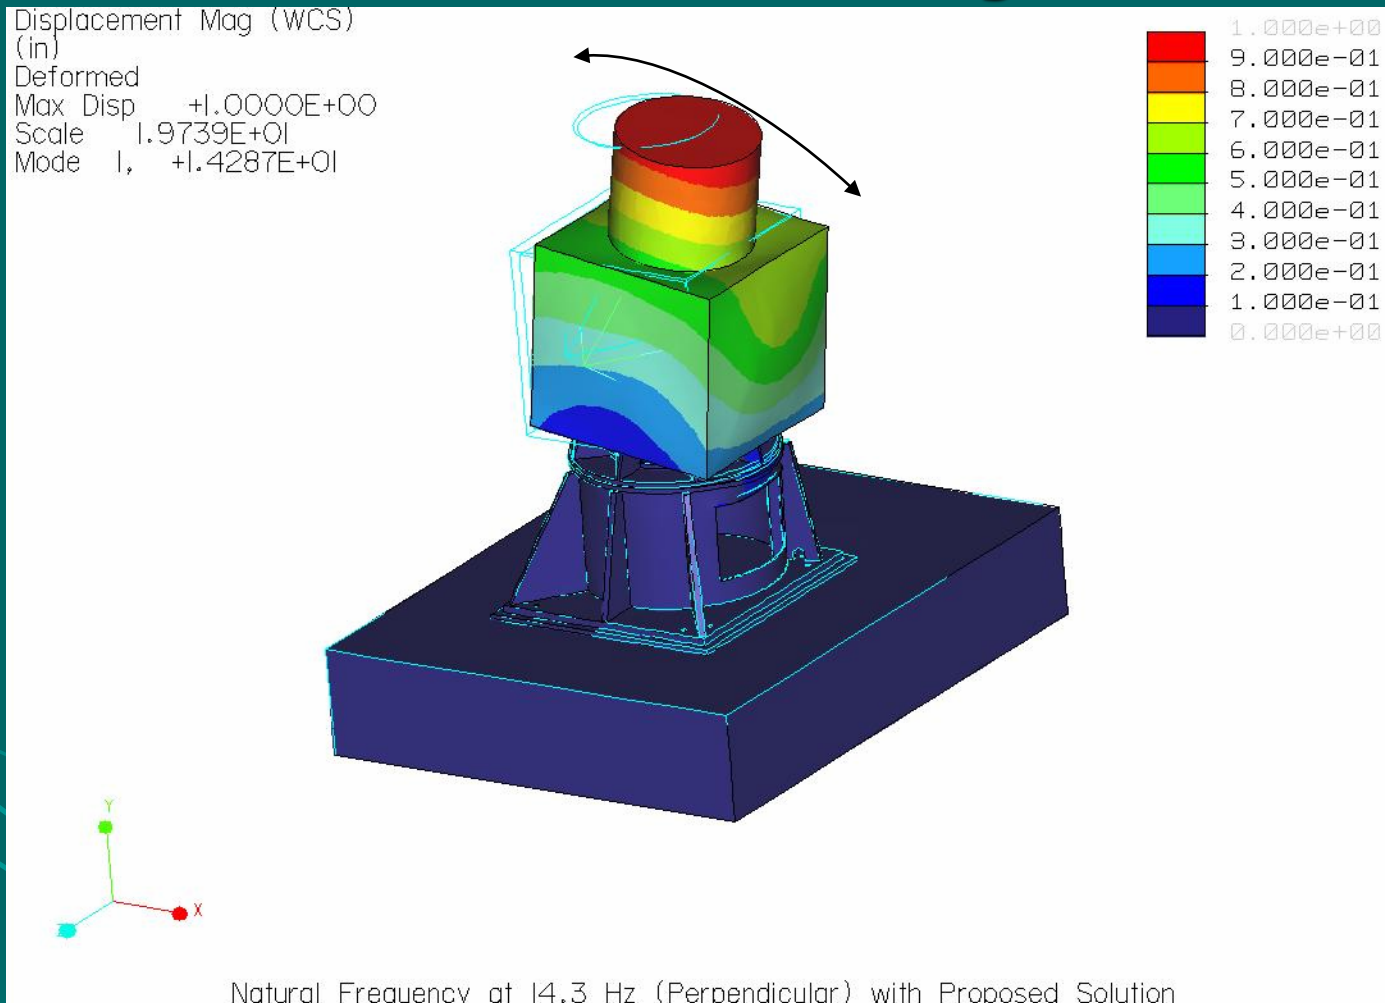
1<sup>st</sup> above-ground bending perpendicular to the  
discharge piping at 14.3 Hz

**Predicted structural natural frequency**

- **Vibration was being amplified by a structural natural frequency of the pump**
- **Modification of the motor stand resulted in the predicted shift in the structural natural frequencies and the desired 15% separation**
- **De-tuning of the structural natural frequencies resulted in a reduction of the vibration from 9.0 mils pk-pk to 3.0 mils pk-pk**
- **Vibration increased to 4.5 mils pk-pk due to unequal thermal expansion of the motor rotor**
- **Improving the motor residual imbalance resulted in a vibration amplitude of 1.5 mils pk-pk which did not increase with time**

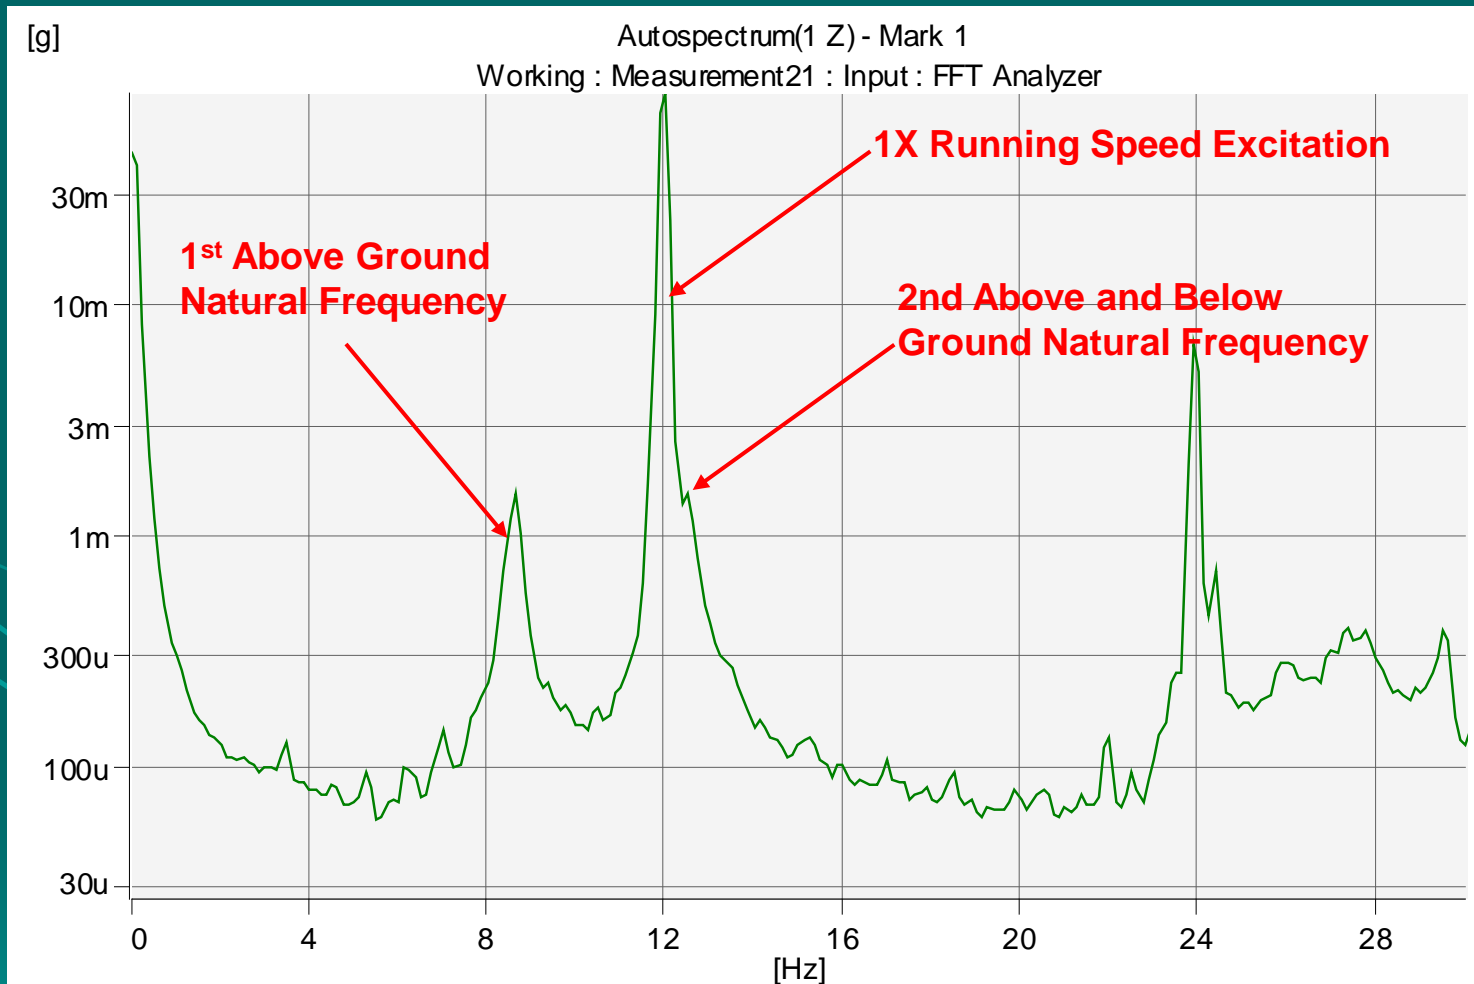
# Typical Vibration Spectrum – Perpendicular to Discharge

- **Vibration was being amplified by a structural natural frequency of the pump**
- **The problematic vibration mode had the top of the motor and the bottom of the pump moving in-phase with each other**
- **Due to differences in construction, the natural frequencies varied slightly from pump to pump**
- **Weights on top of the motor acted as “tuned-absorbers” for some pumps**
- **The flexibility of the conduit box similarly resulted in “tuned-absorber” effect**

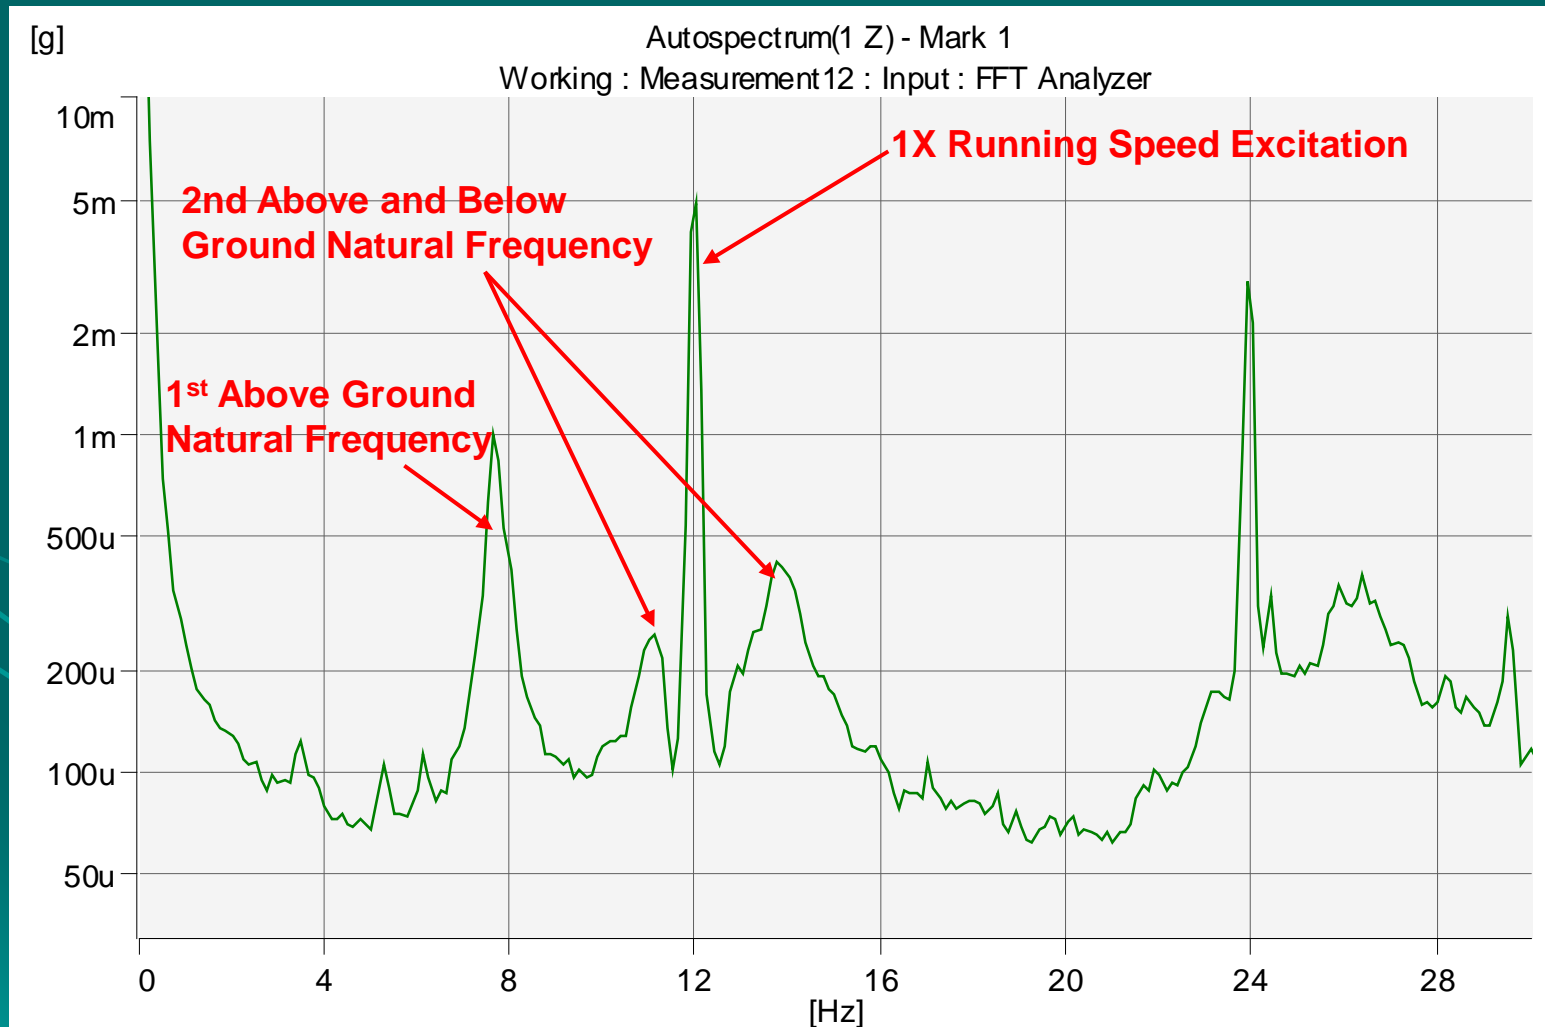
# Vibration Spectrum - Perpendicular to Discharge with Added Weight

- **Vibration was being excited by a structural natural frequency which had combined above and below ground motion**
- **Adding mass only to the top of the motor would not have been sufficient to de-tune the below ground natural frequency**
- **With mass added to the top of the motor and to the suction bell, the vibration levels were reduced from 1.1 in/s RMS to below 0.28 in/s RMS and within the specification limits**
- **Stiffening of the junction box connection was recommended to reduce the chance of fatigue failure in the future**

- A finite element model was calibrated to match the test results
- Initial analysis predicted that more than 4,000 lbm of material needed to be added at the top of the motor to de-tune the natural frequency
- A more significant effect was predicted by adding mass to the bottom of the pump (suction bell)
- Recommendations varied from pump to pump, but all included added mass to both the suction bell and the top of the motor
