The Effect of Foundation Piers on the Natural Frequencies of a Vertically Mounted Sewage Pump in Resonance with Vane Pass Excitations

27th International Pump Users Symposium

September 24 - 27, 2012

Mechanical Solutions, Inc.

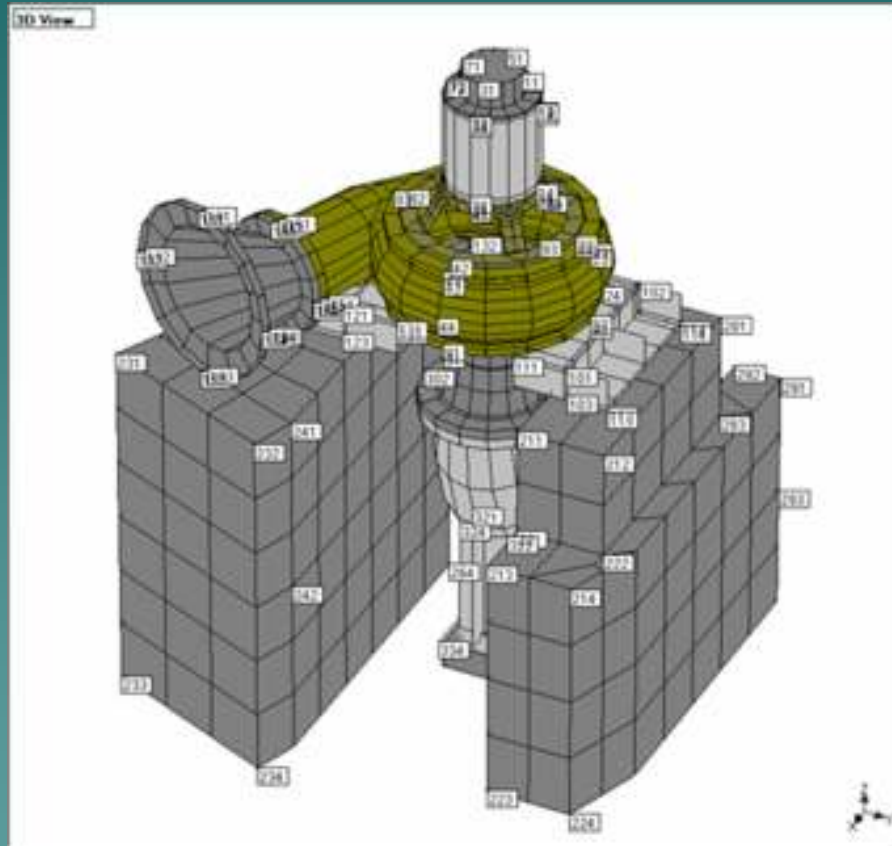
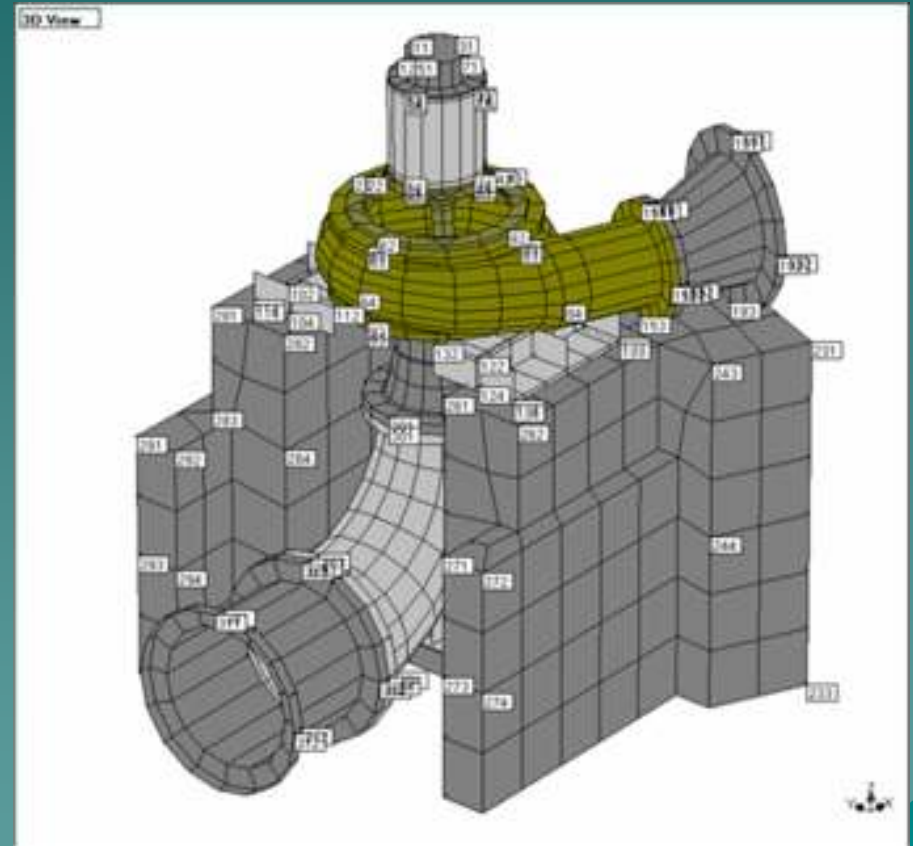
Figure 4

Over 500 vibration measurement/ direction using tri-axial accelerometers

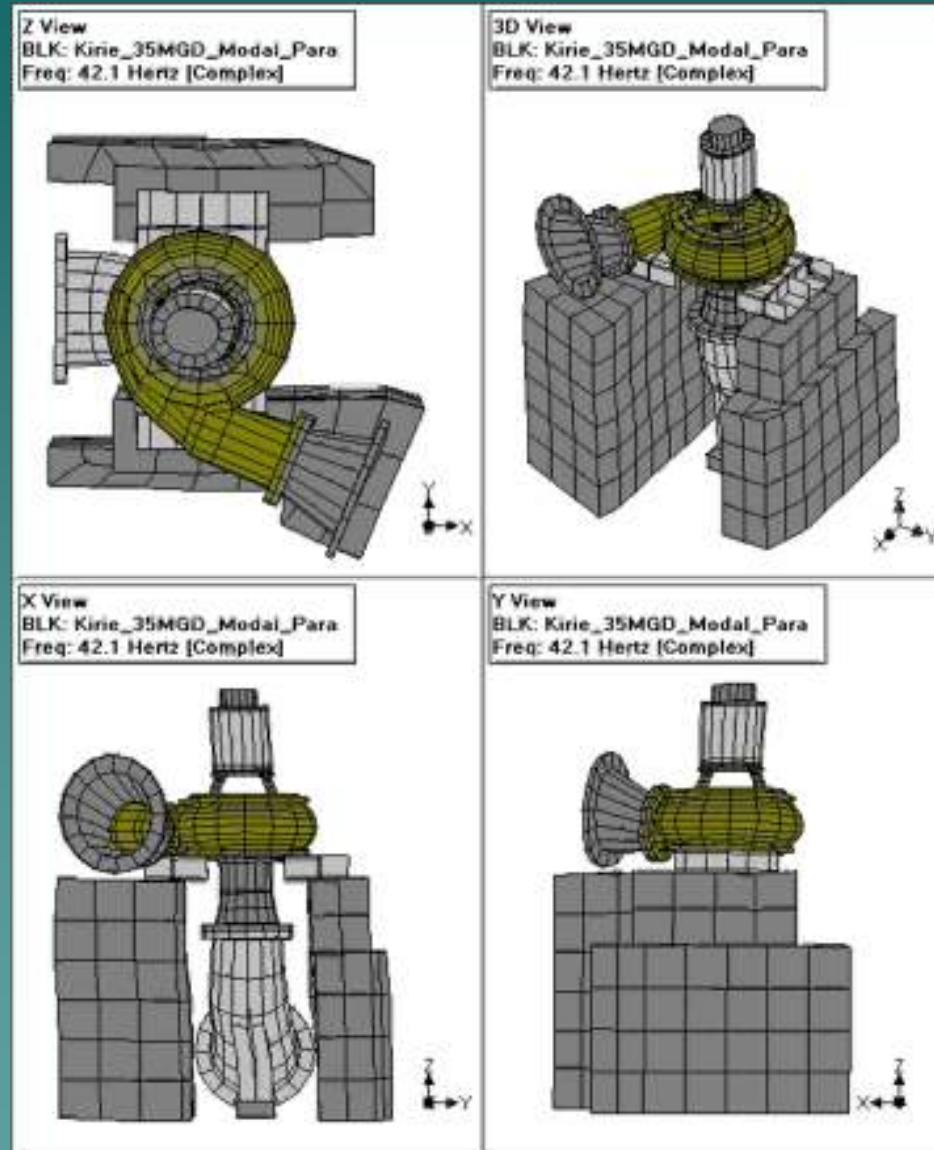
Figure 7

Modal Test Animation at 42 Hz

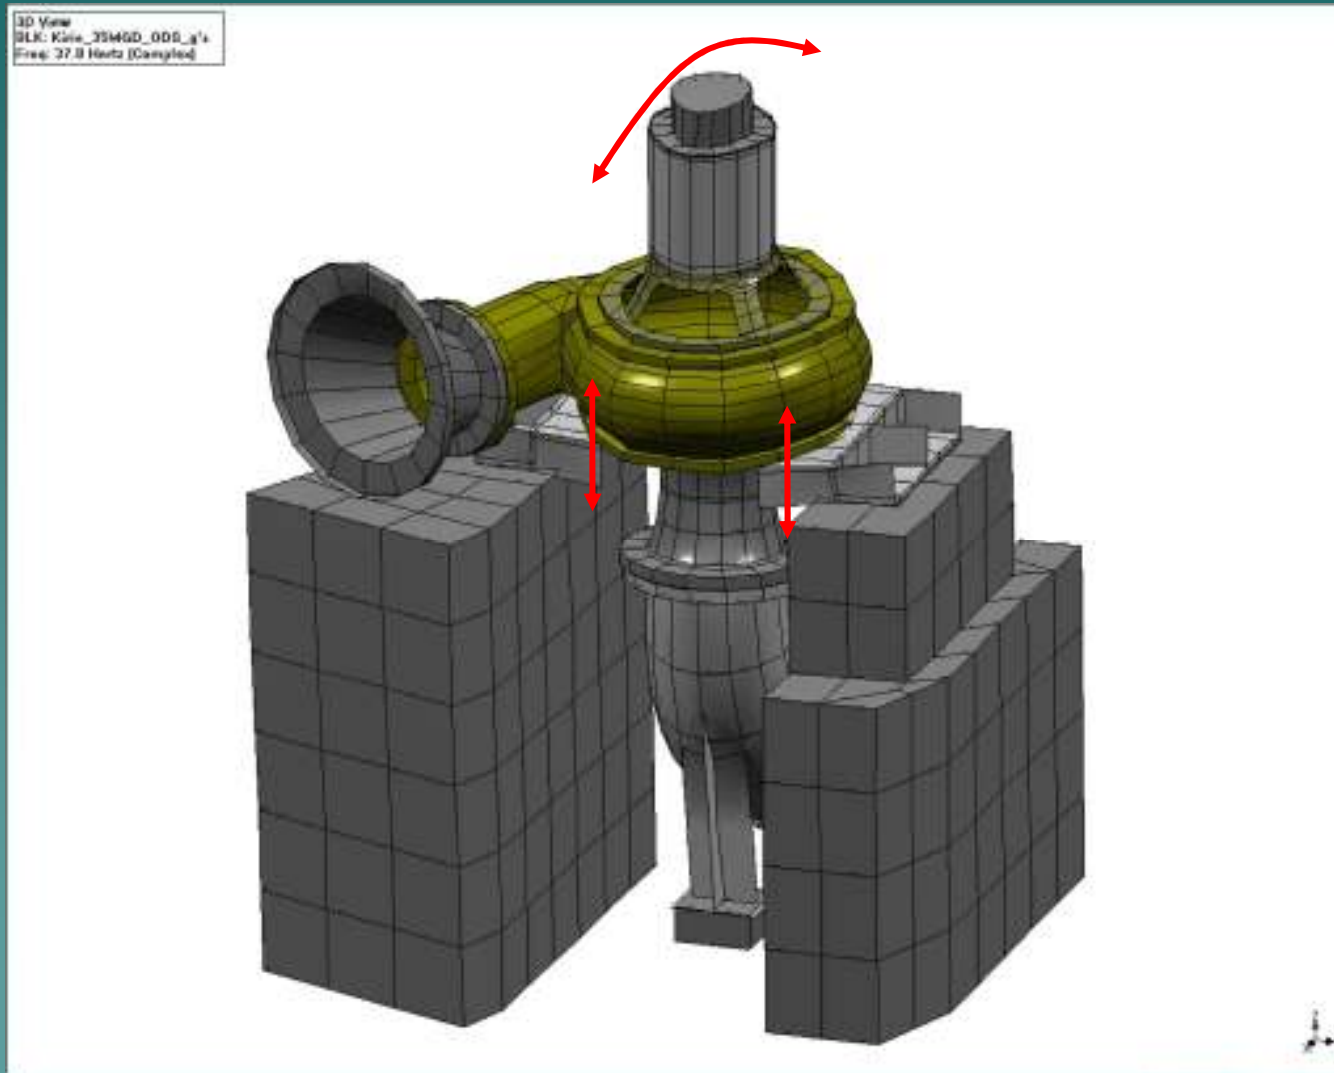
Figure 8

- ◆ When the pump was finally installed, high vibrations were being measured on the pump bearing tower of 0.6 in/s RMS at 4x running speed (vane pass). ***But Why? Hadn't the analysis provided guidance to avoid this???***
- ◆ The task now was to determine the source of the vibration via field trouble shooting methods and propose a suitable solution without costly trial and error field fixes using the existing FEA model.

ODS Animation at VPF (38.0 Hz)
