25th International Pump Users Symposium

BB3 Structural Vibration Problem Resolved Using Analytical Methods

Installation

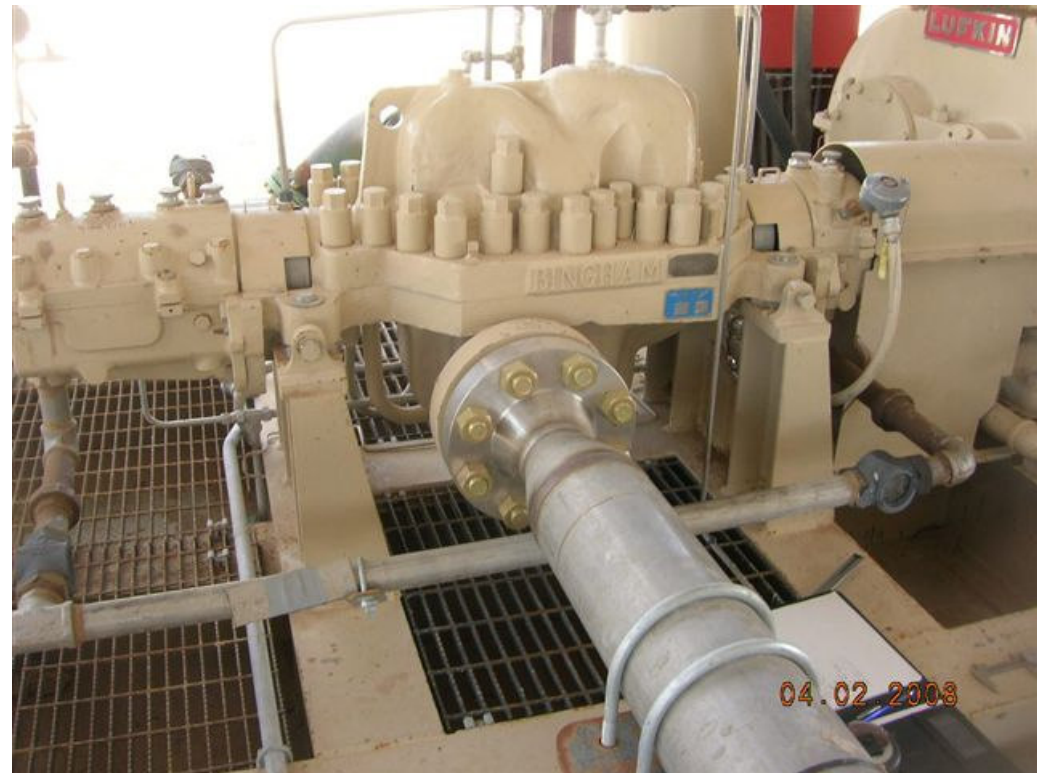
- 3 stage BB3 type
- Water injection service (1200 GPM @ 2650 ft)
- Driven through gearbox by natural-gas engine
- 3560 to 6000 RPM continuous operating speed range

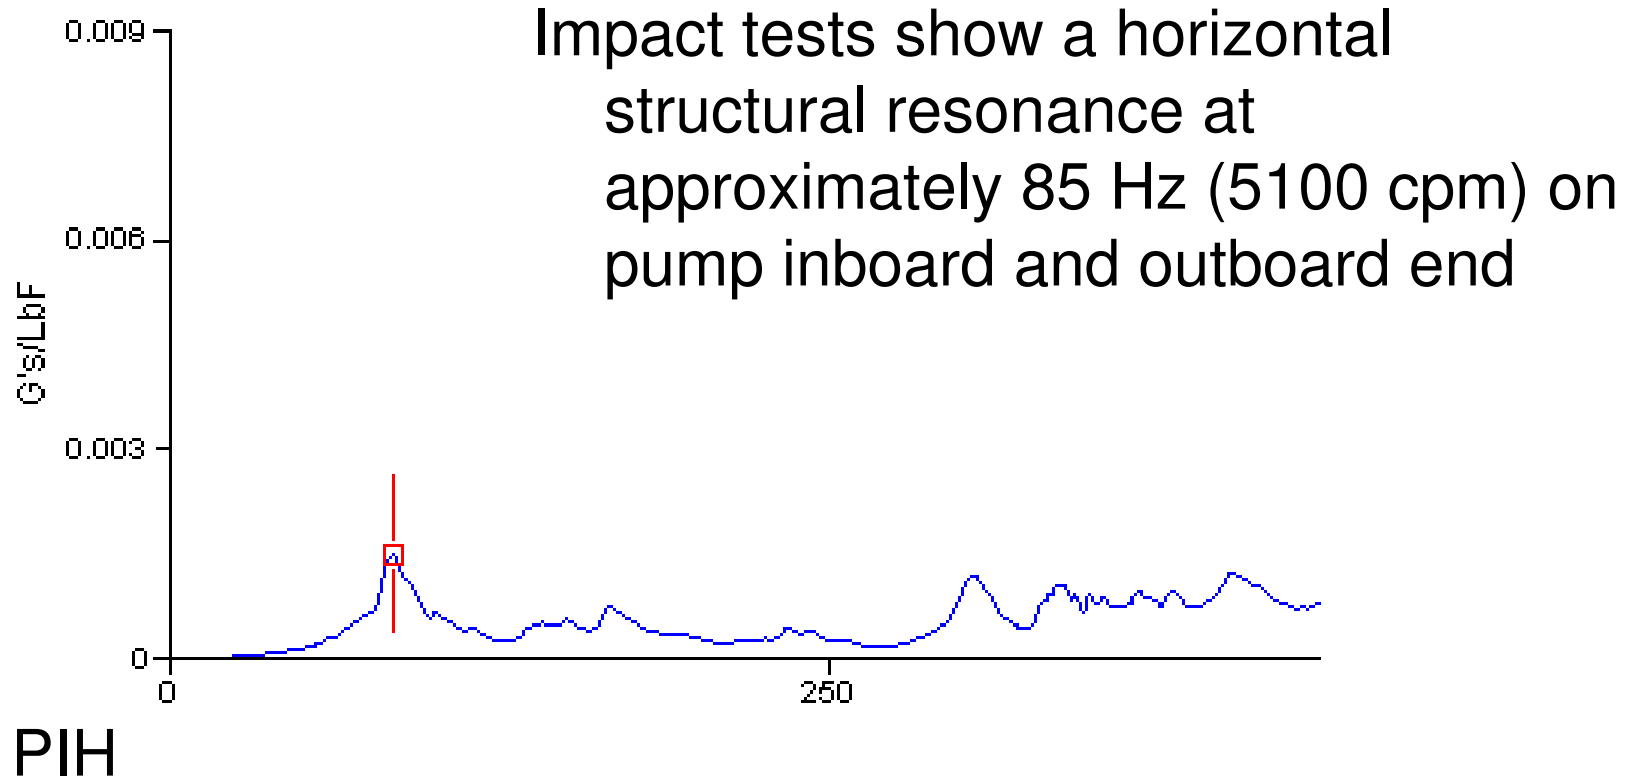
Structural Resonance – Impact Testing

- High bearing housing and casing vibrations showed after the pumps were relocated and put into a new service (Ran fine in previous life)
- Same problem with 3 identical units
- Horizontal vibration (~ 0.6 in/sec) at or above 5200 RPM
- Not able to reach full speed (6000 RPM)

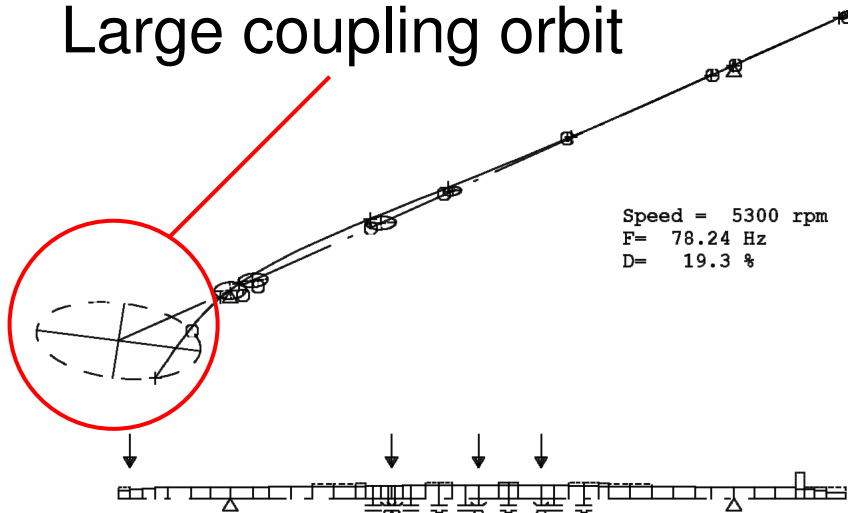
Overhung mode critical speed
(~4700 RPM)

- High speed operation. (6000 RPM)
- Heavy coupling. (~100 lbs total)
- Long shaft span at drive end.
- Nearest seal is eye of suction impeller.

Low damping

Large coupling orbit

Critical Speeds: Mode 4: $n_c = 4688$ rpm $D = 18.2$ %

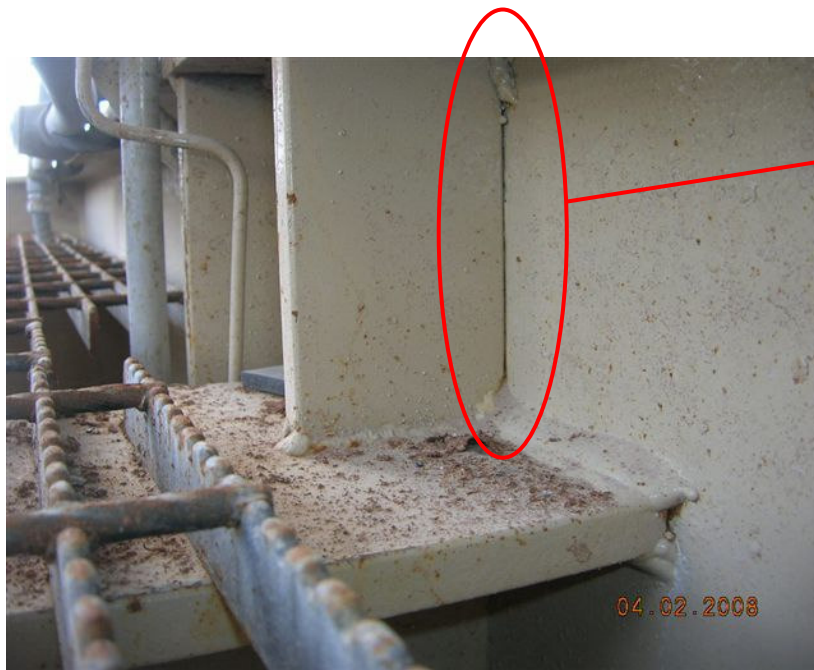
Support Structure Modal FEA

Not every seam welded

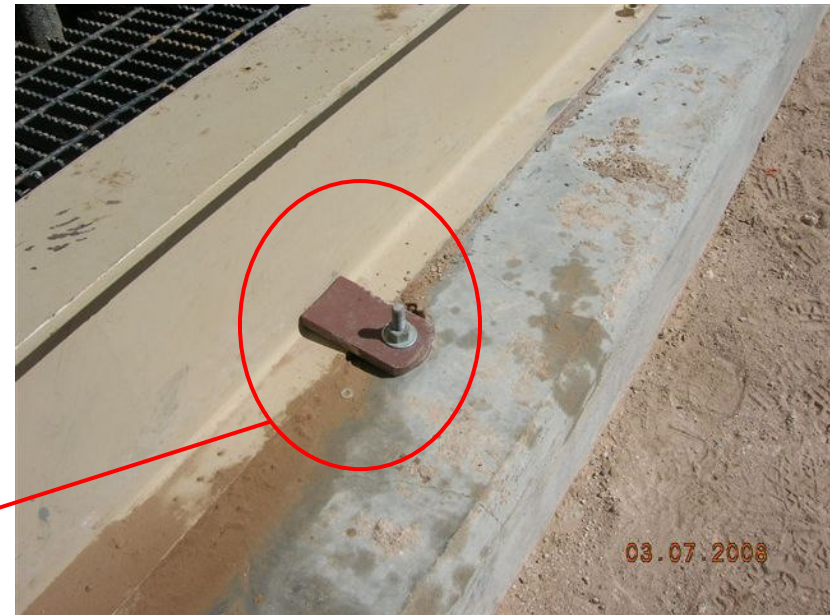
Uncertain hold-down locations

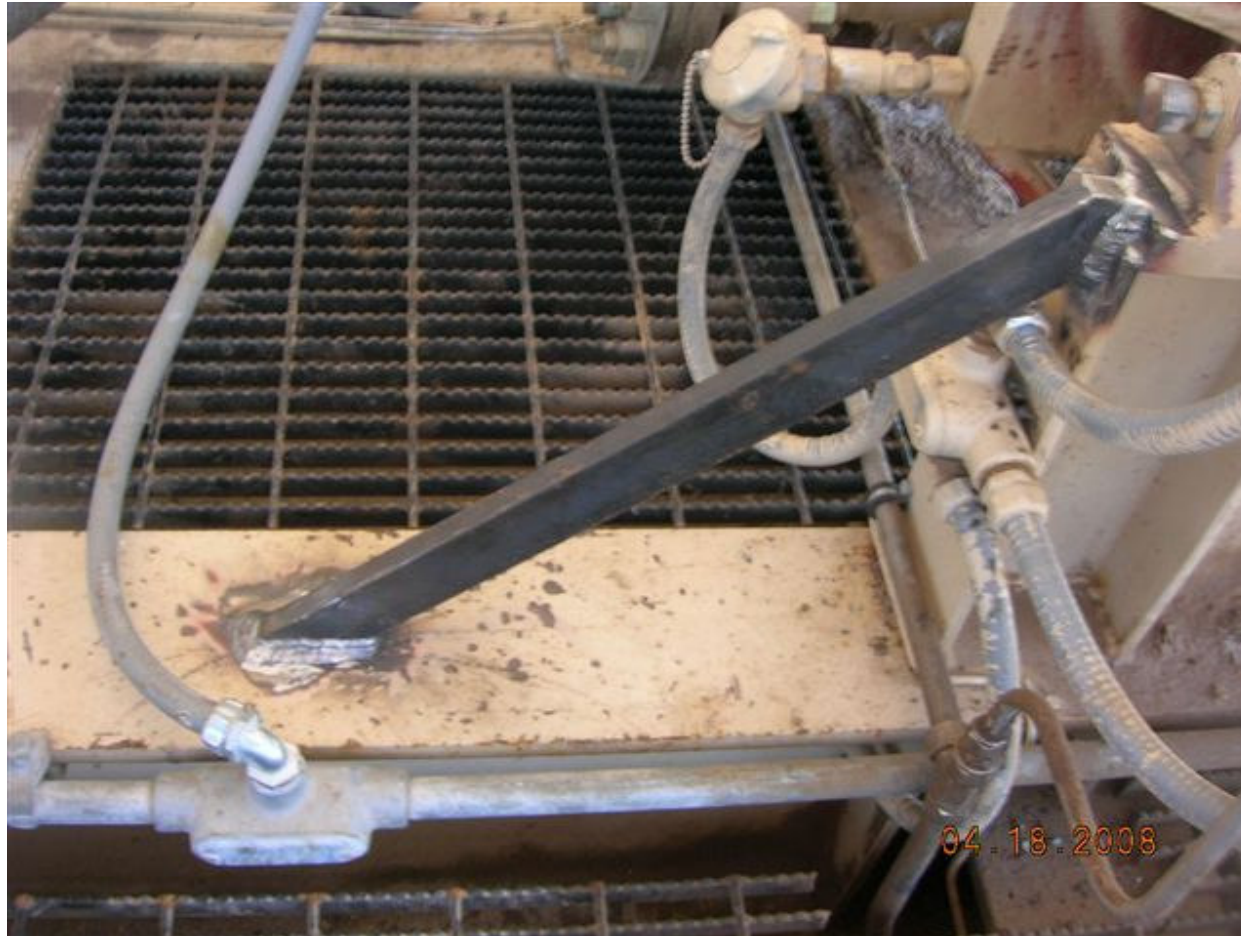
Implementation

Bracing added to all four pedestals (as piping allowed)

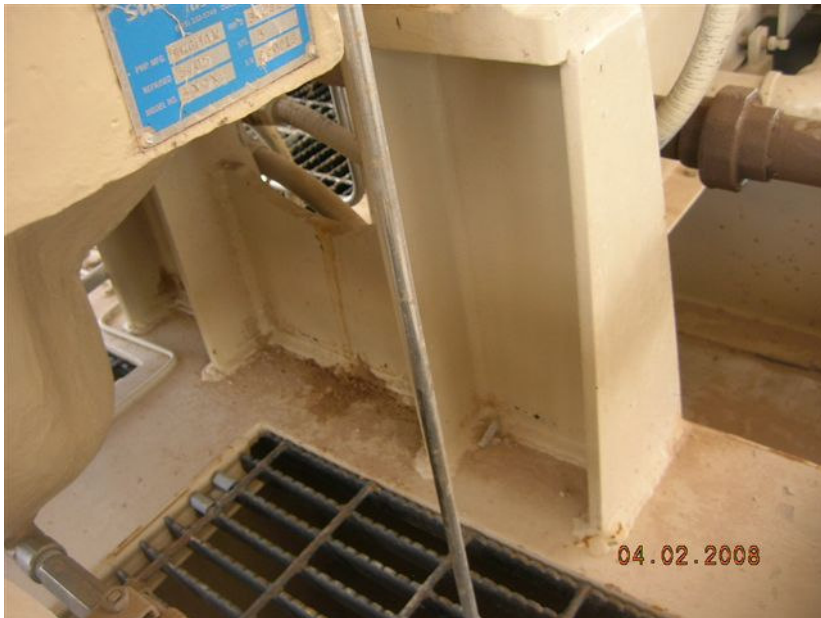
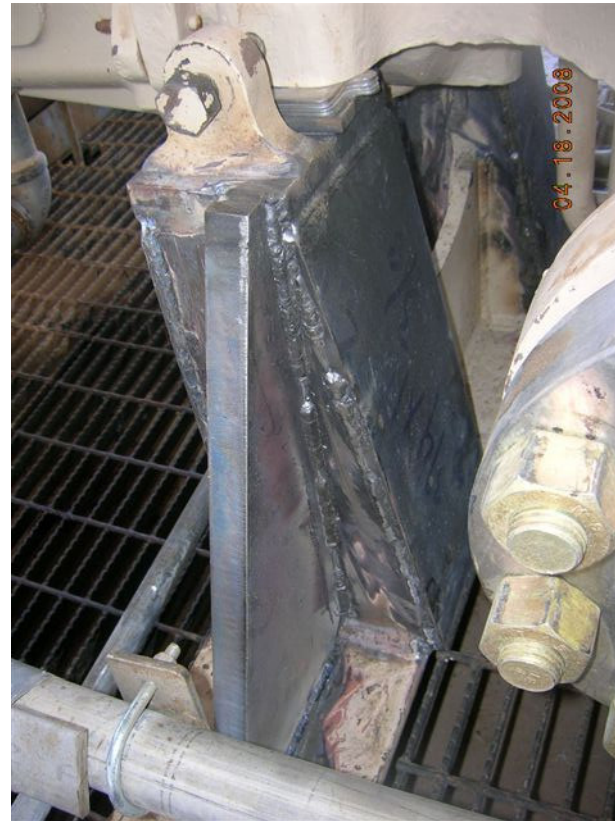
Implementation

Drive-end pedestals also
'Boxed' to reduce twisting

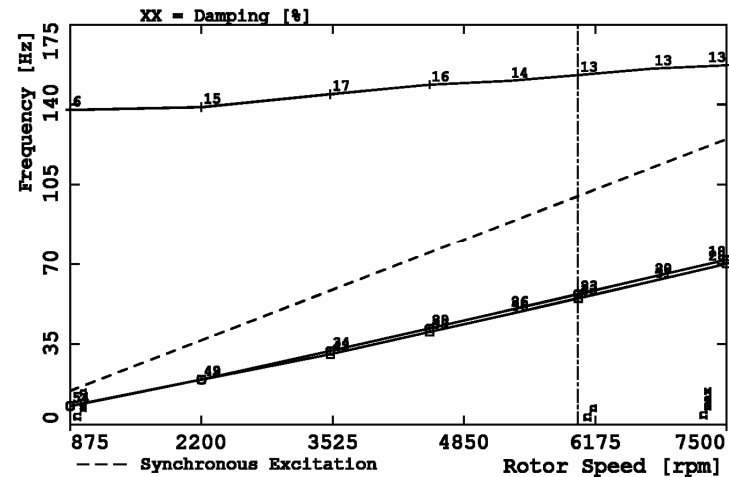
Coupling Changes

- Original – 48 lbs (pump-side)
- Profiled – 36 lbs (pump-side)
- Field Balanced
- Entirely new
13 lbs (pump-side)

Critical Speeds: Mode 4: $n_c = 4688$ rpm $D = 18.2$ %

- Reduced Vibration
 - Original 0.60 in/sec @ 5200 RPM
 - Added Struts 0.28 in/sec @ 5800 RPM
 - Changed Coupling 0.19 in/sec @ 6100 RPM
- Ability to run through entire operating speed range
