BONE-DRY RUNNING TESTS UTILIZING DIAMOND LIKE CARBON COATED SILICON CARBIDE BEARINGS AND POLYMER LUBRICATING STRIPS IN AN ANSI MAGNETIC DRIVE PUMP

Anthony E. Stavale

ITT A-C Pump Company

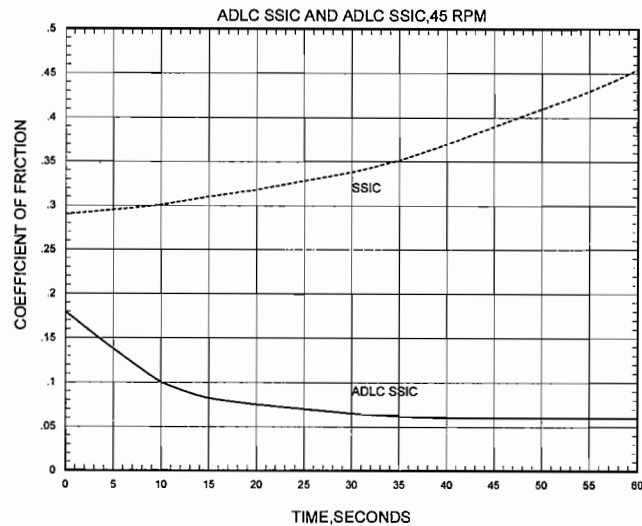
As shown in Figure 1, the dry friction coefficient of this coating is as low as 0.05 (ADLC vs ADLC) compared to 0.5 and higher for sintered silicon carbide. The friction coefficient under normal lubricated operation is typically less than 0.01.

Figure 1. Dry Coefficient of Friction Vs Time.

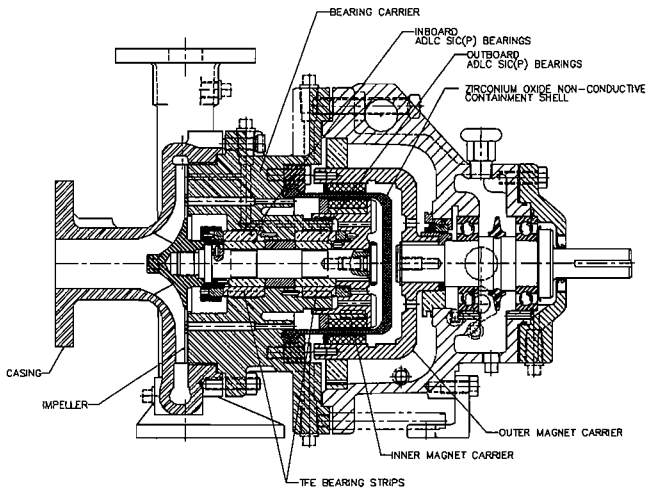
The test pump was a $1.5 \times 1 \times 6$ horizontal end suction ANSI magnetic drive pump fitted with a nonconductive containment shell as shown in Figure 2. The magnet drive was rated for 7.5 hp at 3600 rpm and was built using standard production parts. The threaded-on impeller was fastened with adhesive, as a precaution, to prevent possible loosening under dry running operation. The impeller front clearance was increased, for test purposes, to allow for any unexpected thermal growth of the shaft. The pump was coupled to a five hp 3600 rpm motor. Type J thermocouple wires were fitted to the OD of the stationary inboard and outboard bearings at approximately the midpoint of the bearing, since it was impractical to monitor temperature at the interface of the rotating and stationary bearings. Prior to testing, the thermocouple wires were calibrated for accuracy. During testing, ambient, inboard, and outboard bearing temperatures were recorded on a data acquisition system as a function of time. Observations were noted for any unusual noise, excessive vibration, or burning odors. Upon shutdown, the outer shaft was observed for a smooth, gradual coastdown.

Figure 2. Test Model 1.5 x 1 x 6 ANSI Magnetic Drive Pump- 7.5 HP/3600 RPM.

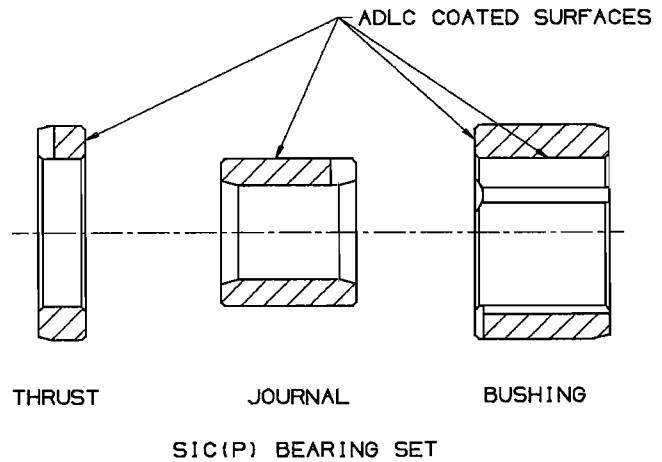
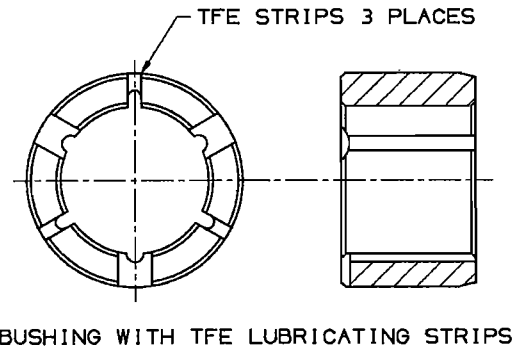
The ADLC coated surfaces are shown in Figure 3 for the stationary bushing, rotating journals, and thrust bearings. The bearing substrate material was controlled porosity sintered silicon carbide. The three grooves shown in the stationary bushing were

filled with Teflon® strips in Tests 5 and 10, and omitted in all other tests. The Teflon® strips are L-shaped in order to provide dry lubricant to both radial and thrust faces of the silicon carbide bearings. As heat is generated at the rotating and stationary bearing interface during dry running, these polymer strips expand outward due to their greater thermal expansion coefficient and wipe both the radial and thrust surfaces of the bearing. Once normal pumping is established, and excessive heat is no longer generated, the strips would retreat back into their grooves and remain inactive.

Figure 3. Bearing Test Configurations.

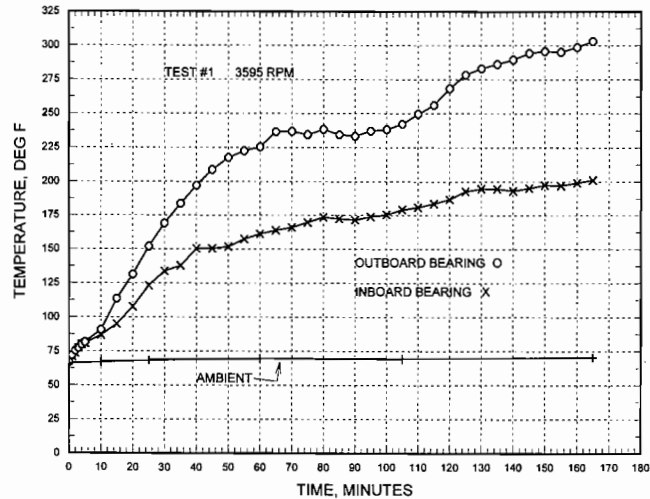
A time vs temperature plot of inboard and outboard bearing temperatures for Test Configuration 1, which consisted of ADLC SiC(P) rotating and stationary bearings, is shown in Figure 4. This arrangement successfully ran bone-dry for 161 min prior to reaching the 300°F temperature limit previously set for terminating the test. During the test, it was observed that the pump ran quietly and smoothly and there were no burning odors emanating from the pump. Upon shutdown, the coastdown of the outer shaft was smooth. A slight squeak was heard when rotating the shaft by hand; however, the noise disappeared after a few minutes of cooling. After dismantling the unit for inspection, light to moderate scoring was observed between the stationary and rotating bearings as shown in Table 5. Bearing wear was not measured during this test. Two additional repeat tests were performed using new bearing sets of the same test configuration (Tests 8 and 9). As shown in Table 6, nearly all wear occurred in the stationary bushings for these tests and ranged between 0.0004 in to 0.0008 in. This wear was evidenced by approximately 1/4 tsp of black SiC powder that was found between the bearing running surfaces. A photograph of the SiC powder is shown in Figure 5. It is apparent that the ADLC coating has been worn away, at least in the stationary bushing, considering the degree of wear involved. However, despite this wear, the bearing set was still able to maintain its dry run performance. This may be attributed to the parts having lapped themselves together while operating, thereby eliminating any high spots and any minor amounts of edge loading present. The arrangement also shows that it has the ability to run dry even in the presence of solid particles, in this case, very abrasive SiC powder. Although bearing temperature will increase in the presence of solids due to the added friction involved, operating temperatures are still low enough to virtually eliminate the risk of thermal shock should liquid suddenly enter the pump. In addition, a reduced amount of axial bearing float, such as used in an open impeller design, would be highly desirable to reduce the risk of mechanical shock due to “slamming” of the rotor once liquid is admitted to the pump.

Figure 4. Bone-Dry Run Test-SiC(P) ADLC Stationary and Rotating Bearings.

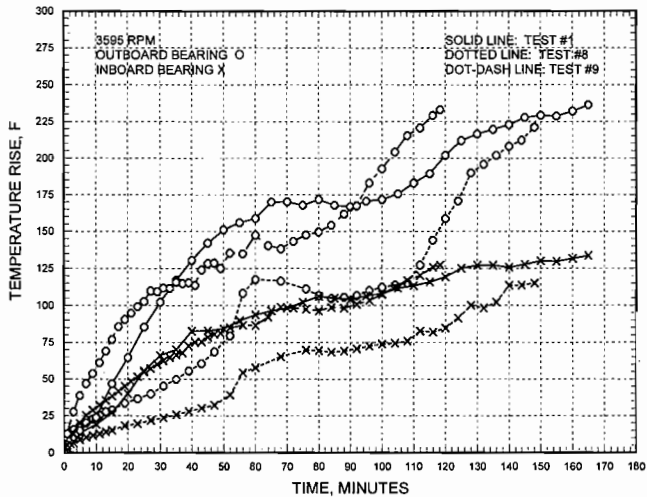
for the ADLC SiC(P) vs ADLC SiC(P) bearing arrangement. It was found that the repeatability between these tests was reasonably consistent as shown in Figure 6. The bone-dry run times to reach 300°F were 161, 147, and 117 min, respectively, for Tests 1, 8, and

9. The average dry running time for this configuration was 142 min. As shown in Table 5, an inspection of the bearings after all three test trials found their condition to be very similar. The bearings were judged to be in good condition and it would be expected that they could be put into service without problem. It should be noted that the outboard bearing ran consistently hotter than the inboard bearing. This is attributed to the following:

Figure 6. Bone-Dry Run Repeatability Tests—SiC(P) ADLC Stationary and Rotating Bearings.

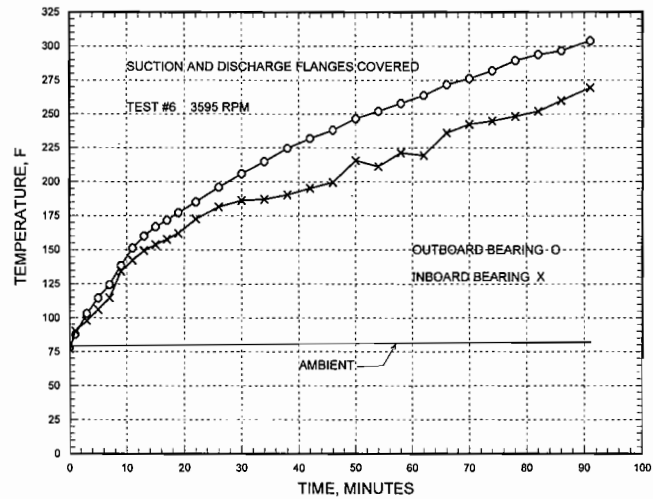
In an actual field installation, the degree of cooling attainable will depend on the volume of piping in the system and whether or not the discharge valve is open. Accordingly, a configuration was tested (Test 6) with the suction and discharge flanges covered with blind flanges to simulate a worse case condition, thereby greatly diminishing the cooling effect of the air flow. The results of this test are shown in Figure 7. The dry run time to reach 300°F was nearly 1.5 hr, which is very significant dry run protection under these unfavorable conditions. After dismantling the unit for inspection, the bearing condition was found to be very similar to Tests 1, 8, and 9 (with air flow). The bearing wear for Test 6 was a maximum of 0.0008 in.

Figure 7. Bone-Dry Run Test with Flanges Covered—SiC(P) ADLC Stationary and Rotating Bearings.

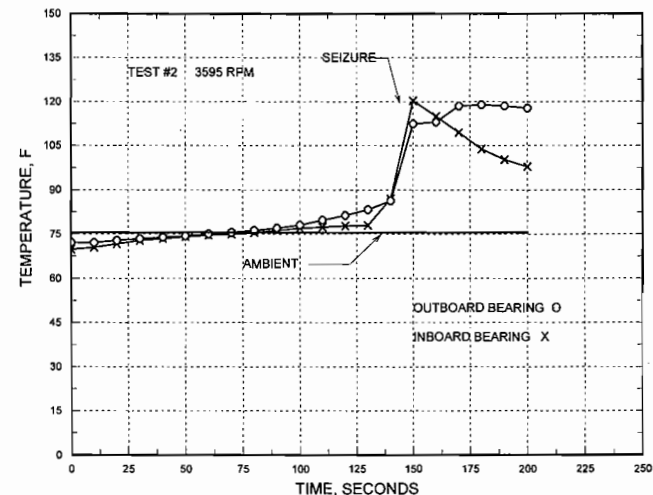
rotating bearing, while using uncoated silicon carbide on the other running surface. This would be advantageous from a cost standpoint. Test 2 utilized the ADLC on the stationary bearings only, while Test 3 incorporated the ADLC coating only on the rotating bearings. Both of these configurations seized prematurely; however, there was no internal contact with the containment shell. As shown in Figure 8, the ADLC coating on the stationary bearing only (Test 2) seized in under 2.5 min. The ADLC coating on the rotating bearings only, fared much better. As shown in Figure 9, Test 3 ran bone-dry for 32 min prior to seizing. In both of these configurations (Test 2 and 3), the outboard sleeve bearing cracked as detailed in Table 5. Although the 32 min dry run time of Test 3 was much shorter than that achieved in Test 1 (161 min), an argument can be made that if monitoring is not provided, the unit will eventually fail in either case without manual intervention. Therefore, the configuration with ADLC coating on the rotating surface only may still have some merit, based on cost considerations, and would serve to reduce the cost per bearing set by at least half.

Figure 8. Bone-Dry Run Test—SiC(P) ADLC Coated Stationary vs SiC(P) Uncoated Rotating Bearings.

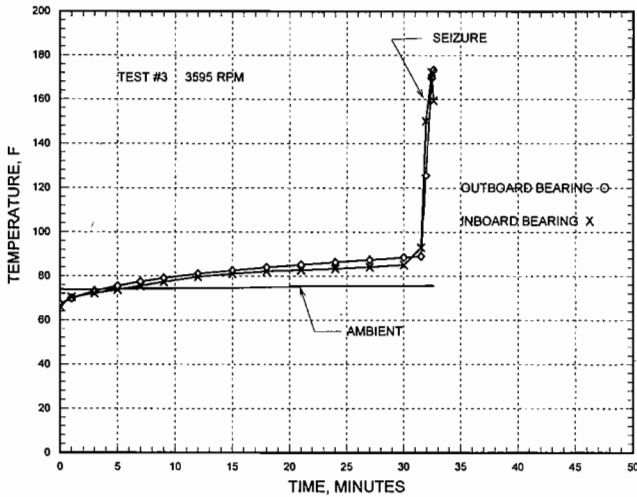
Figure 9. Bone-Dry Run Test—SiC(P) Uncoated Stationary vs SiC(P) ADLC Coated Rotating Bearings.

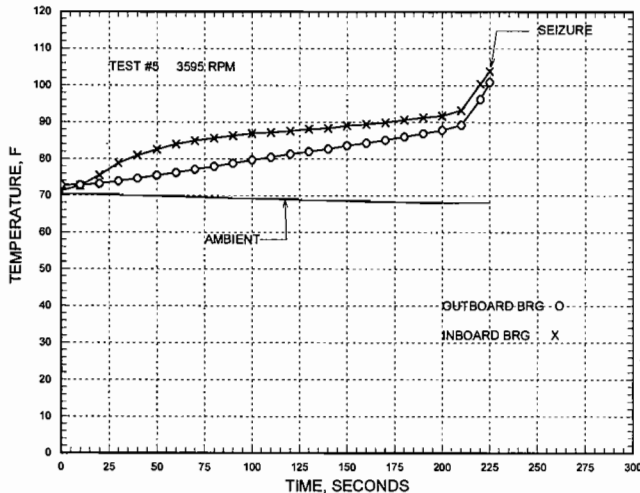
A bone-dry baseline test (Test 4) was performed on the test pump at 3595 rpm with SiC(P) rotating and stationary bearings without the ADLC coating or Teflon® strips, in order to determine the extent of dry running possible with plain silicon carbide. Not surprisingly, this configuration seized in under five sec operation. It should be noted that the failure was too sudden to develop a meaningful data curve. An inspection of the parts showed this failure to be the most severe of all test configurations; however, no internal rubbing of the containment shell occurred. It was found that both sleeve bearings were shattered and both stationary bushings were cracked. The addition of Teflon® strips in the stationary bushing showed a remarkable improvement in bone-dry run performance (Test 5). As shown in Figure 10, this low cost configuration incorporating Teflon® strips with SiC(P) vs SiC(P) bearings without the ADLC coating, extended dry run operation prior to seizure from just under five sec to nearly four min.

Figure 10. Bone-Dry Run Test—SiC(P) Uncoated Stationary and Uncoated Rotating Bearings with TFE Strips.

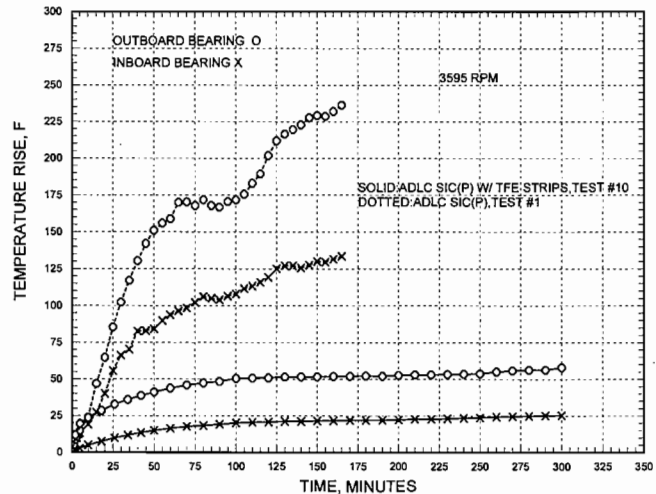
bearings; the result offered a major advance in dry run technology. As shown in Figure 11, the outboard bearing temperature leveled off at only 139°F ($\Delta T = 58^\circ\text{F}$) after five hr of bone-dry run operation. The inboard bearing stabilized at 107°F ($\Delta T = 26^\circ\text{F}$). The test was stopped after five hours due to time constraints, but it was expected that this configuration would have continued to run bone-dry successfully for many more hours. It was noted that there was no squeak audible when turning the shaft by hand after the unit was shutdown, as was detected in previous tests. In comparison, the best performing ADLC SiC(P) vs ADLC SiC(P) test experienced an outboard bearing temperature which peaked at 300°F ($\Delta T = 233^\circ\text{F}$) and an inboard bearing which reached 198°F ($\Delta T = 131^\circ\text{F}$) after 161 min of operation (Test 1). As shown in Table 5, the bearings from Test 10 were found to be free from scoring and judged to be in very good to excellent condition (the best of all configurations tested), despite having been in dry run operation nearly twice as long as the longest lasting previous test (Test 1). A comparison of outboard sleeve bearings between Tests 1 and 10 is shown in Figure 12. As shown in Table 6, the amount of bearing wear for Test 10 after five hr of bone-dry run operation ranged from 0.0001 in to 0.0002 in. This is an eight-fold improvement in wear resistance over Test Configuration 8. One interesting observation that should be noted is that, during the dismantling inspection, there was barely any silicon carbide powder found between the bearing running surfaces as was so evident during previous tests. This explains why the bearing temperatures and wear were so low. The SiC powder, which gets trapped between bearing running surfaces, will increase friction and consequently operating temperature. Additionally, the very abrasive nature of the SiC powder will only tend to exacerbate wear further. Based on these test results, the introduction of the Teflon® strips appears to maintain a low friction and soft running surface even in areas where the ADLC coating has been abraded away. This helps to reduce the abrasion and grinding action of SiC against SiC, which lessens the formation of SiC powder; consequently reducing friction and heat buildup.

Figure 11. Test Comparison of ADLC SiC(P) and ADLC SiC(P) Coated Bearings with TFE Strips.

Test results show that the bearing test configuration with Teflon® lubricating strips and ADLC SiC(P) vs ADLC SiC(P) bearings was superior to all configurations tested under bone-dry run operation. This bearing arrangement successfully ran bone-dry for five hr at 3600 rpm and had the longest operating time, lowest temperature rise, and least wear of all configurations tested. After examination of the unit, virtually no damage was found to the ADLC coated SiC(P) bearings and it was expected that the pump could have continued to run successfully in this condition for many more hours. The maximum temperature rise (ΔT) after five hr of bone-dry run operation, as measured at the OD of the stationary bushing, was 58°F for the outboard bushing and 26°F for the inboard bushing.

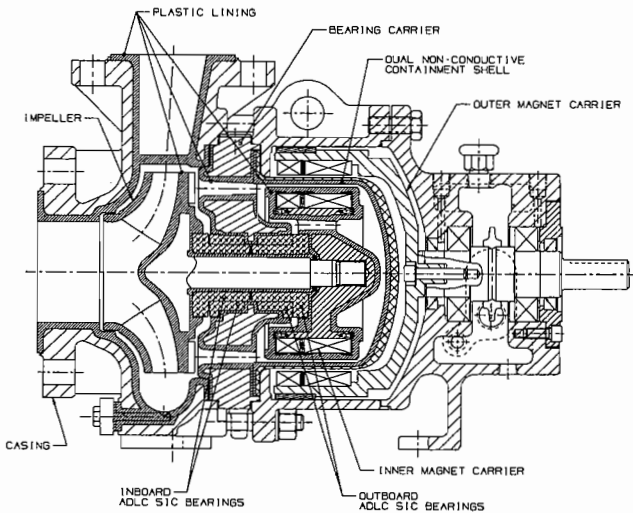
Bone-dry run tests conducted with plastic lined magnetic drive pumps, such as shown in Figure 13, indicate that the plastic lining, normally 1/8 in to 3/16 in, has an insulating effect on the efficient transfer of heat away from the SiC bearings. The large difference in dry run performance between a lined and metal bearing carrier is shown in Figure 14. These plastic lined magnetic drive pumps

Figure 13. Plastic Lined ANSI Magnetic Drive Pump.

are becoming increasingly popular. Plastic lining materials, such as PFA/PTFE, are available and offer the highest degree of confidence in a liner material, virtually inert to chemical attack. They can be applied in highly corrosive services up to 356°F. High performance plastic lined magnetic drive pumps can begin to become of economic importance when comparing their costs to pumps with metallurgies such as 316ss and alloy 20. A favorable cost benefit can be especially realized when comparing these pumps against metallurgies such as the Hastelloys and more “exotic” alloys, such as titanium and tantalum [4]. Inherent to a plastic lined magnetic drive pump is a nonconductive containment shell, which is essential to dry run survivability, as mentioned previously.

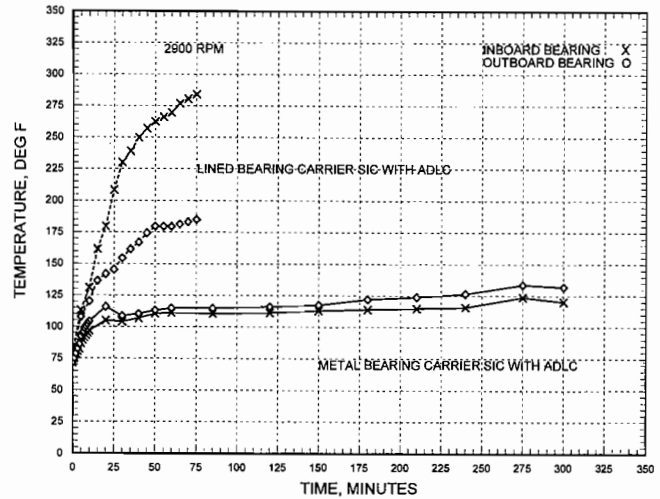
Figure 14. Bone-Dry Run Test Comparison with Lined and Metal Bearing Carrier.

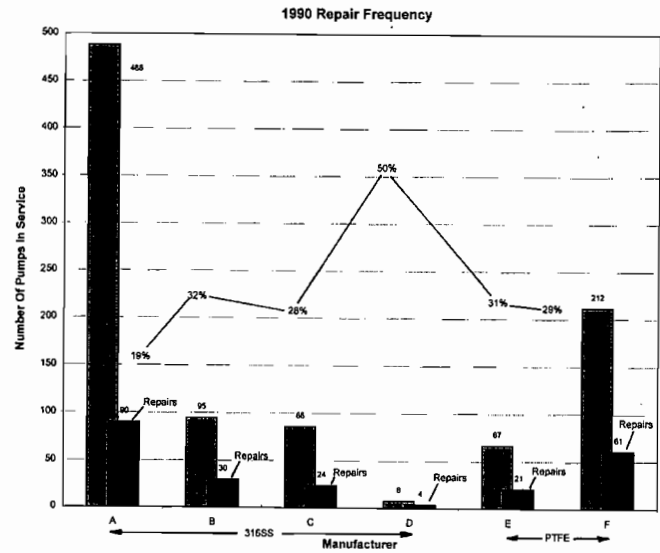
The 1990 and 1992 repair trends of magnetic drive pumps at a large German chemical plant [5] are shown in Figures 15 and 16. Manufacturer F, of plastic lined magnetic drive pumps, began to introduce the ADLC coating on SiC bearings during late 1990 and it was found that the repair frequency had fallen dramatically. During 1990, the repair frequency at this plant for Manufacturer F was 29 percent and had fallen to 11 percent during 1992, which represents a 62 percent reduction in failure rate. Although it is uncertain exactly what percentage of this reduction can be attributed to the ADLC coating and/or improvements in operating procedures and maintenance practices by plant personnel, it is

Figure 15. 1990 Repair Trends of Magnetic Drive Pumps at a Large German Chemical Plant.

Prior experience by a plastic lined magnetic drive pump manufacturer indicates that the ADLC coated SiC bearings had significantly contributed toward a 62 percent reduction in failure rate during frequency of repair audits at a large German chemical plant. Similar experiences have also been confirmed at other chemical plants.

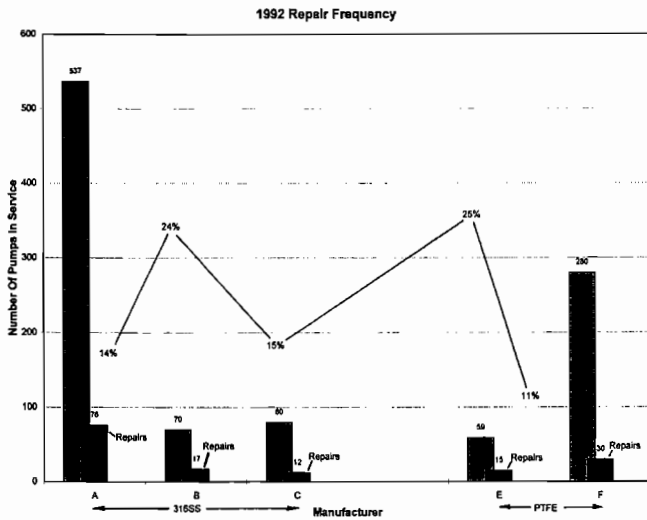
clear that Manufacturer F had the largest reduction in failure rate among both metal and plastic lined magnetic drive pump suppliers at this plant. This same trend has been confirmed by this manufacturer at other chemical plants.

Figure 16. 1992 Repair Trends of Magnetic Drive Pumps at a Large German Chemical Plant.
