CHANGES IN PUMP VIBRATION LEVELS CAUSED BY THE MISALIGNMENT OF DIFFERENT STYLE COUPLINGS

Jerome A. Lorenc

Instrumentation Engineer
Goulds Pumps, Incorporated
Seneca Falls, New York

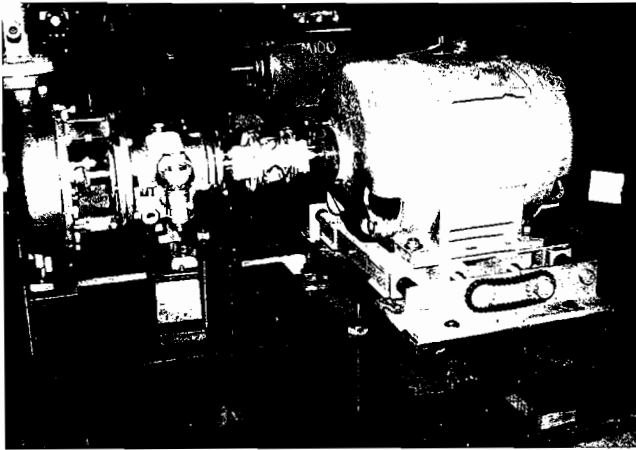
Figure 1. Test Setup. Pump, coupling 01, motor, and adjustable motor base.

An ANSI style 2x3-10 pump with a maximum diameter impeller was selected for this test program. A 100 hp, 3560 rpm, 365 TS frame induction motor was chosen as the driver. The motor was mounted on an adjustable motor base. The motor base was mounted on the pump/motor baseplate such that only motor movement perpendicular to the pump shaft axis could be obtained. The equipment setup is shown in Figure 1.

The pump, motor, and baseplate were set up (Figure 1) on a closed loop tank facility. Special attention was given to assure proper installation of the baseplate, pump, and motor. Once installed, it was not altered throughout this test program. The motor to pump alignment was performed using the rim and face alignment method [1]. Parallel and angular misalignment were reduced to less than 0.003 in total indicated runout (TIR). This alignment procedure was performed before each coupling was tested.

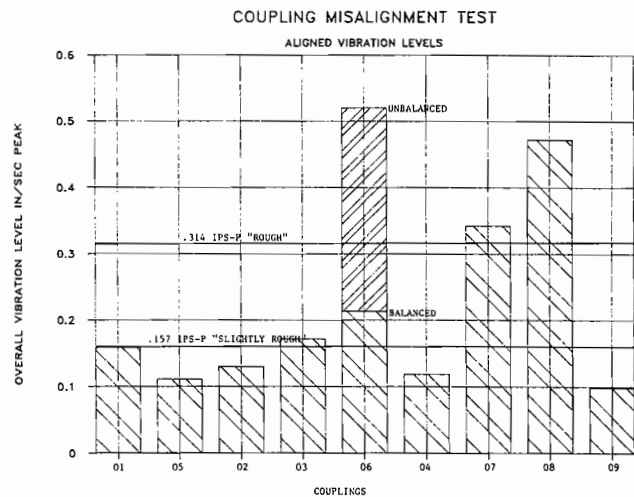
Figure 2. Aligned Pump Overall Vibration Levels with Different Couplings Installed.

A bar graph is depicted in Figure 2 of the initial overall vibration level for each coupling obtained while the motor was accurately aligned to the pump.

The bar graph of the initial pump vibration level for each coupling with accurate alignment is shown in Figure 2. Overall

The 06 coupling, during its first installation, caused a pump vibration level of 0.520 ips-P. This coupling was found to be 1.34 in-oz out of balance. The coupling was balanced to less than 0.25 in-oz. The second installation and operation of the pump with this coupling resulted in a pump vibration level of 0.213 ips-P.

When the 07 and 08 couplings were installed, the pump vibration levels classified the pump as a "rough" running machine. It is believed that the high initial pump vibration levels obtained when these two couplings were installed are the result of the couplings being out of balance. Facilities to check and balance these two couplings were not available.

The metal couplings tested generally exhibited a lower initial pump vibration level than the elastomeric type couplings. Two reasonable causes can be cited. As discussed previously, the balance of the coupling is one possible cause. Coupling manufacturers do not dynamically balance each coupling they manufacture. The larger the coupling and the more cast surfaces, the greater the possibility for the coupling to be out of balance. Another possible cause could be that once an elastomeric style coupling is started, there is no precise way to keep the elastomeric material concentric with the motor/pump's centerline. Centrifugal forces could move the elastomeric material off center thereby unbalancing the coupling. Repeated starts with the 06 coupling when it was first installed resulted in pump vibration variations from 0.450 ips-P to 0.550 ips-P.

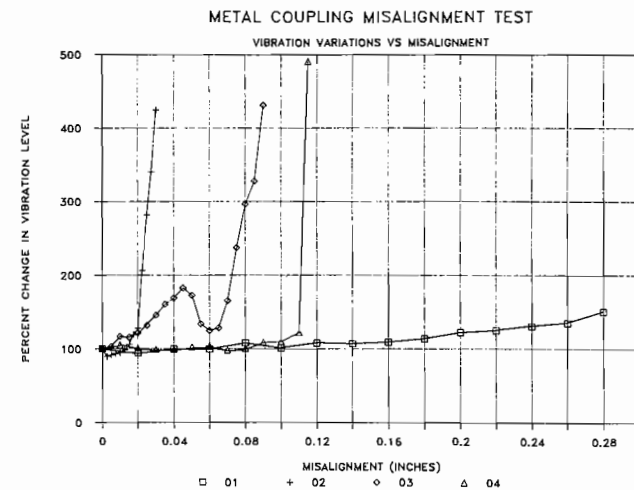
Figure 3. Pump Vibration Level Changes with Increased Amount of Parallel Misalignment Using Metal Couplings.

For ease of comparison, all the vibration levels were normalized using the overall vibration level obtained when the motor was accurately aligned to the pump. The percentage change in vibration level as the misalignment was increased was plotted for each coupling. A graph of the four metal couplings tested is shown in Figure 3, followed by a graph of the five elastomeric type couplings tested (Figure 4).

The 01 coupling has a permissible parallel misalignment considerably greater than any of the other couplings tested, as indicated in Table 2. This has been supported by the results from the tests conducted. Even with 0.280 in misalignment the pump vibration increased by only 50 percent (Figure 3).

The 02 coupling increased the pump vibration level with the least amount of misalignment. The pump vibrations increased rapidly after 0.020 in misalignment. This is a gear type coupling. Once the clearances in the gear are eliminated by the misalignment, this style coupling creates forces which increase the vibration of the pump. The pump vibrations increased as soon as misalignment occurred when the 03 coupling was tested. An

unexpected reduction in the pump vibration occurred when the misalignment was increased through 0.040 to 0.055 in. Pump vibration level increased rapidly with misalignment greater than 0.055 in. The cause of the decrease was discovered upon inspection of the coupling housing halves. Inside the coupling housing halves is a lug that is used to position the coupling housing halves relative to the spring. During the initial misalignment, the spring was hitting this lug, causing the high pump vibration levels. Once the lug was worn down, the spring was allowed to move, thereby relieving the forces and pump vibration levels.

The 04 coupling did not cause pump vibration levels to increase until a mechanical interference occurred on the coupling. The pump vibration increased rapidly (Table 1) at 0.115 in misalignment because its assembly bolts were hitting its hubs. If the assembly bolts were shortened the interference would not exist and the motor could have been misaligned further. However, it was advised that the amount of misalignment already obtained during this test caused deflections which exceeded the material limits of the discs of this coupling.

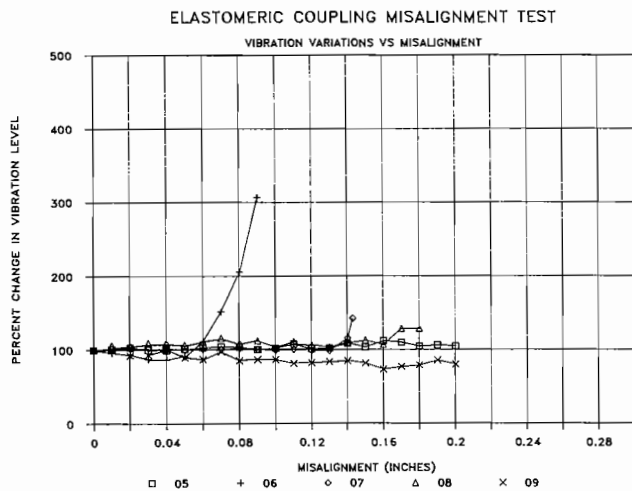
Figure 4. Pump Vibration Level Changes with Increased Amount of Parallel Misalignment Using Elastomeric Couplings.

The results for the elastomeric type couplings are plotted in Figure 4. Of the elastomeric couplings tested, the 06 coupling caused the pump vibration levels to increase with the least amount of misalignment. This coupling's elastomeric material inflexibility under compression is the cause of the induced forces which increased the pump vibrations.

The other four elastomeric couplings were able to accommodate a large amount of misalignment without any substantial increase in the pump vibration level. However, these couplings do this at the expense of their life expectancy. The elastomeric material in each of these couplings was hot to the touch after their run test of approximately 30 min. Prolonged running of these couplings with this type of misalignment could cause the degradation of the elastomeric material. An unknown which was not explored by these tests was what happens to the flexibility characteristics of the elastomeric material when they are subjected to prolonged high temperatures or temperature cycles such as a misaligned pump on an on/off cycle. There is a concern that the elastomeric material would increasingly become harder and more brittle and begin to create forces that would increase the pump vibrations.

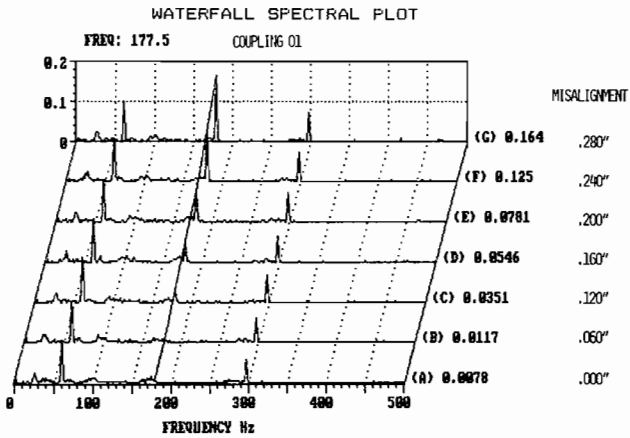
Figure 5. Waterfall Spectral Plot for 01 Coupling.

Reviewing the spectrum plots will give some insight into how and why the pump vibration levels change when each coupling was misaligned. The 01 coupling increased the overall pump vibration level due to an increase in vibration at 3 \times the pump running speed (Figures 5 and 6). This corresponds to the three flexure beams that make up the coupling. Both the 02 and 03 couplings increased the overall pump vibration level by an increase at 1 \times pump running speed (Figures 7, 8, 9, and 10). As mentioned earlier, the 04 caused the pump vibration levels to increase because of a mechanical interference. Its spectrum plots show a sharp increase in all harmonics of the pump running speed when the mechanical interference takes place. This "picket fence" spectrum is typical of either a mechanical looseness or interference (Figures 11 and 12).

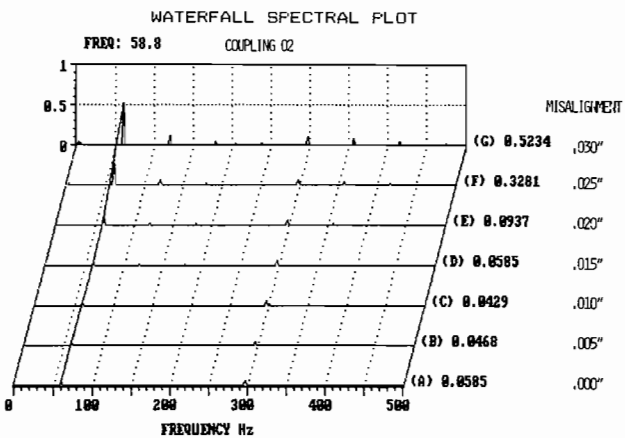
Figure 7. Waterfall Spectral Plot for 02 Coupling.

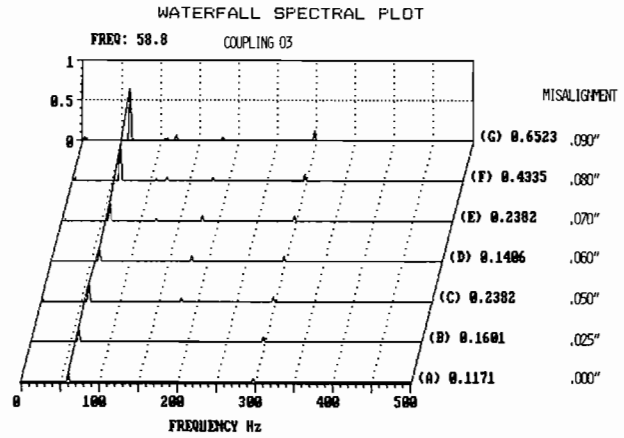
Figure 9. Waterfall Spectral Plot for 03 Coupling.

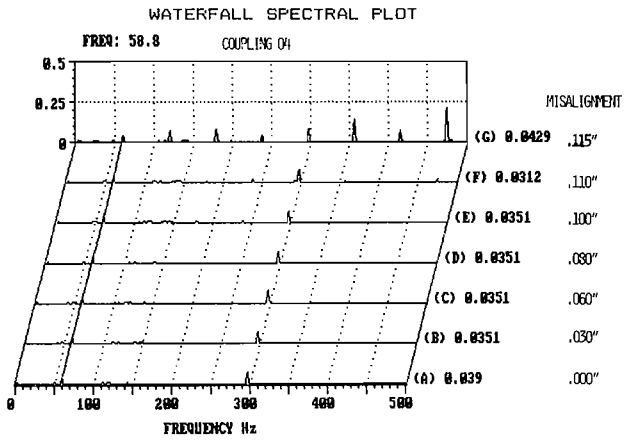
Figure 11. Waterfall Spectral Plot for 04 Coupling.

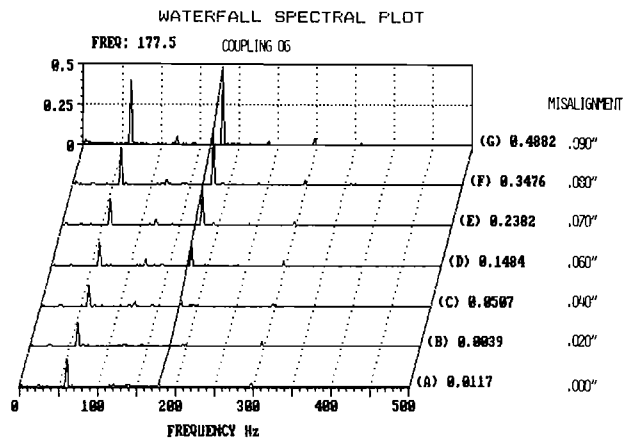
Figure 15. Waterfall Spectral Plot for 08 Coupling.

The 05 and 08 couplings had little or no change in their spectrum plots (Figures 13, 14, 15 and 16). The 06 coupling increased the overall pump vibration levels due to an increase in the vibration at 3 \times the pump running speed (Figures 17 and 18). This corresponds to the three bladed construction of the elastomeric insert of this coupling. The 07 coupling vibration spectrum exhibited amplitude increases at 3 \times and 6 \times the pump running

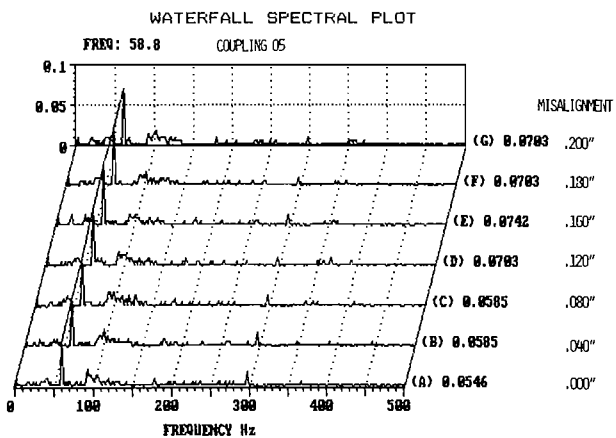
Figure 13. Waterfall Spectral Plot for 05 Coupling.

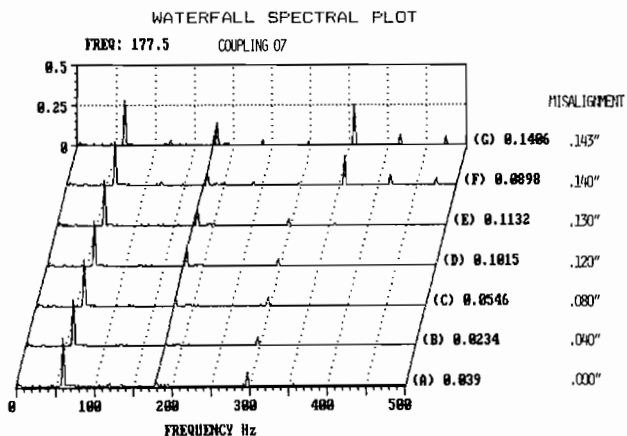
Figure 17. Waterfall Spectral Plot for 06 Coupling.

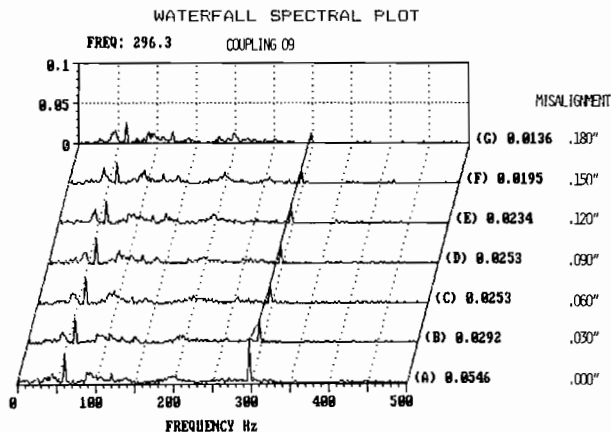
Figure 21. Waterfall Spectral Plot for 09 Coupling.

speed (Figures 19 and 20). This was caused by the six bolt assembly (three bolts on each hub) construction of this coupling. The 09 coupling caused a slight decrease in the pump vibration. Review of its spectrum plots shows a small decrease in the 5x pump running speed signal (Figures 21 and 22). This does not correlate to the construction of the coupling but does correspond to the number of vanes on the pump impeller. This test was

rerun with the results remaining the same. There does not appear to be a clear explanation to the minor reduction in the 5x pump running speed signal.

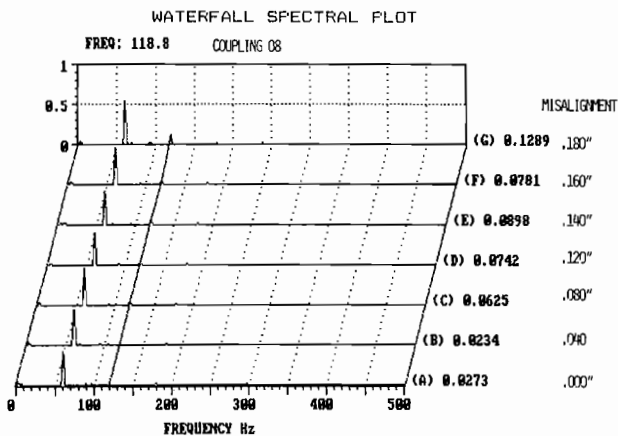
Figure 19. Waterfall Spectral Plot for 07 Coupling.

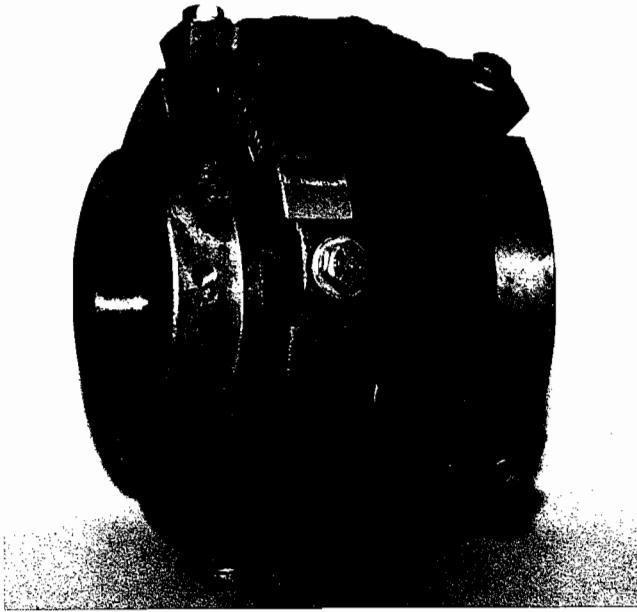
Figure 22. Picture of 09 Coupling.
