CORROSION IN PUMPS

Ronald S. Miller

Ingersoll-Rand Company

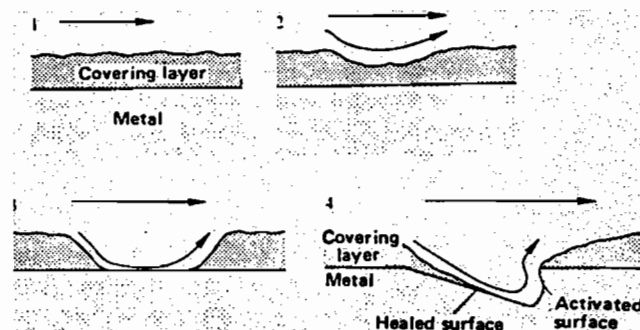
Figure 2. The Corrosion-Erosion Mechanism. This occurs when the local fluid velocity produces shear forces that remove the general corrosion layer [5].

The general corrosion layer formed on many metal surfaces due to reaction with an aggressive environment is expected as a naturally occurring phenomena. As mentioned previously, this oxidized layer is often friable and can be removed by the moving fluid. The shear forces generated by the movement of a liquid can wash away the oxide at specific locations on internal pump components. This oxide removal usually occurs at fluid impingement surfaces or regions of highest fluid velocity within the pump. The removal of these oxides produces local channels and flow paths on the component surface, which increase the turbulence of the fluid, producing additional fluid shear forces. This increases the rate of local oxide removal. The oxide removal mechanism is illustrated in Figure 2.

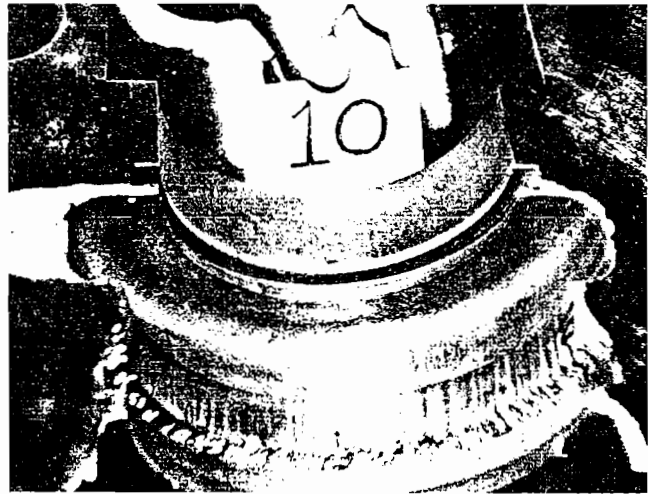
Figure 5. Corrosion-Erosion of a Carbon Steel Casing in a High Temperature, Low Conductivity BFW Service. Damage occurs at high velocity areas.

lence and increased velocity through the channels. Another example of corrosion-erosion is shown in Figure 5. In this case, a carbon steel casing (ASTM-A216 grade WCB) experienced channeling between stages at wear-ring fit locations.

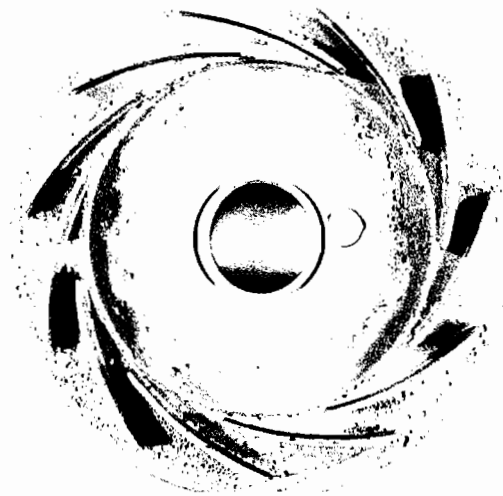
Figure 6. Oxygen Pitting of a Cast Iron Diffuser. Note random broad, shallow pitting.

Oxygen pitting is a form of local corrosion that can occur in aerated high temperature waters found in the utility industry. This form of damage has been observed on all carbon steels and up to the five percent chromium steels. The five percent chromium alloys were used to resist the corrosion-erosion damage mentioned previously. It is the author's company's experience for BFW pumps that if a service has an oxygen content greater than 40 parts per billion (ppb), carbon steels will be susceptible to oxygen pitting. Oxygen pitting is characterized by random broad shallow pitting of the metal surface. The damage due to oxygen pitting of a cast iron diffuser is shown in Figures 6 and 7. In this case, the pitting is not concentrated in any one particular location, but rather over the component's entire wetted surface. Oxygen pitting of a carbon steel impeller is shown in Figures 8 and 9.

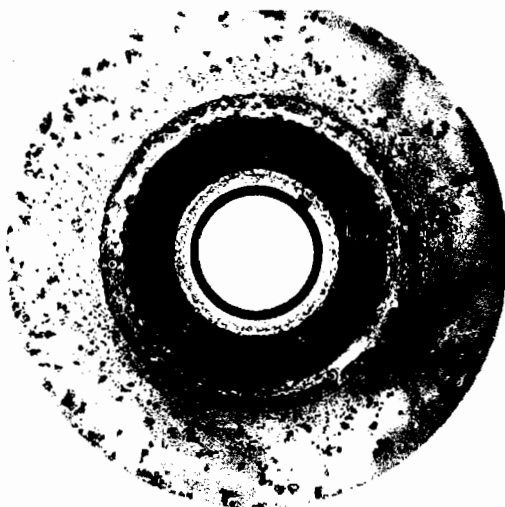
Figure 8. Oxygen Pitting of a Carbon Steel Impeller.

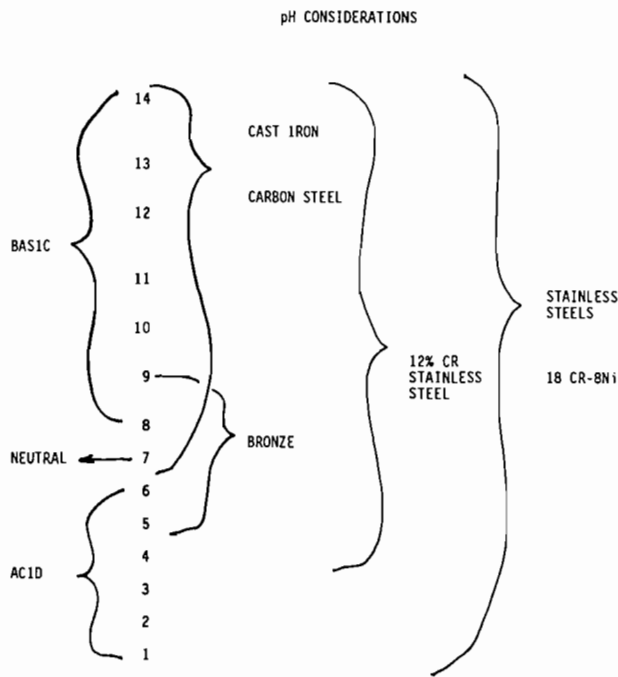
Figure 11. Guideline for Material Selection—Based on pH Value.

There are several factors which can cause a material to experience corrosion pitting. One variable is the solution's pH. In general, acidic conditions will cause corrosion pitting of carbon steels. However, this is not the sole reason for this form of damage in carbon steel. The pH value is only one of the limiting criteria to consider for proper material selection in water solutions. The author's company guideline for selection of materials based upon pH value is shown in Figure 11.

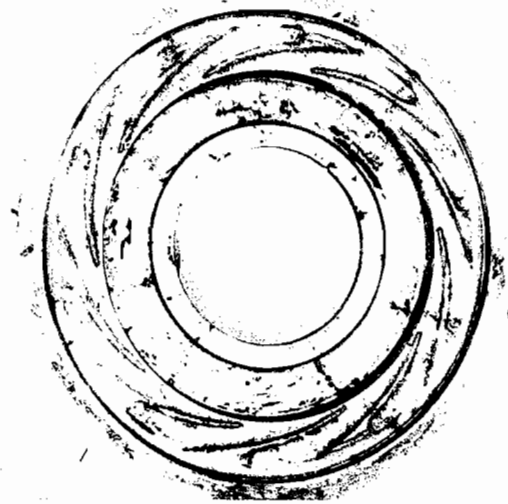
Figure 12. Crevice Corrosion Outlines Location of Diffuser Vanes in this Channel Ring.

ers, or marine organisms that grow on surfaces of a pump component. The outline shown in Figures 12 and 13 is of diffuser vanes that were in intimate contact with a channel ring during a pump's operation in a high-chloride-brine injection service.

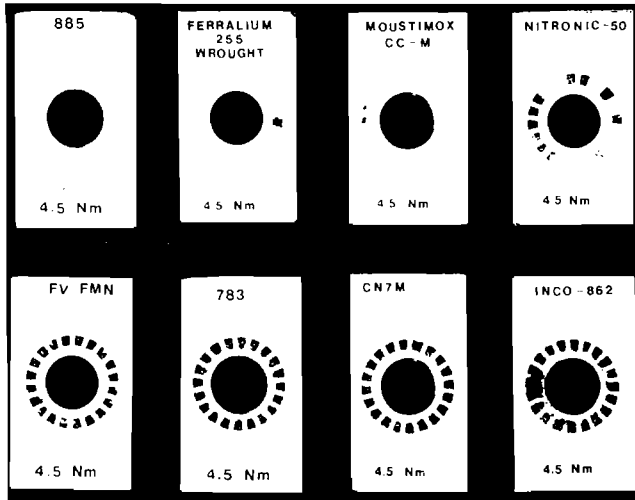
Figure 14. Crevice Corrosion Test Results of Several Alloys, Including IR 885.

multiple-crevice forming device tightened against a test coupon of material to a specified torque. This ensures a repeatable crevice geometry and crevice tightness from test to test. After exposing the test samples to one of the environment for a certain length of time, the crevice test assembly is disassembled, and the number of crevice corrosion sites formed on the coupon's surface is counted. This number determines a material's relative resistance to crevice corrosion. The test results are shown in Figure 14 of a series of samples exposed to the ferric chloride solution. In this figure, it is fairly obvious that the materials that have fewer crevice sites are more highly alloyed stainless steels. The alloying elements found to be most beneficial for crevice corrosion resistance are chromium, molybdenum and nitrogen.

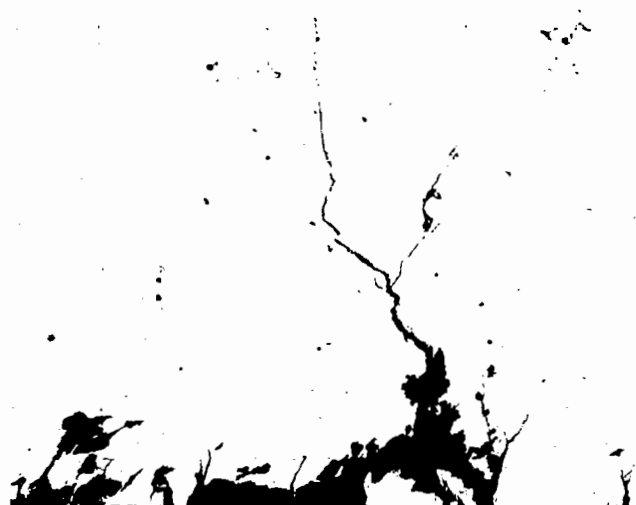
Figure 18. Microsection through Nitronic-60 Ring Showing Branching Cracking Indicative of SCC.

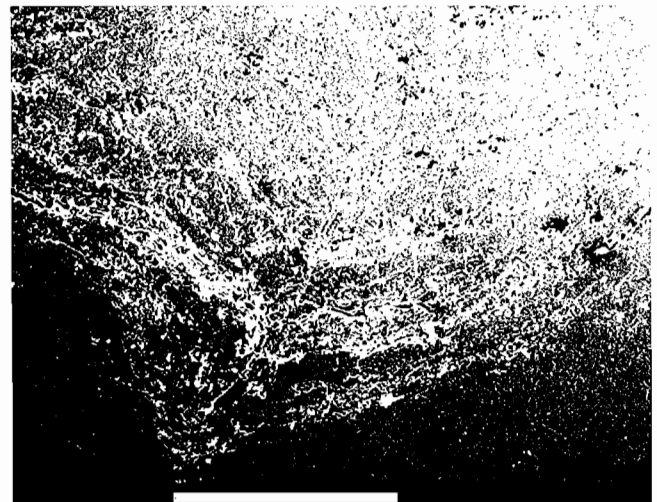
Figure 21. Higher Magnification of Intergranular Attack Due to Sensitization.

The Nitronic-60 bushing shown in Figure 20 experienced selective attack along its grain boundaries because the material was sensitized. A higher magnification view, shown in Figure 21, demonstrates that the corrosion attack is limited to the grain boundaries. This amount of corrosion was observed after only nine months of pump service in a sulfuric acid and copper-sulfate solution. Laboratory evaluation of this component and field exposure testing of test coupons identified that the intergranular attack was due to sensitization of the Nitronic-60. This was due to insufficient solution annealing of the material.
