# INVESTIGATIONS INTO THE CONTAMINATION OF LUBRICATING OIL IN ROLLING ELEMENT PUMP BEARING ASSEMBLIES

**Simon Bradshaw**

Sulzer Pumps (US) Inc.

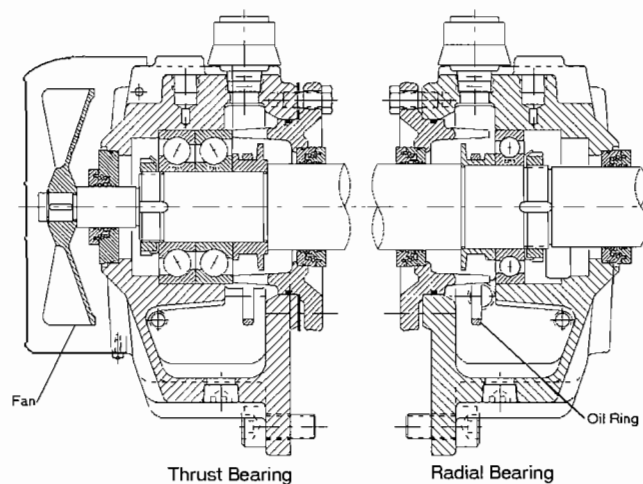
Figure 1. Standard Arrangement for Between Bearing Pumps.

Standardized ball bearing assemblies are a feature of the majority of pumps manufactured by the author's company. Figure 1 shows a matched 40-degree contact angle ball bearing arrangement used as a thrust and radial bearing, and a single deep groove ball bearing used as a radial bearing. Both bearing arrangements use ring oil lubrication with bronze oil rings submerged into the bearing oil sump.

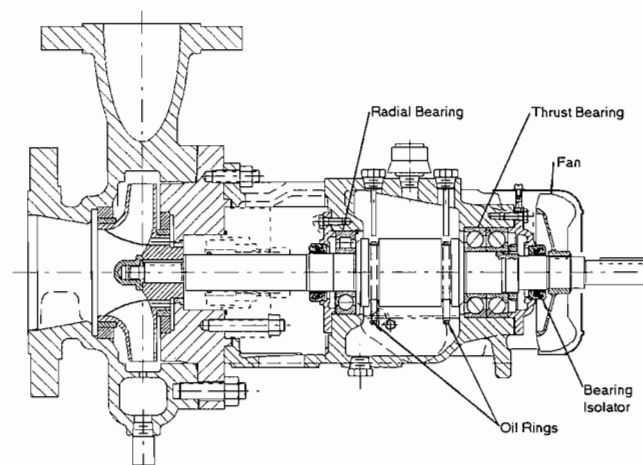
Figure 2. Standard Arrangement for Overhung Process Pumps.

Figure 2 shows the bearing arrangement in a single stage overhung pump, which utilizes matched 40-degree contact angle ball bearings for the thrust and radial bearing, and either a deep groove ball bearing or a cylindrical roller bearing for the radial bearing. The bearings are mounted in a common housing and use ring oil lubrication with bronze oil rings submerged into the bearing oil sump.

In the case of the overhung process pump (Figure 2), there were reports of both "black oil" formation and significant amounts of bronze found in the bearing oil.

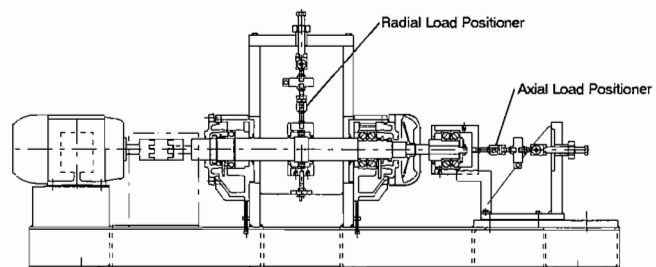
Figure 4. Bearing Test Arrangement.

The test program consisted of 13 two-hour and seven eight-hour tests and was carried out on a custom designed test rig. The rig had the ability to apply radial and axial loads to an assembly duplicating the configuration of the between bearing pump (Figure 4). By provision of Plexiglas viewing windows mounted into the bearing housing and temperature probes, the complete behavior of the bearing being studied could be observed.

Prior to each group of tests, the test rig was disassembled and new angular contact thrust bearings were fitted to the bearing housing. Clean ISO VG32 turbine oil was used for each test. After each test, within seconds of stopping, a sample of oil was taken from the radial and thrust bearing. The test rig was then disassembled and the bearings removed for inspection. At this time the bearing housings were cleaned to remove all traces of oil and contamination.

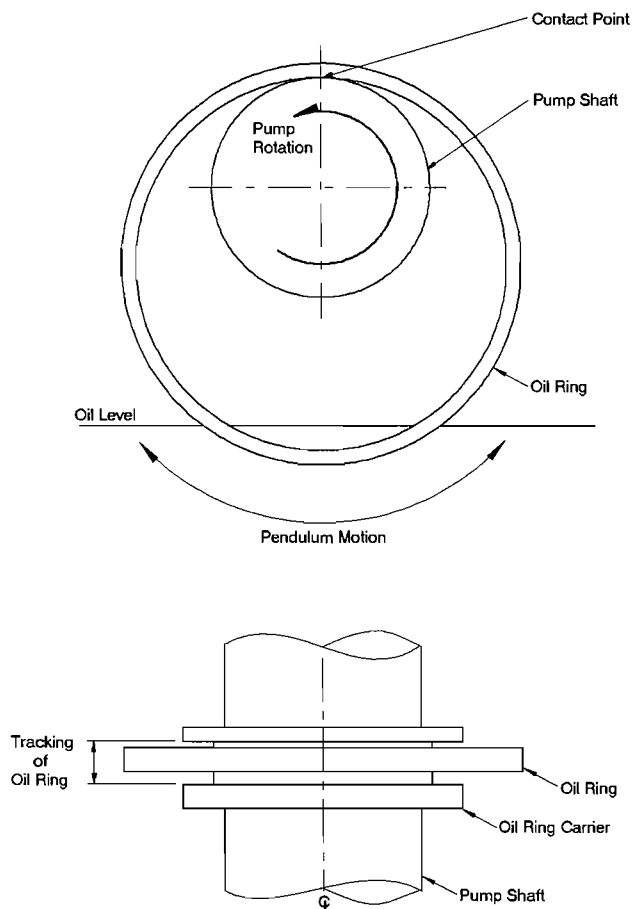
Figure 5. Oil Ring Motion.

- A pendulum motion pivoting about top dead center of the ring (where it contacts the shaft), swinging in a plane at 90 degrees to the shaft axis.
- Tracking of the ring backwards and forwards across the oil ring carrier (Figure 5).

The testing showed that oil ring stability was variable and depended strongly on oil viscosity and oil ring immersion depth. Generally the bronze oil ring operated erratically once operating temperature was reached. This behavior can be characterized as:

Tests showed that the source of bronze in the oil was primarily due to the oil ring erratically hitting the bearing housing and bearing cap or wearing against the oil ring carrier. Varying the oil level did not eliminate this behavior. As the oil level was varied, the oil ring motion became erratic at a different oil temperature. It is not possible to set an oil level that will remove this behavior completely. The behavior is also very sensitive to small changes in oil viscosity.

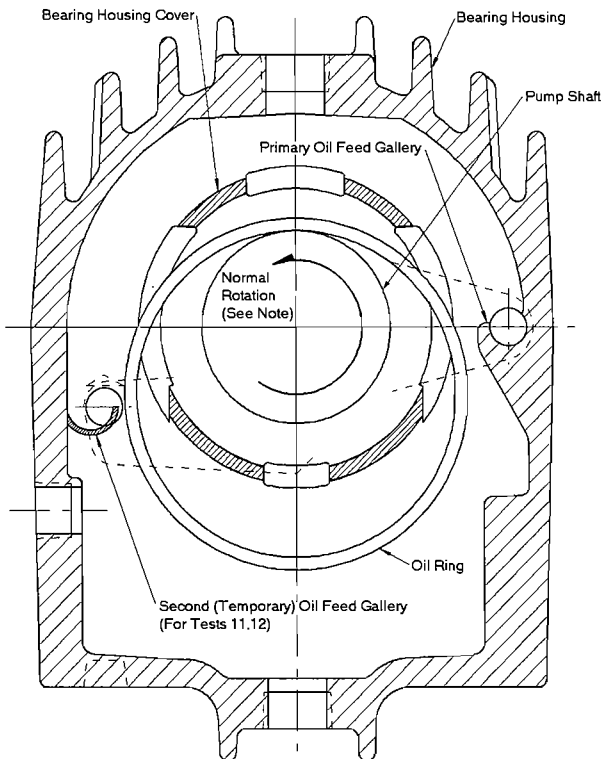
Figure 6. Bearing Housing Modifications for Increased Oil Delivery.

Note: Normal CCW rotation at the thrust bearing end (as shown) was reversed for test 3 only

From the test observations, the hypothesis was that oil delivery was sufficient to ensure adequate lubrication. To verify this, additional oil feed gallery was added to increase oil delivery (Figure 6). Tests were conducted using this arrangement and oil samples compared with previous tests showed no improvement in color. The only observation was that increased oil delivery resulted in increased bearing temperature due to more oil churning within the bearings.

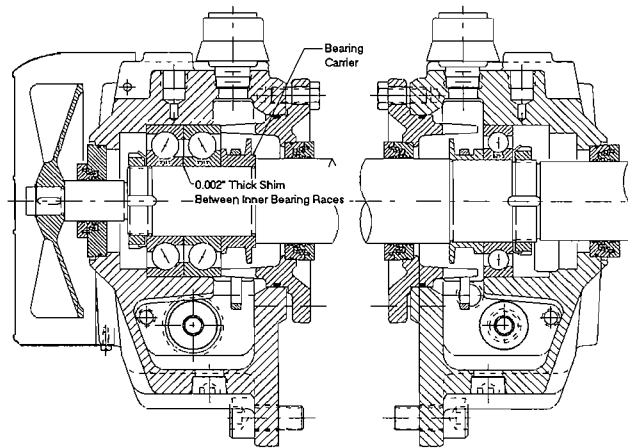
Figure 7. Original Bearing Design with Interbearing Shim.

When the matched angular contact thrust bearings were originally installed, a between bearing shim was included (Figure 7). This 0.002 inch thick shim was fitted between the inner races of the angular contact thrust bearings to increase the internal clearance, resulting in a lower operating temperature. Testing showed that the inclusion of the interbearing shim caused high levels of bearing skidding (of the unloaded bearing) and "black oil" formation. For the remainder of the tests, the interbearing shim was removed and testing was conducted using medium clearance angular contact bearings and medium preload angular contact bearings. This was done to evaluate the effect of decreasing the bearing internal clearance and its effect on black oil formation. Subsequent testing showed that two bearing fit factors affected "black oil" formation:

The conclusion was that the internal clearance of matched angular contact bearings is critical to their correct operation. Provided the bearing internal clearance is held at a low design value, the bearing can be made to operate with minimum skidding and black oil formation.

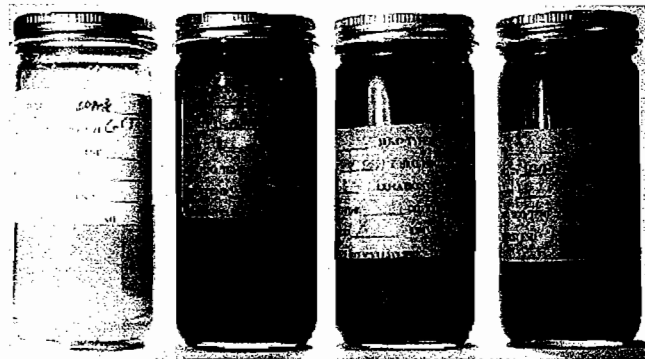
Figure A-1. Control and Tests 1, 2, and 3.

#1 Original design bronze oil ring 2 hours test duration	68	Medium Clearance	TURBINE VG32	Black+lots of fine bronze	Gross skidding of unloaded bearing with cage wear. Loaded bearing had some cage wear	NO

#2 New design bronze ring 2 hours test duration	55	Medium Clearance	TURBINE VG32	Mid brown+lots of fine bronze	Skidding of unloaded bearing with cage wear Loaded bearing had slight cage wear.	NO

#3 New design reverse rotation bronze oil ring 2 hours test duration	73	Medium Clearance	TURBINE VG32	Black+lots of fine bronze	Skidding of unloaded bearing with cage wear Loaded bearing had similar cage wear.	NO

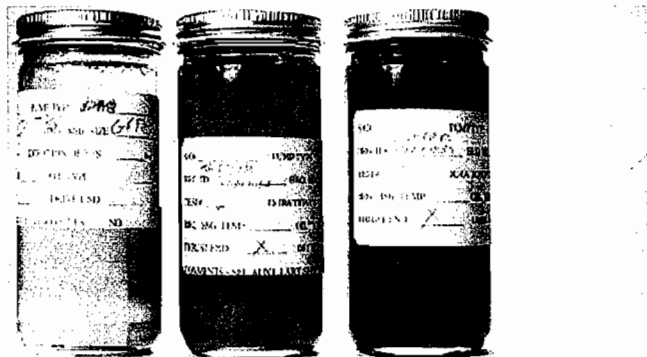
Figure A-2. Control and Tests 4 and 5.

#4 New design 2 hours test duration	72	Medium Preload	TURBINE VG32	Slightly darker and some clouding+fine bronze	Little or no skidding of unloaded bearing with slight cage wear Loaded bearing had similar cage wear.	YES

#5 New design see figure 5 bronze oil ring 2 hours test duration	57	Medium Clearance	TURBINE VG32	Mid brown+lots of fine bronze	N/A	NO
#6 New design bronze oil ring Same bearing as test 5 2 hours test duration	53	Medium Clearance	ANTI WEAR VG46	Virtually unchanged +lots of fine bronze	N/A	YES

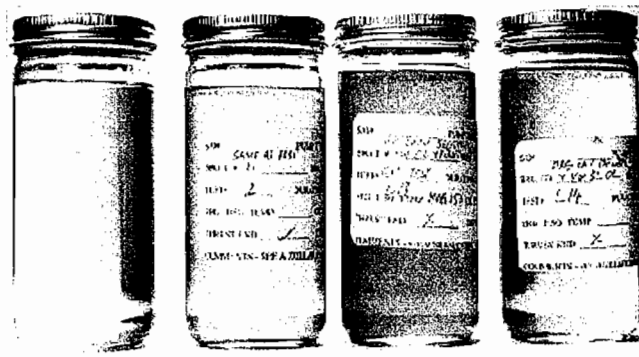
Figure A-5. Control and Tests 12, L13, and L14.

#12 New design 2nd oil trough bronze oil ring Same bearing as test 10 test duration 2 hours	65	Medium Clearance	ANTI WEAR VG32	Virtually unchanged +some fine bronze	N/A	YES

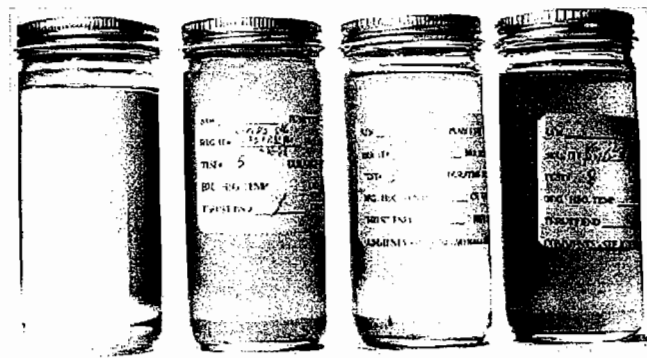
Figure A-3. Control and Tests 6, 7, and 8.

#7 New design bronze oil ring Same bearing as test 5 2 hours test duration	68	Medium Clearance	ANTI WEAR VG68	Virtually unchanged +some fine bronze	N/A	YES

#8 New design bronze oil ring Same bearing as test 5 2 hours test duration	53	Medium Clearance	TURBINE VG32	Virtually unchanged slight darkening +some fine bronze	Skidding of unloaded bearing with slight cage wear. Loaded bearing had similar slight cage wear.	YES

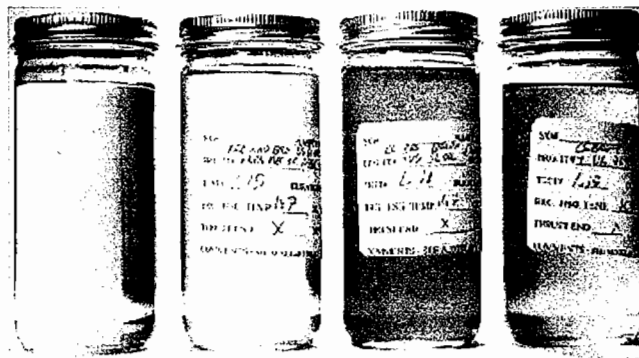
Figure A-6. Control and Tests L15, L16, and L17.

#L15 New design non metallic oil ring Same bearing as test L13 test duration 8 hours	70	Medium Preload	ANTI WEAR VG68	Virtually unchanged no bronze	N/A	YES

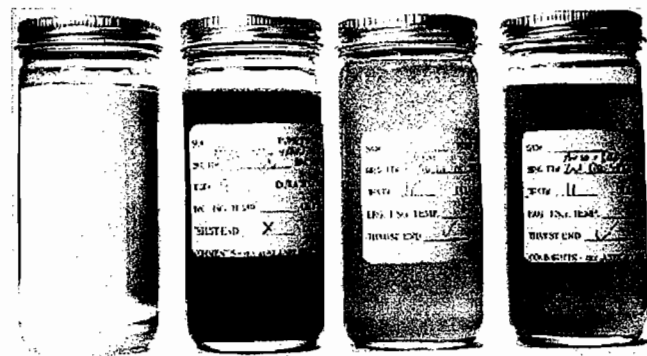
Figure A-4. Control and Tests 9, 10, and 11.

#9 New design bronze oil ring 2 hours test duration	63	Medium Clearance	ANTI WEAR VG32	Mid-brown+fine bronze	N/A	NO
#10 New design bronze oil ring 2 hours test duration	60	Medium Clearance	ANTI WEAR VG46	Slight darkening +fine bronze	N/A	YES

#11 New design 2nd oil trough bronze oil ring Same bearing as test 10 test duration 2 hours	70	Medium Clearance	ANTI WEAR VG46	Slight darkening +fine bronze	N/A	YES
