REPLACEMENT OF THE BOILER FEEDPUMPS DURING THE RETROFIT OF THE 500 MW UNITS AT A GERMAN POWER STATION

by
Cord H. Laux
Sulzer Pumpen A.G.
Winterthur, Switzerland
Uwe Burchhardt
VEAG Vereinigte Energiewerke A.G.
Berlin, Germany
and
Uwe Kirstein
VEAG Vereinigte Energiewerke A.G.
Jänschwalde, Germany

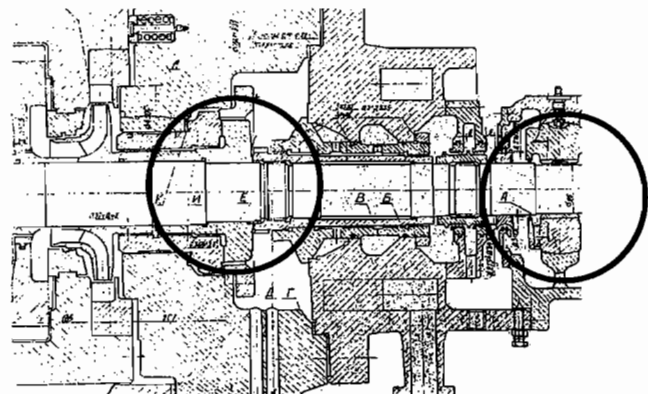
Figure 2. Technical Problems of the Pump Built in Russia.

• Design of the axial thrust balancing device in the form of a disk (Figure 2, excessive wear during transient operation).

The axial thrust is largely compensated by means of a cylindrical, nonstepped balance drum. Thus, no touching during transients can occur. The residual thrust is taken up by a tilting pad axial bearing that can be subjected to load on both sides. This ensures sufficient safety, even with maximum running clearances and increased coupling thrust. The piston is shrunk-fitted to the shaft. The piston can be easily dismantled with an appropriate hydraulic device.

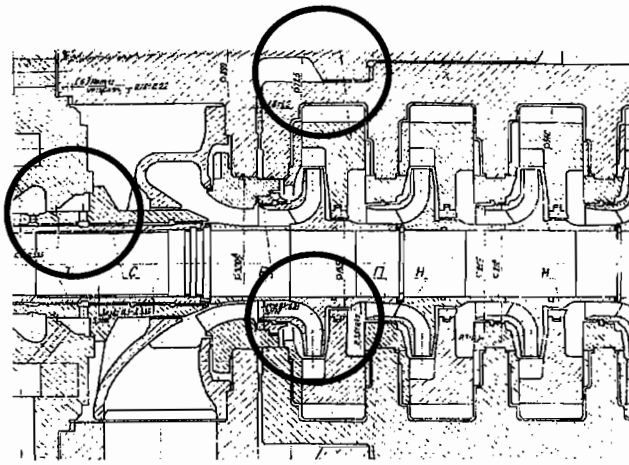
Figure 3. Technical Problems of the Pump Built in Russia (Continued).

• Seal water supply system on the throttling bush shaft seal (Figure 3, high heat losses, complicated system, shaft prone to bending during transients).

• Thermal problems in connection with the shaft seal (consequently lowering of the bearing support, increased wearing clearances, likely rotor instability).

A mechanical shaft seal, type 270 F 6.5 in, with a material combination silicon carbide paired with synthetic-impregnated carbon, has been fitted as shaft seal. The circulation is affected via an externally located cooler and magnetic filter, and without any dosing circuit as is customary for an operation in combined oxygen treatment (feedwater between alkaline and neutral). A cooling chamber is provided to reduce the heat transfer from the hot pump in the direction of the rotating seal ring. The mechanical seals can be dismantled as a complete unit. During operating conditions, the circumferential speed in the middle of the rotating seal ring is about 157 ft/s. The leakage quantity measured in the installation is less than one liter per hour.

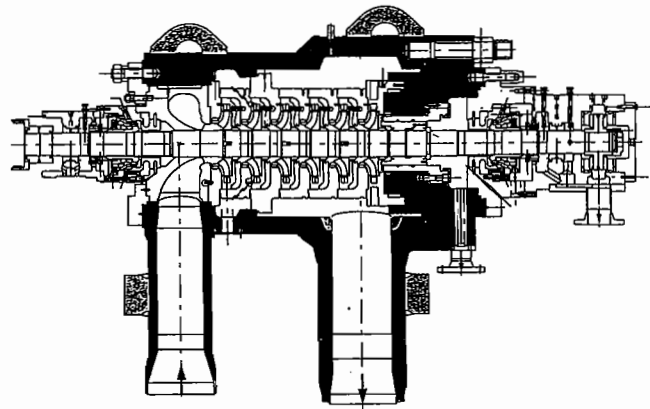
*Figure 5. Cross Section of the Pump.*

Following their removal and dismantling, the casing and cover of the old main pump were examined for possible further use, remachined for the fitting of the new cartridge and then subjected to another quality inspection. The positions that had to be adapted for the new cartridge are shown in Figure 5.

Different casings had to be repaired, because the ultrasonic and liquid penetrant tests revealed cracks and porous lines in the welds. The cracks were ground out and welded. With one casing, the delivery branch had to be cut off and welded again.

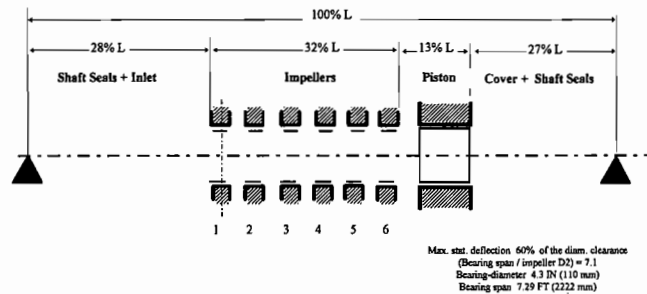
Figure 6. Bearing Span at Jänschwalde (New Cartridge in Existing Casing).

The main pump, type HPT300-315-6s/33A, is a centrifugal machine with barrel casing design. The suction and delivery branches are arranged vertically facing downwards (Figure 5). The bearing span of 7.28 ft is governed by the existing casing of the pump, i.e., about 10 percent more than the span usually needed for a six-stage hydraulic. From the standpoint of the bearing span, the selected six-stage pump corresponds to a seven-stage machine (Figure 6), when it is manufactured according to the latest principles. Consequently, the static sag of the retrofitted pump rotor is greater than that expected with a brand new machine.

The larger bearing span conditioned by the use of the existing casing naturally resulted in increased static sag of the shaft, which favored the scuffing. Precise alignment of the impeller in the casing is therefore of decisive importance.

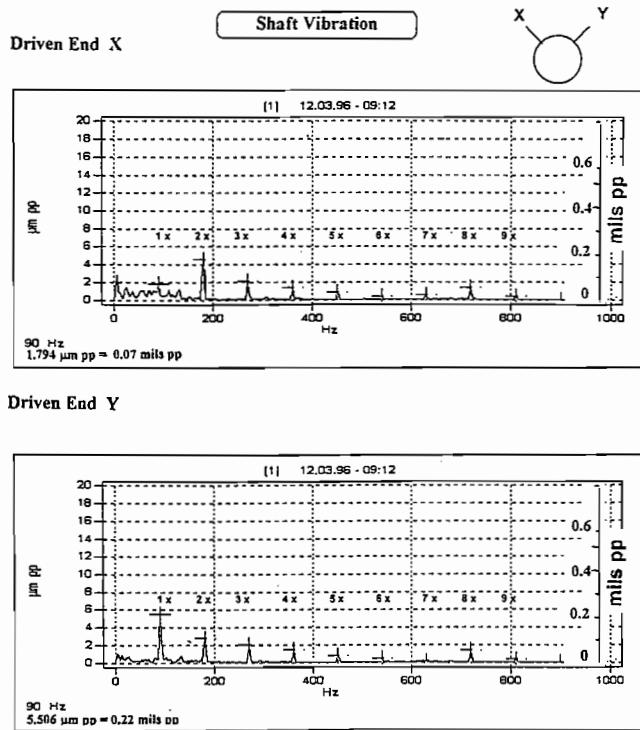
Figure 8. Frequency Plot of Shaft Vibration.

The pump in operation is exceptionally quiet. The frequency spectrum is shown in Figure 8 and Figure 9 of the vibration of the Pump F1 at the continuous operating point in the plant. This pump already has an opened impeller gap clearance. The harmonics of the speed frequency are designated in Figure 8 and Figure 9 with 1×, 2×, etc.

• 1×–The peak is 1.8 μm p/p (in x-direction), respectively, 5.5 μm p/p (in y-direction) (filtered for rotational frequency) NB. This value corresponds to a cumulative value of Smax≈0.35 mils p (9.1 μm p) (unfiltered) and provides information about the sum
