# A CASE HISTORY-IMPROVEMENTS TO AN EXISTING COOLING TOWER SUMP AND HORIZONTAL SPLIT CASE PUMPS

**Paul J. Wallen**

**Gregory S. Towsley**

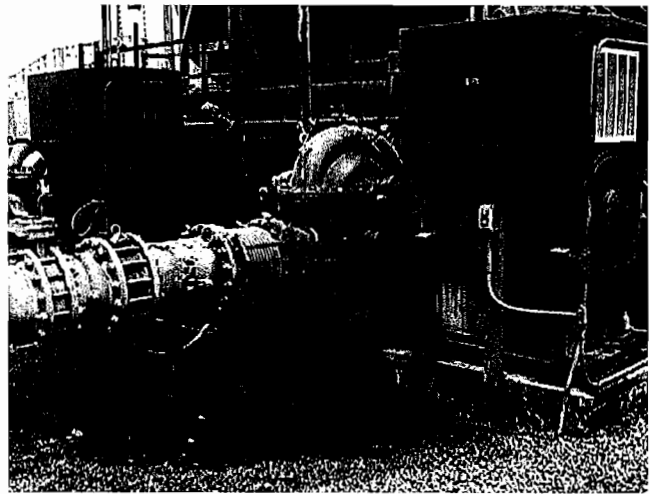
Figure 6. Pump and Cooling Tower Basin Installation.

The construction of the new urea plant and cooling tower basin took place within the company's existing property. It must be noted that ample space was available for the construction of the basin and location of the pump units. Figure 4 (Plan View) and Figure 5 (Elevation View) show the original layout of the pump suction inlet area of the cooling tower basin. Figure 6 shows a view of the pump unit and cooling tower basin installation. Figure 7 is a view of the pump suction inlet piping.

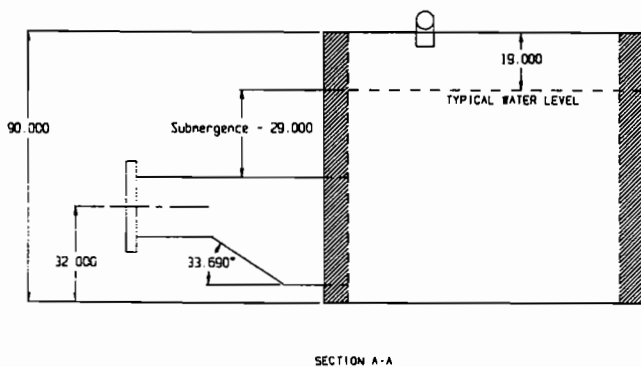
Figure 5. Original Cooling Tower Basin—Elevation View.

As can be seen in Figure 5 and Figure 7, a standard eccentric reducer is installed in the horizontal position. With the eccentric reducer positioned in this fashion, there are no pockets for air to become trapped. It is therefore unlikely that cavitation is occurring due to air entrapped in the suction piping being drawn into the pump with the incoming water flow.
