Bearing Failure on a Boiler Feed Water Pump

A Case Study by:

Kevin Karban

Kerry Gunn

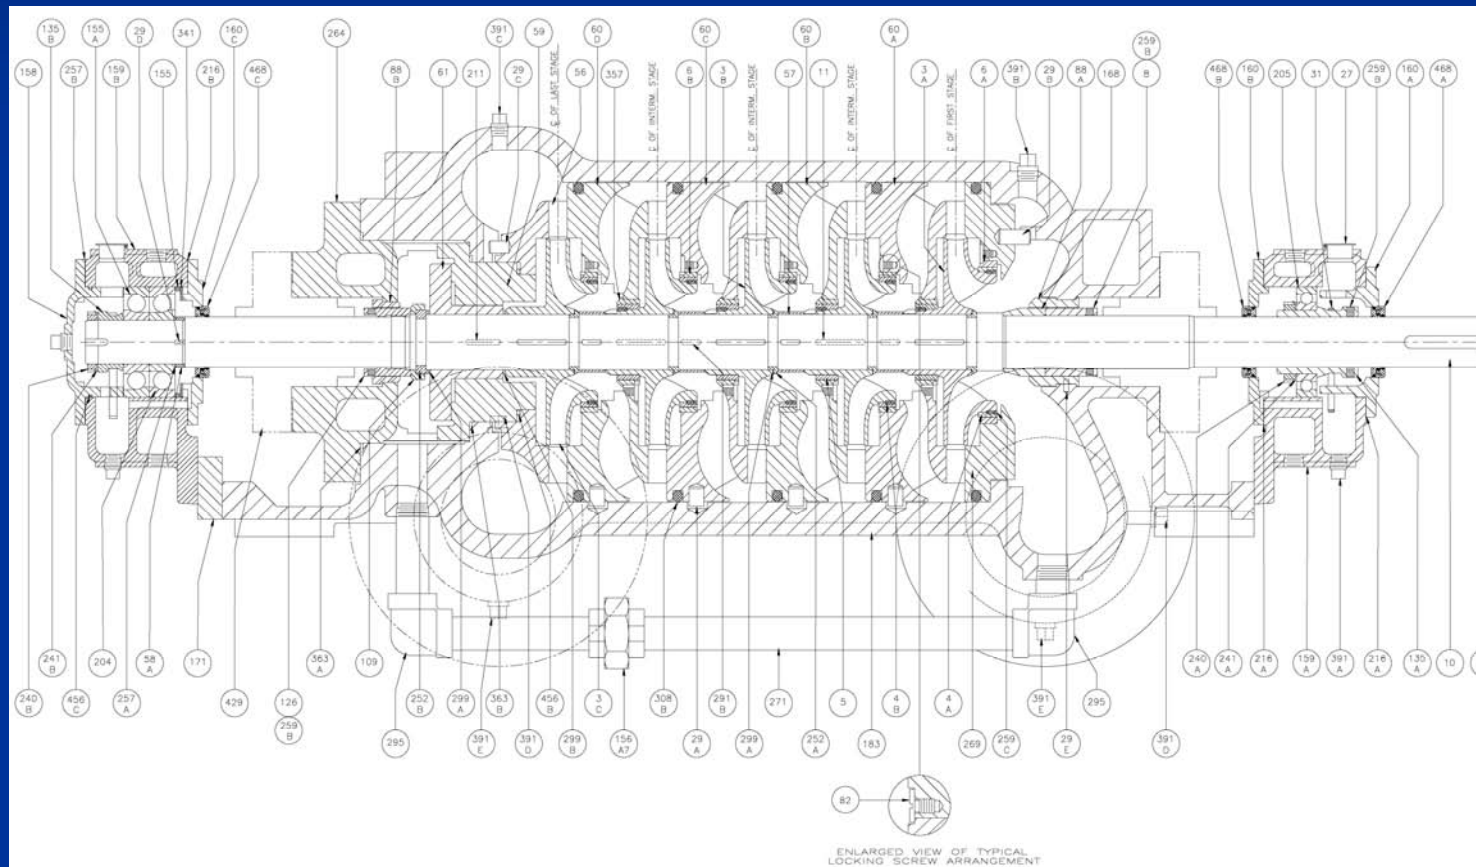
Pump Cross Section Drawing

- BB3 Between bearing multistage centrifugal pump.
- Ingersoll-Rand 5-HMTA-5
- Service is Boiler Feed Water, 240F Operating Temperature, 10 PSIG Suction Pressure, 895 PSIG Discharge Pressure
- The pump was originally built for high pressure amine service at a different facility and was acquired in 1974 for use in the boiler feed water service.
