# Diagnosing and Correcting a Damaging Below-Ground Column Natural Frequency in a Vertical Pump Using Field Testing and FEA

28<sup>th</sup> International Pump Users Symposium  
September 24 - 27, 2012

Case Study

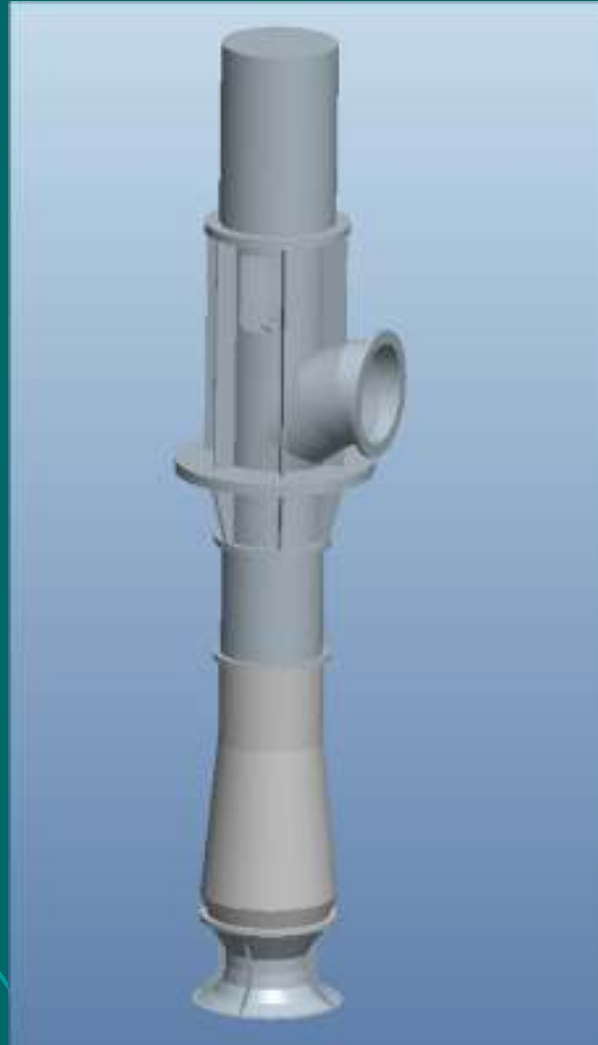
Detailed solids model of the pump

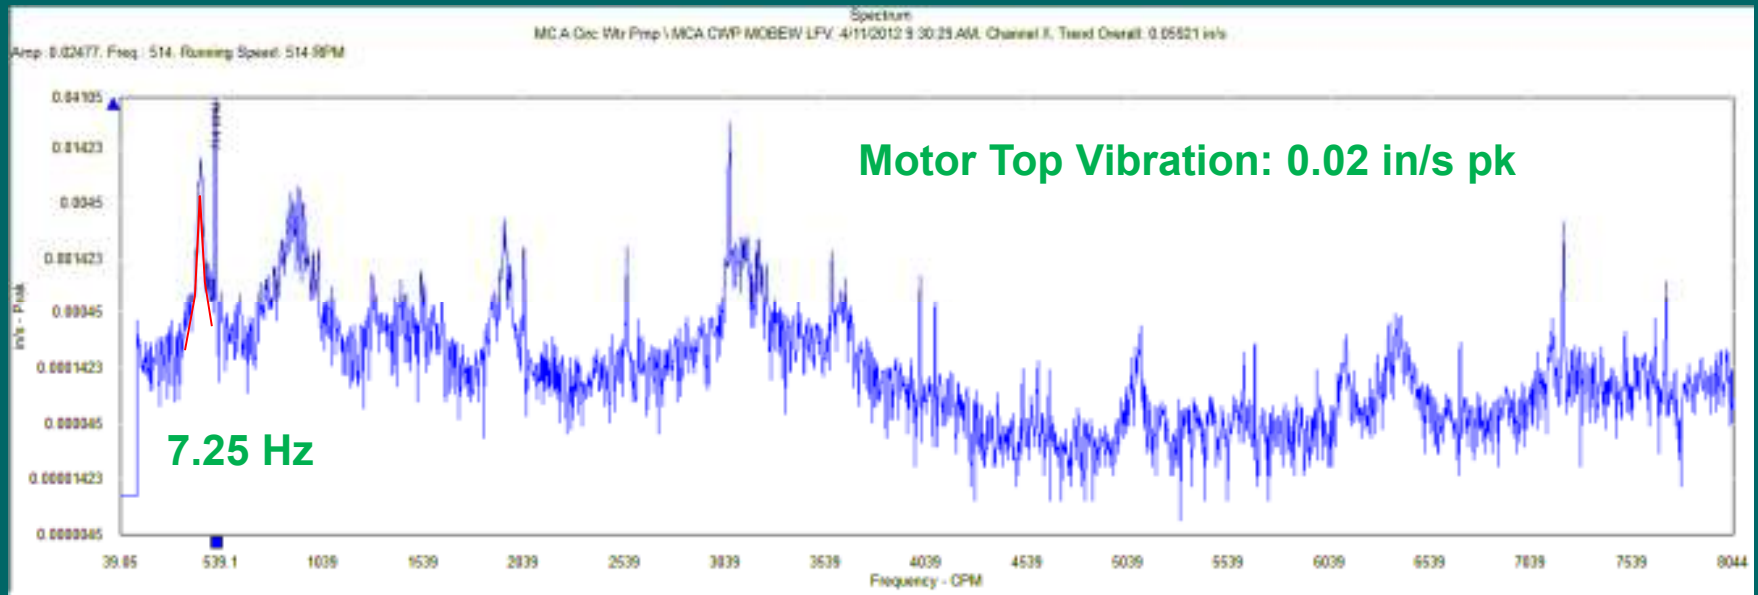
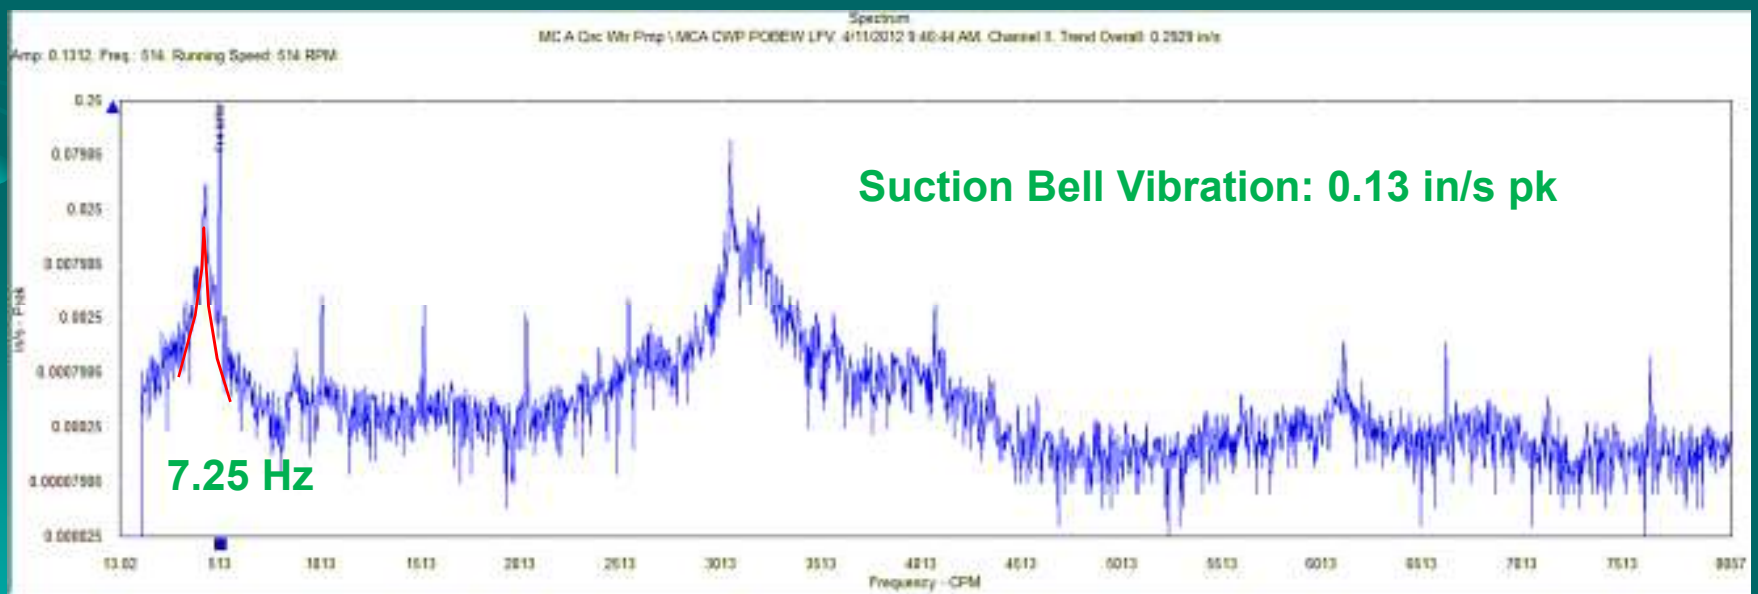
# Follow-Up Testing with Weight

- The root cause of the high vibration at the top of the motor was due to a below-ground dominated mode (trunion mode) rather than the typical motor cantilever rocking mode. This is why the additional ribbing of the above ground structure did not significantly shift the offending natural frequency.
- The looseness between the discharge head mounting flange and the soleplate shifted the offending mode away from the 1x running speed frequency.
- The addition of weight to the bottom of the suction bell in conjunction with the increased added mass effect of the surrounding water lowered the offending below-ground natural frequency to have sufficient separation margin (~15%) from the running speed.
