Dramatic Vibration Improvement due to Ring-Section Pump Foundation Repair Based on ODS in a Power Plant

26th International Pump Users Symposium

Mechanical Solutions, Inc.

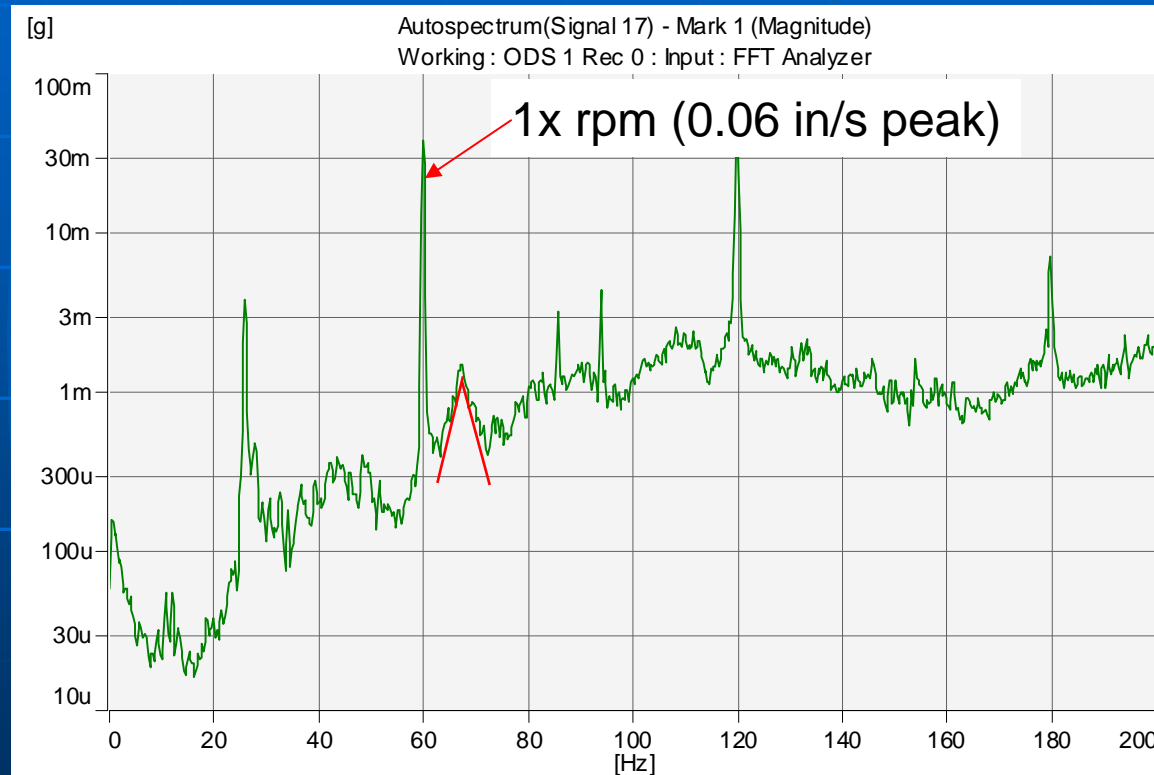
Pump #1 Typical Spectrum OBB in the Horizontal Direction

Natural frequency at 67.3 Hz (12.6% above 1x rpm)

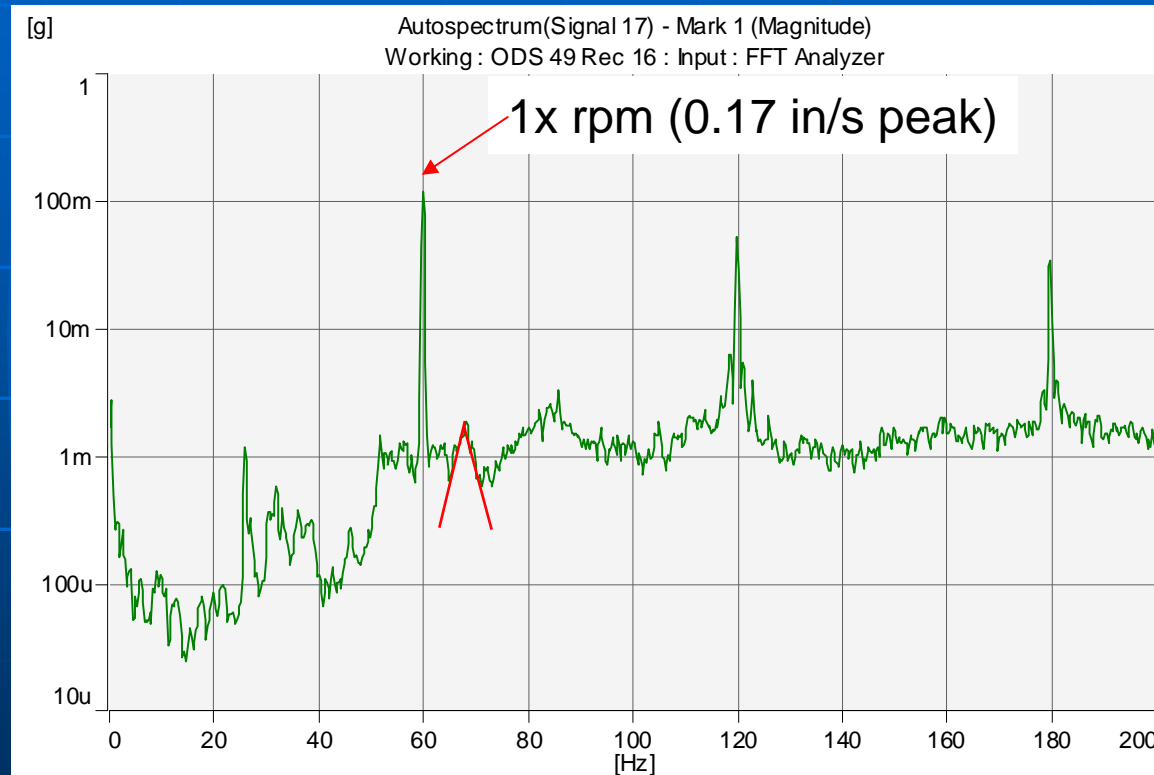
Pump #3 Typical Spectrum OBB in the Horizontal Direction

Natural frequency at 68 Hz (13.8% above 1x rpm)

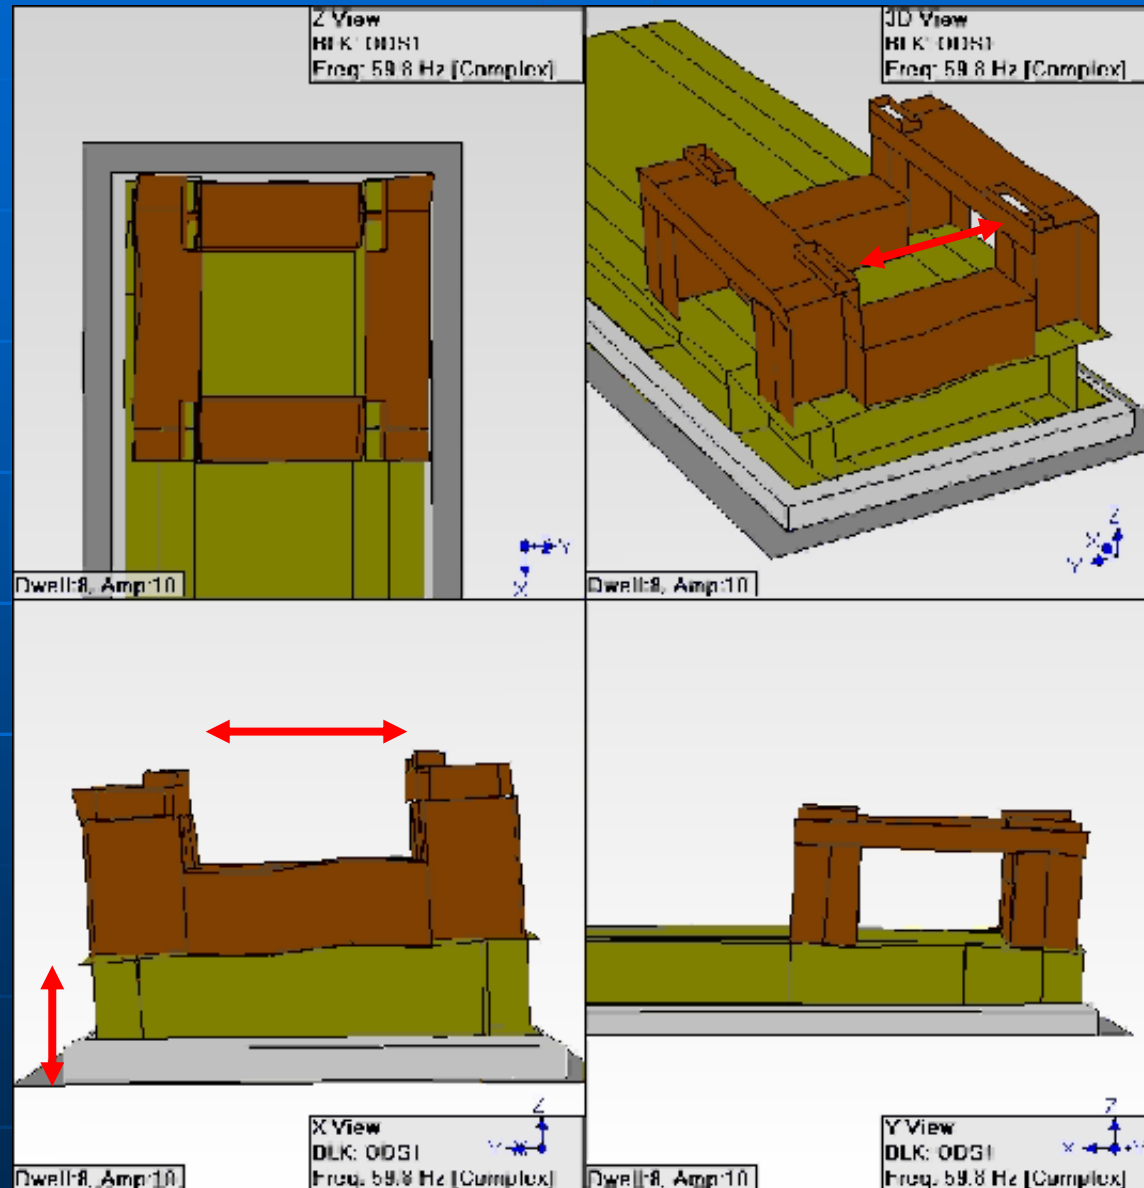
Pump #2 @
1x rpm after
OB feet
bolts
tightened

1. Excessive flexibility at the baseplate due to possible softness or delamination of the internal grout (Pump #2 moved 10x more than Pump #1).
2. OBB housing vibration increased almost 6 times in 4 hours of operation (from 0.06 in/s peak to 0.35 in/s peak @ 1x rpm), and 50% shaft vibration.
3. During the cold start up, 1x rpm spike located between two natural frequencies (57 Hz from the rotor lateral and 63.5 Hz from the structure). The structure became less stiff and reducing the damping of the system; therefore, the rotor natural frequency shifted upwards in the neighborhood of the running speed.
4. Shaft phase angle variation over time. (OBX -60 deg., OBY -20 deg., IBX -110 deg., and IBY -110 deg.)
5. Pumps #1 and #3 did not indicate rotor natural frequencies near the running speed. The lateral rocking mode was identified 13% above 1x rpm.

- All J-bolts of the baseplate torqued up to 600 ft-lb.
- Pump IB feet bolts torqued up to 1000 ft-lb.
- Dowel pin and holes cleaned up and drove pins in tight.
- Pump OB feet tightened after full warm-up condition

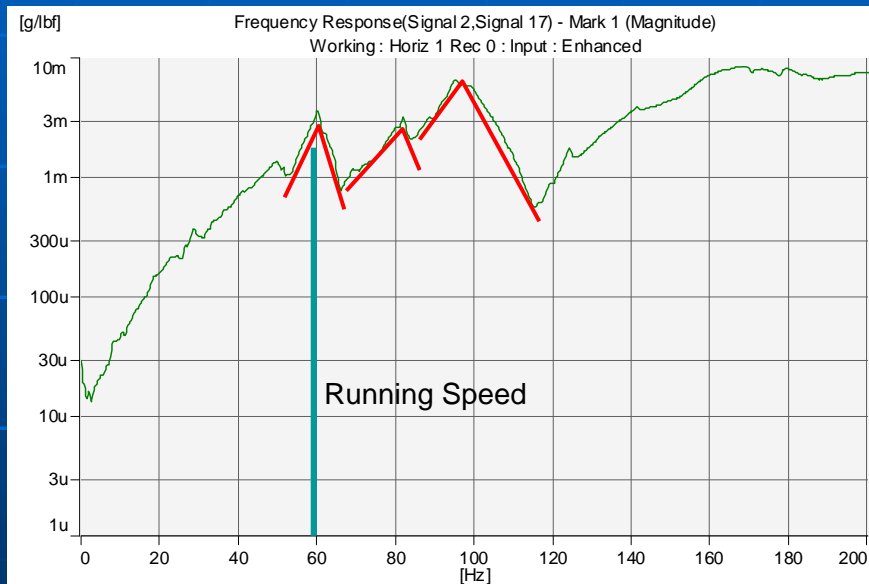
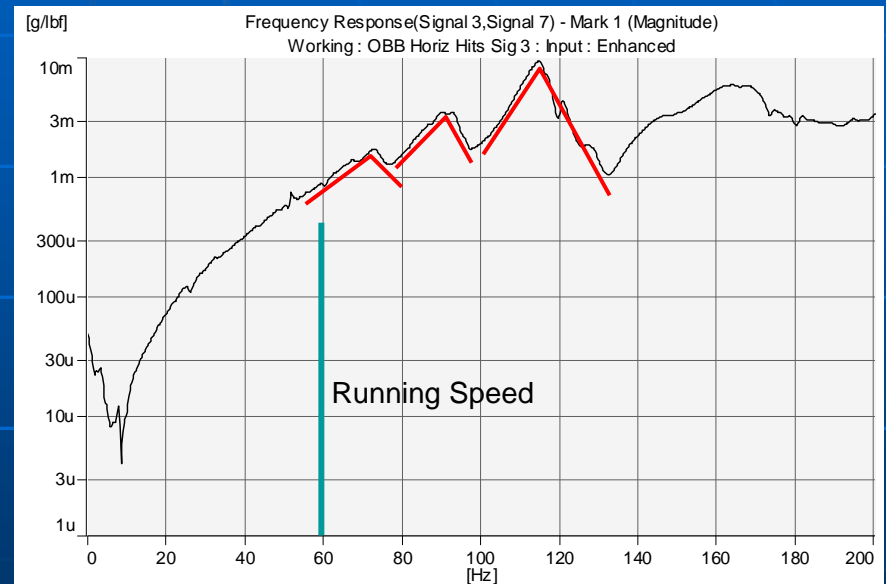
Comparison of FRF from EMA Test (not Operating) in the Horizontal Direction at the Pump OBB Housing

Natural frequency at 73 Hz (23% above 1x rpm)

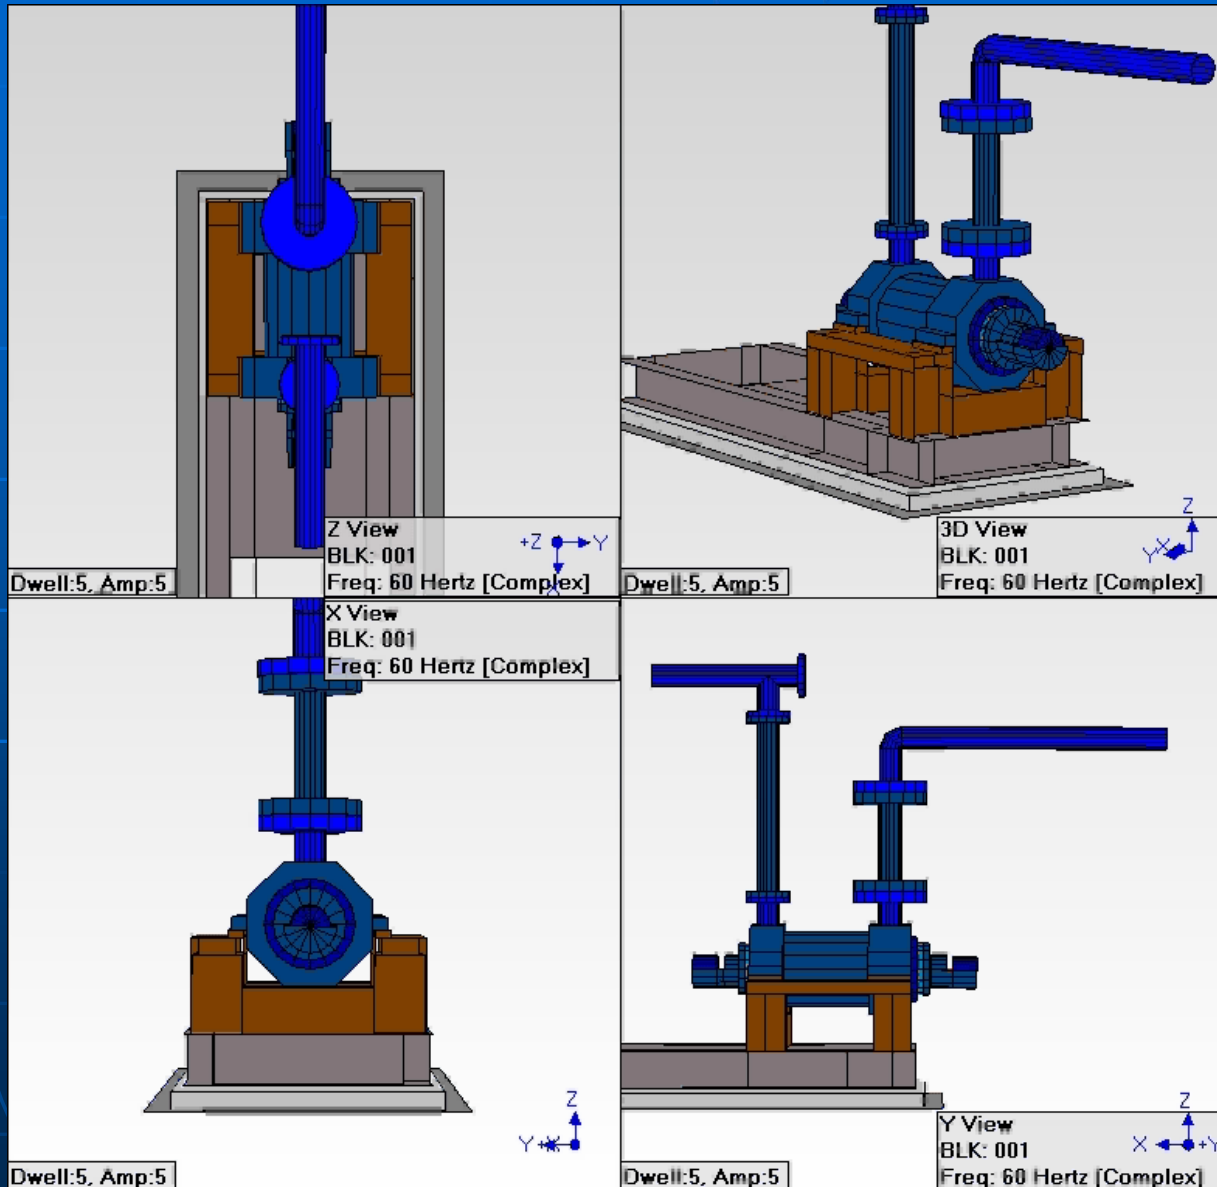
Final Operating Deflection Shape

- The root cause of the vibration on Pump #2 was due to excessive flexibility at the baseplate caused by softness or delamination of the internal grout. This phenomenon originated due to the looseness of the anchor J-bolts.
- After all modifications performed on the baseplate, the maximum vibration amplitude at the OBB housing in the horizontal direction was reduced from 0.35 in/s peak to a greatly improved value of 0.09 in/s pk @ 1x rpm.
- The ODS is a powerful troubleshooting tool to facilitate and visually understand most common vibration problems in any pumping system or turbomachine.
