Latest Advancements in Mechanical Seal Technology Using Laser Machined SiC Faces to Withstand Electro Kinetic Driven Corrosion

25th Pump User Symposium

Some facts on power plant Jänschwalde, Vattenfall Europe Generation AG & Co. KG:

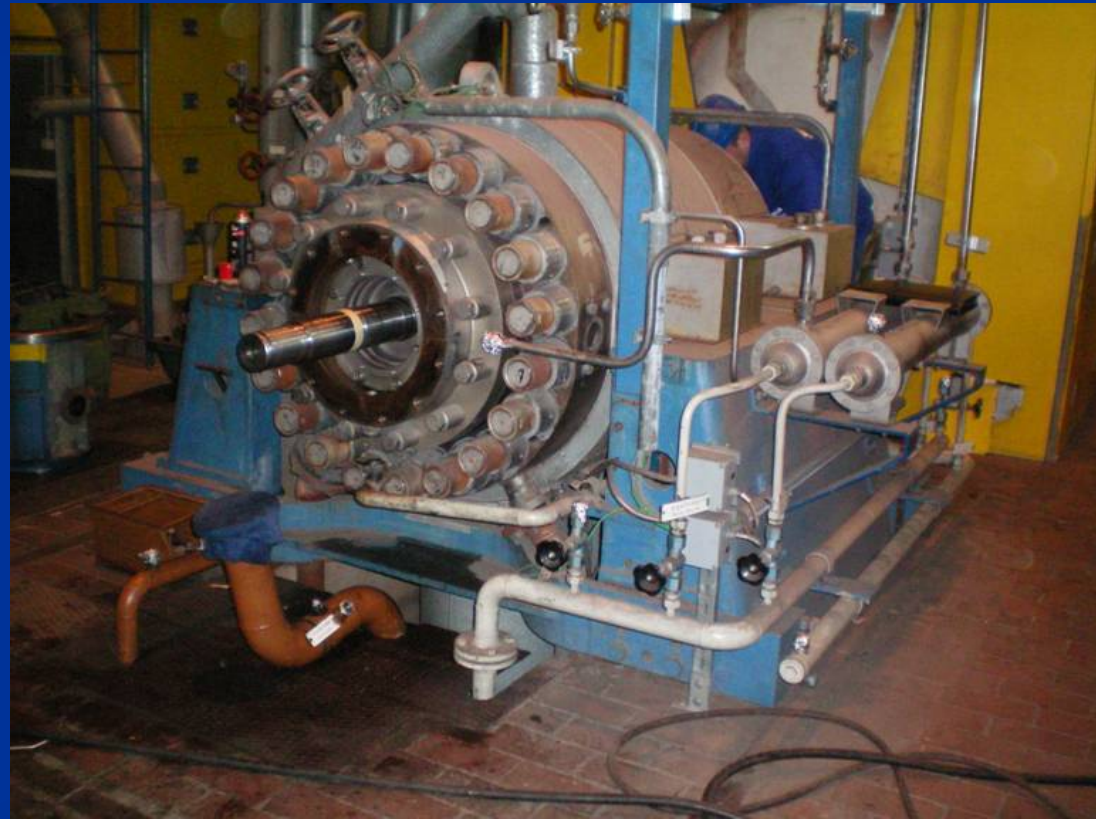
Subject Boiler Feed Pump:

Indicated as the plant's worst bad actor pump

After 3,000 hours, very unpredictable performance, varying per pump. In some cases, seal MTBM was cut in half after each repair!

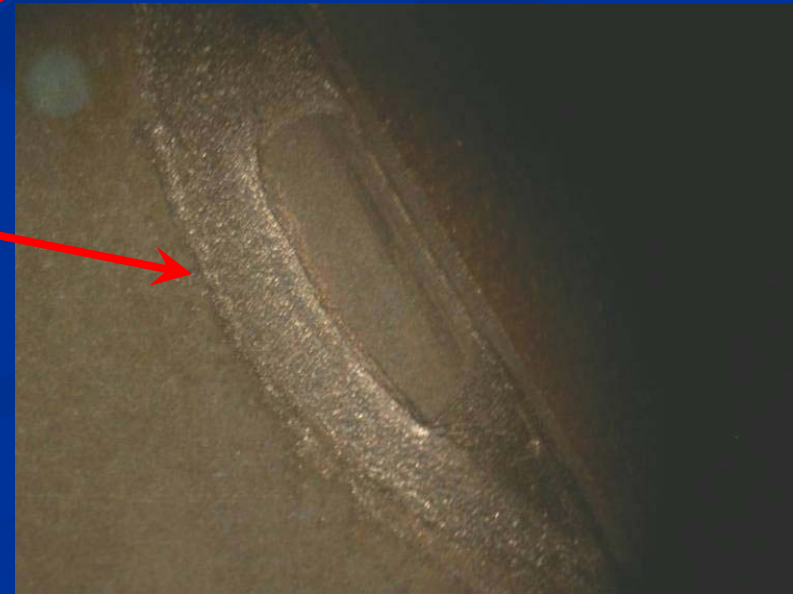
Signs of electrical currents discharging at seal metal parts (sleeve bore) as well as at the seal faces

Material research indicates that electro corrosion initiates material fatigue by extracting binder material from the carbon graphite, leading to subsequent failure
