# RELIABILITY IMPROVEMENTS TO A HIGH PRESSURE, HIGH TEMPERATURE, THIRTEEN STAGE CHARGE PUMP

Dave A. Johns

Shell Oil Company

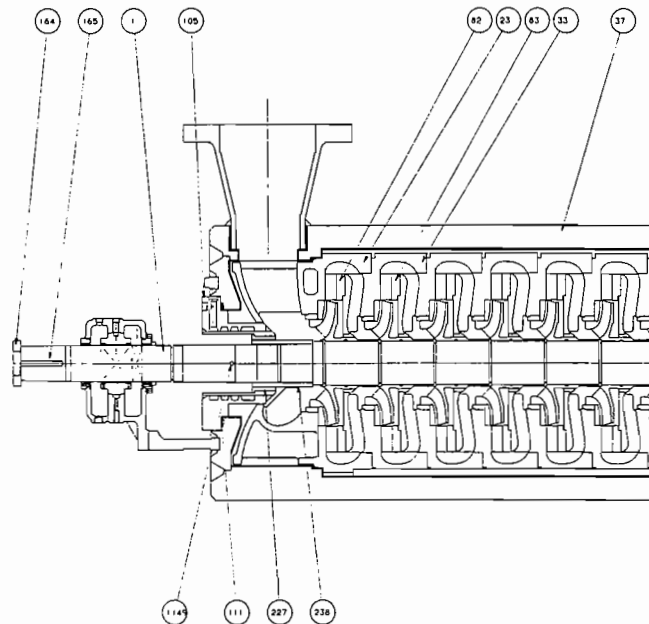
Figure 1. Pump Assembly.

The Hydrocracker Unit at the Norco Manufacturing Complex depends on a single (unspared) pump to charge oil to the unit. General data for this pump are presented in Table 1. Pump assembly drawing is shown in Figure 1.

Since installation in 1965, this pump has had a record of poor reliability with several seal failures resulting in fires. Previous

attempts to improve reliability have made some progress, but the pump was never able to run from turnaround to turnaround. The majority of the seal failures were on the coupling end and most of the failures occurred during pump startup.

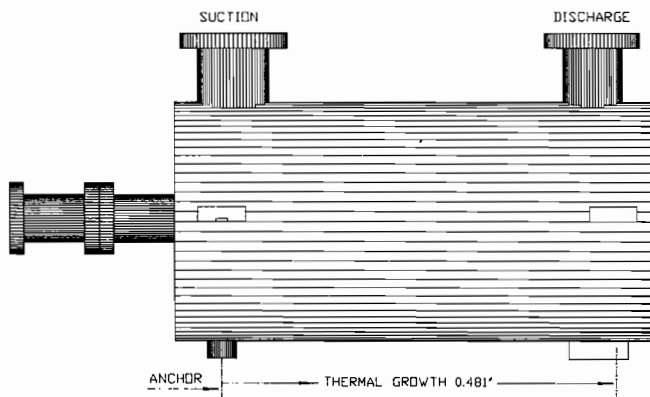
Figure 17. Location of Horizontal Spring Supports.

showed very little change. After the system reached operating conditions, the spring cans were adjusted to calculated hot operating loads.
