**REPETITIVE SHAFT CRACK FAILURE ANALYSIS
ON A MULTISTAGE CENTRIFUGAL PUMP IN REACTOR CHARGE SERVICE
IN A NUCLEAR POWER PLANT - BASED ON ODS AND FEA**

Maki M. Onari

Victor G. Arzani, P.E.

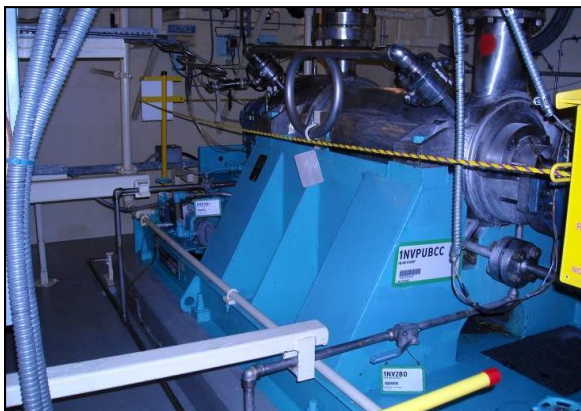
Figure 2. Photo of the 1B NV Pump

The pump on which most of the testing was conducted was on the 1B NV, which was reported to be the only pump with three failures showing cracking at the discharge end of the shaft. The failures took place between 1989 and 2007 (MTBF=7.3 years). Figures 1 and 2 show the cross sectional drawing of these pumps and a photo of the problematic pump 1B NV.

In 1989, the first failure took place, but the failure analysis was not properly documented and the failed shaft was not preserved. Three years later in 1999, a crack was found at the rear end of the 9th stage hub. In December 2007, the last failure was discovered under the 11th stage impeller hub (Figure 3) with evidence of fretting as shown in Figure 4. A circumferential crack was found at the keyway with 132 degrees arc as shown in Figure 5. It was also reported by CNP that the vibration amplitude of the pump had been always considered low and adequate.

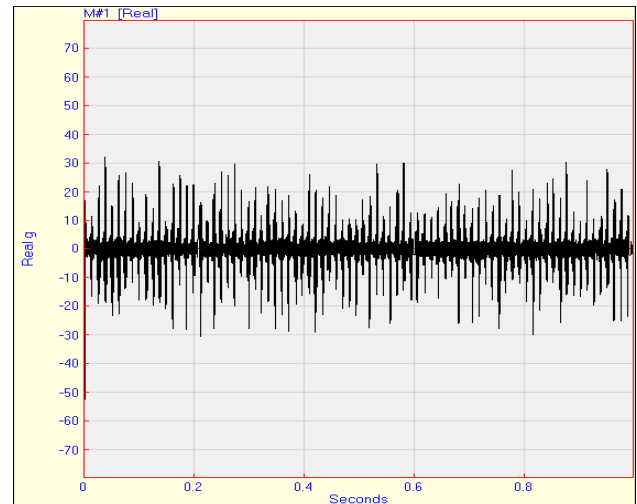
Figure 29 Acceleration Signal Derived From Axial Proximity Probe Readings (g's versus Time in Seconds)

A 75 psi (5.2 bar) pressure saw-tooth impulse of 0.2msec duration was applied to the inboard end of the shaft. This impulse was determined to result in 30 g (294.2 m/s²) acceleration at the outboard end, which correlated with the axial proximity probe readings. Figures 17 and 18 show the vibration spectrum and wave form from the axial proximity probe mounted at the outboard bearing of the pump. Figure 29 depicts the acceleration differentiated two times from the proximity probe displacement data.

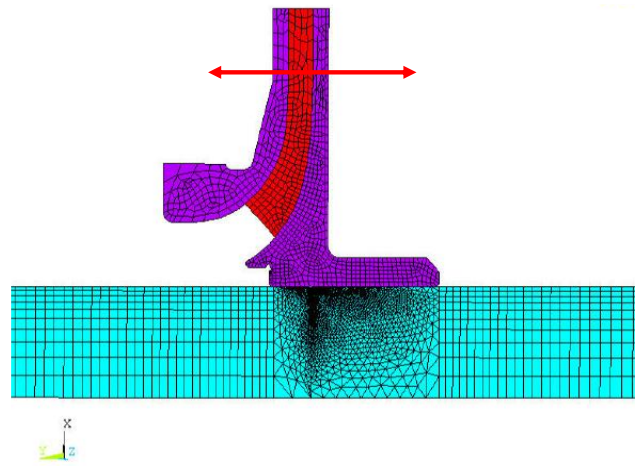
Figure 31 Impact Acceleration of 30 g's pk (294.2 m/s²) at 30 Hz

Figure 31 shows the same axi-symmetric model with a finer break-up around the initial crack (5.0 mils or 127 microns) included into the model. Figure 32 shows a zoomed view of the explicitly modeled crack on the shaft.
