RESOLVING VIBRATION ISSUES OF DIESEL ENGINE DRIVEN FIRE WATER PUMPS

Sherief Mekawey
Principal MDS Engineer
GE-Bently Nevada

42nd Turbomachinery
29th Pump SYMPOSIA

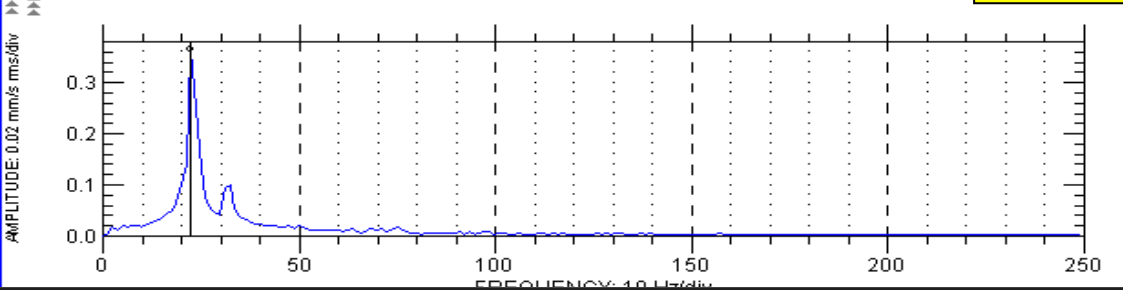
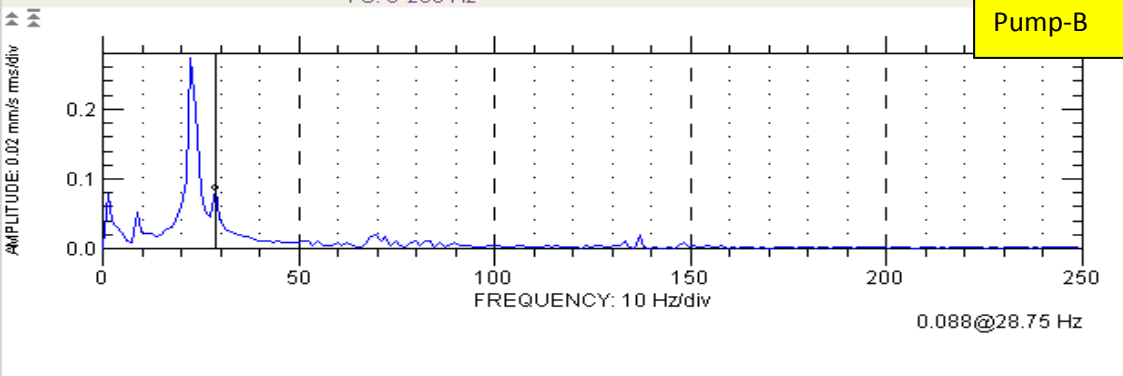
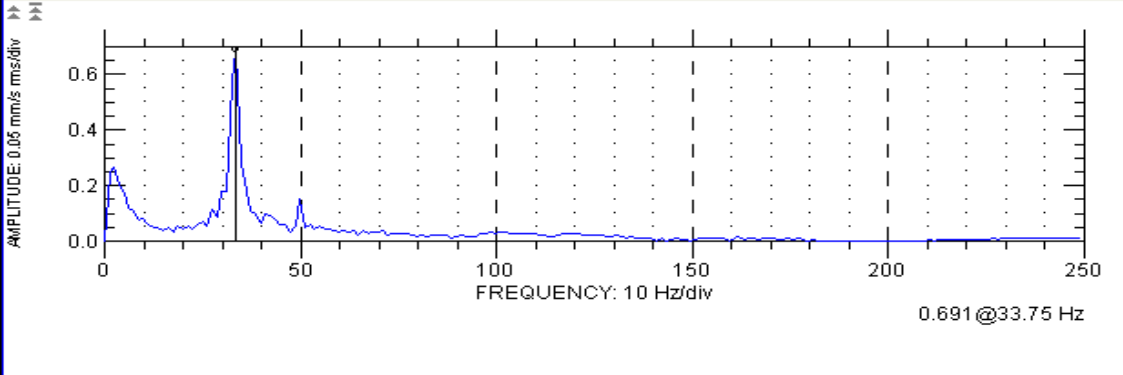
Observation#3: Bump test data on the Gearbox structure indicated a resonance at 22.5Hz and 33 Hz, which is less than 20% separation margin (Pump Running speed 28.75cps)

- Unbalance of Gearbox cordon shaft or coupling hub mounted at gearbox input shaft
- Transfer of vibrations from diesel engine to the gearbox and pump assembly
- Structural resonances from gearbox support assembly.
- Premature wear of gear teeth / excessive backlash.

- In situ balancing of gearbox cordon shaft and GB O/P shaft.
- Installation of vibration isolators below the engine feet or the base frame
- Modify the Gearbox structure to shift the natural frequency with 30% separation margin.
- Inspection of Gearbox for excessive gear wear/backlash.

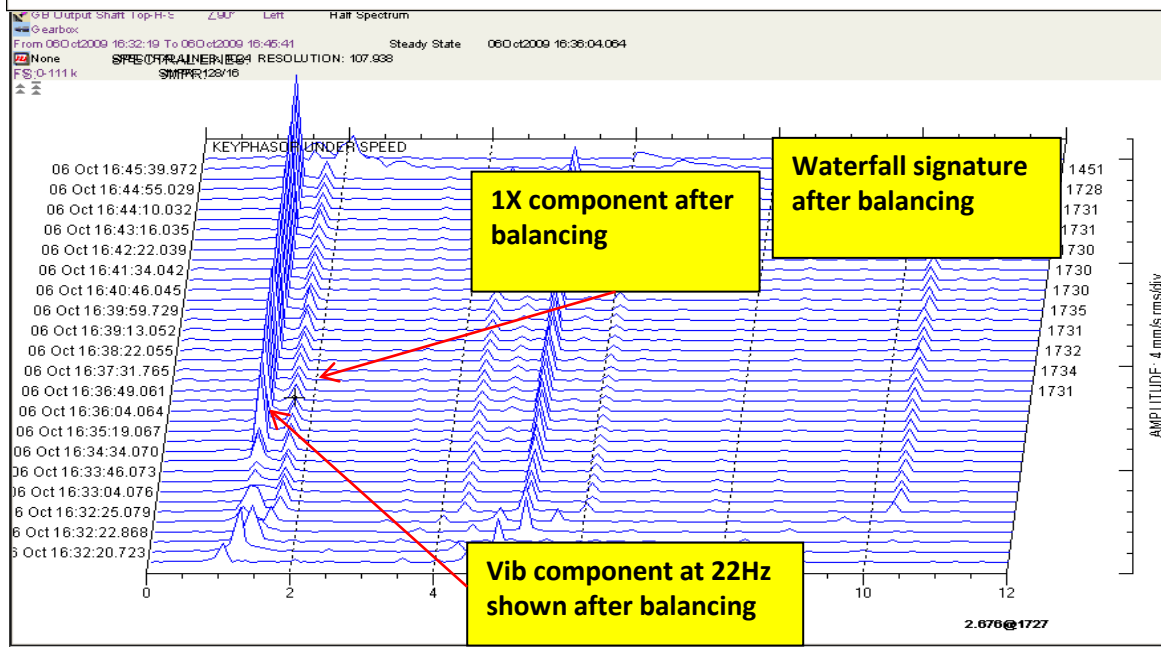
Reason could be: vibration isolators are not installed either under the engine feet nor under the frame on which the engine is mounted.

Action#2: The engine stand was replaced with a new stand with vibration isolators
