# ROTATING EQUIPMENT PUMP RELIABILITY UPGRADING PROJECT

**Ed Ringstead**

**Shell U.K. Limited**

**Stanlow Manufacturing Complex**

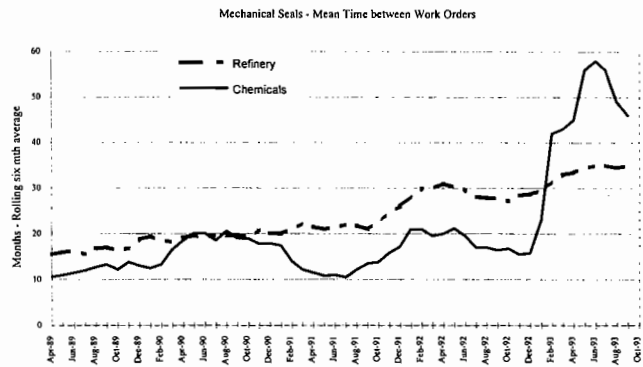
Figure 7. Mechanical Seals—Mean Time between Work Orders.

Seal failure rates are now at their lowest point ever, with only 52 failures of the converted seals since May 1990, an annualized rate of less than 23 failures a year—less than 10 percent of the previously experienced failure (Figure 7).

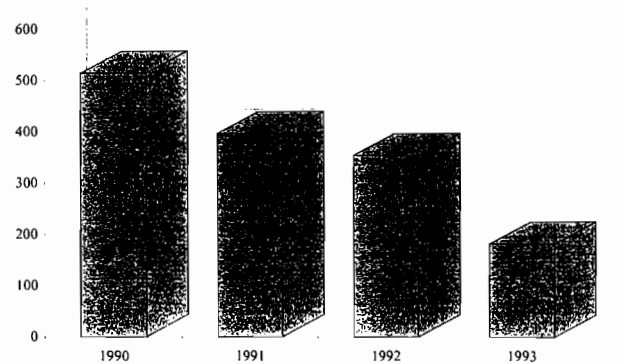
Figure 8. Pump Maintenance Costs (£k).

Pump maintenance costs have fallen steadily over the course of the project, from £515,000 in 1990, £397,000 in 1991 to £365,000 in 1992 (Figures 8 and 9).
