Rotor Retrofits Improve Pump Station Vibration

27th International Pump Users Symposium
September 12 – 15, 2011

By:
Jeffrey R. West P. E.
Udelhoven International Inc.

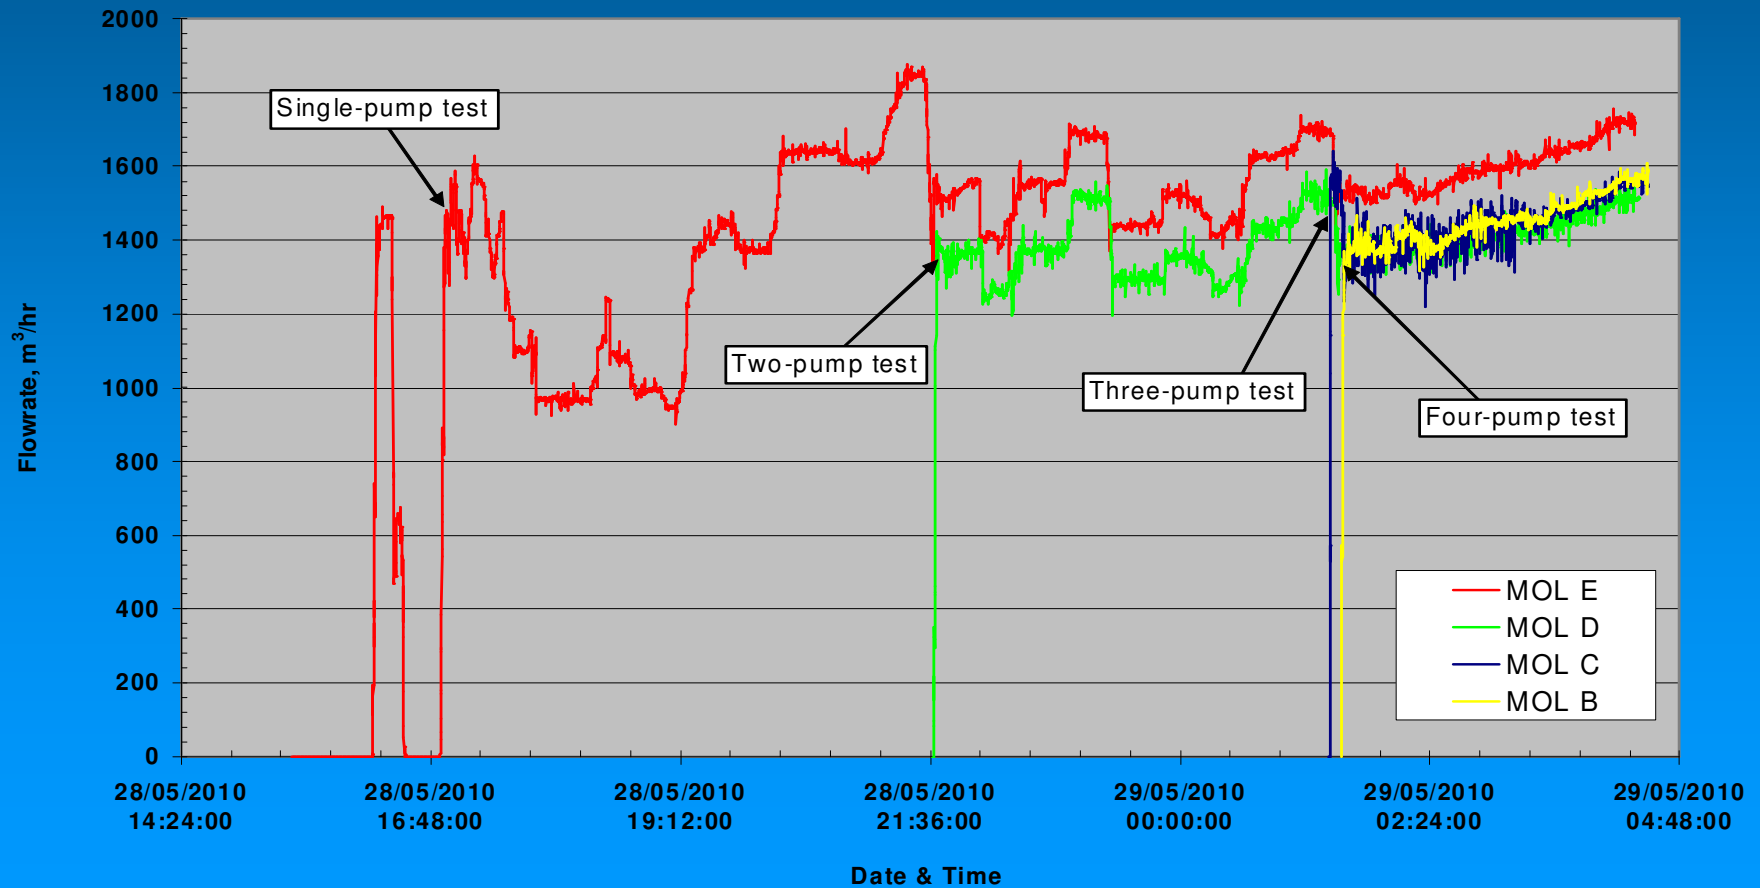
Pump Performance Test #2 - MOL Pumps Flowrate Measurements from Ultrasonic Flowmeters

➤ Single and Multi-Pump Flow Rates
